B. PAWŁOWSKI\*, P. BAŁA\*, T. TOKARSKI\*, J. KRAWCZYK\*

**PREMATURE CRACKING OF DIES FOR ALUMINIUM ALLOY DIE-CASTING**

Two identical dies for aluminium alloy die-casting failed prematurely because of a number of parallel cracks on the working surface. These cracks were of a mechanical nature related to incorrect microstructural banding orientation of the die core and related to improper heat treatment. The microstructural banding orientation was determined by metallographic examination of the specimens, which were cut from the dies along the three axes of the coordinate system. Scanning electron microscopy (SEM) examination of the fracture surfaces and along the crack path (including energy dispersive spectroscopy (EDS) analysis) indicated that the root cause of the premature cracking of the dies was improper heat treatment (quenching and tempering conditions). Additionally, resistance to fracture of the investigated specimens, as measured by the Charpy V-notch test, was five times lower than that required for the desired hardness.

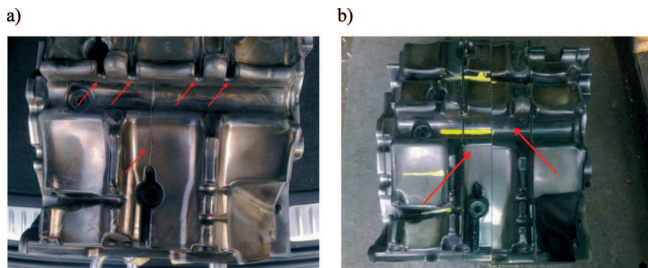
This paper investigates two damaged dies (surface parallel cracks, indicated by arrows in Fig. 3) that failed after a few thousand shots, instead of after the guaranteed one hundred thousand shots.

Fig. 3. Surface cracks of dies A (a) and B (b) that failed after a few thousand shots

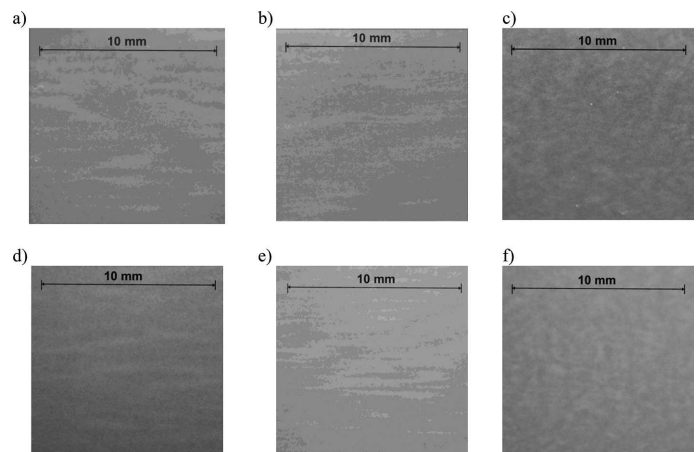
The chemical composition of the investigated steel (die A, in wt. %) was 0.32% C, 0.22% Si, 0.44% Mn, 4.71% Cr, 2.17% Mo and 0.58% V and meets the Dievar steel manufacturer requirements [11]. The microstructural banding orientation of the investigated dies can be seen in the macroscopic images of etched metallographic specimens for the XY, XZ and YZ planes (see Fig. 4), which are presented in Fig. 5. The appearance of the microstructural banding (fibrous microstructure of steel) is caused by the segregation of substitutional alloying elements during the dendritic solidification and is affected by subsequent plastic deformation. As shown in Fig. 5, for both dies, the microstructural banding direction is parallel to the X-axis of the coordinate system used, which is also the direction of surface crack propagation. A banding structure of the dies was also observed at higher magnification during the microscopic examination. The results of these observations are shown in Fig. 6. As all observed surface cracks (for both dies) were parallel to the X-axis, it is clear that such a geometrical orientation of the dies with respect to the microstructural banding promotes crack propagation. However, such microstructural banding, as presented in Fig. 5 and Fig. 6, is acceptable according to the North American Die Casting Association industry standard [12] but the banding direction does not meet the requirements of the manufacturer's design assumptions.

Fig. 5. Macroscopic images of etched metallographic specimens, etched with 2% nital, a) die A XY plane, b) die A XZ plane, c) die A YZ plane, d) die B XY plane, e) die B XZ plane, f) die B YZ plane

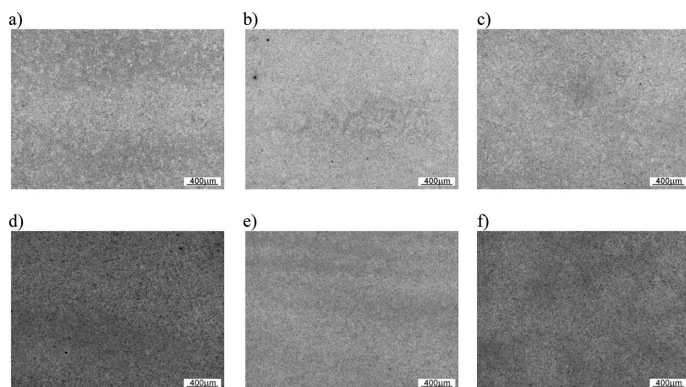
Fig. 6. Microscopic evidence of microstructural banding, etched with 2% nital, a) die A XY plane, b) die A XZ plane, c) die A YZ plane, d) die B XY plane, e) die B XZ plane, f) die B YZ plane

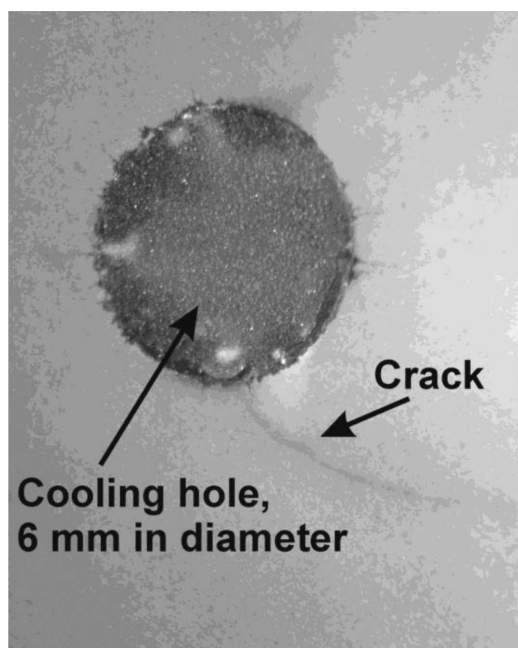
The question remains whether such an orientation could be responsible for crack nucleation on the surfaces of the dies. In the case of die A, selected for further study, it was found that nucleation of one of the cracks took place at the cooling hole edge, as shown in Fig. 7.

Fig. 7. Crack origin at the edge of cooling hole

Macroscopic observation of the cooling hole cross section (Fig. 7) revealed that around the edge of the hole, many fine cracks had started. Microscopic images of some of these are presented in Fig. 8.

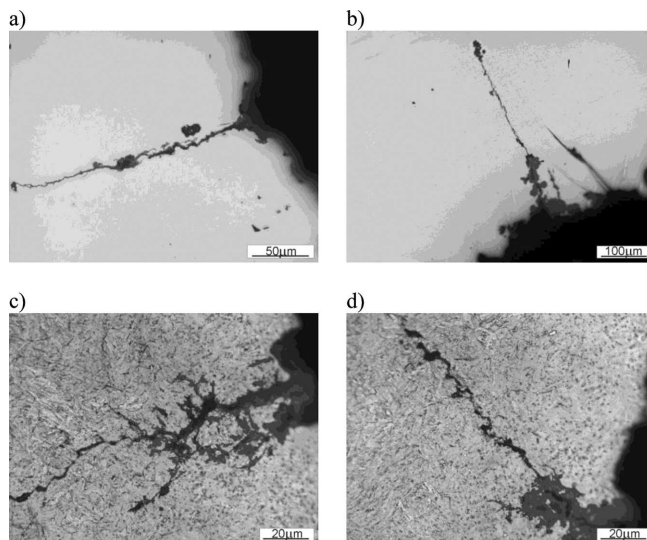
Fig. 8. Microscopic images of cracks nucleated at the edge of cooling hole: a), b) – not etched, c), d) – etched with 2% nital

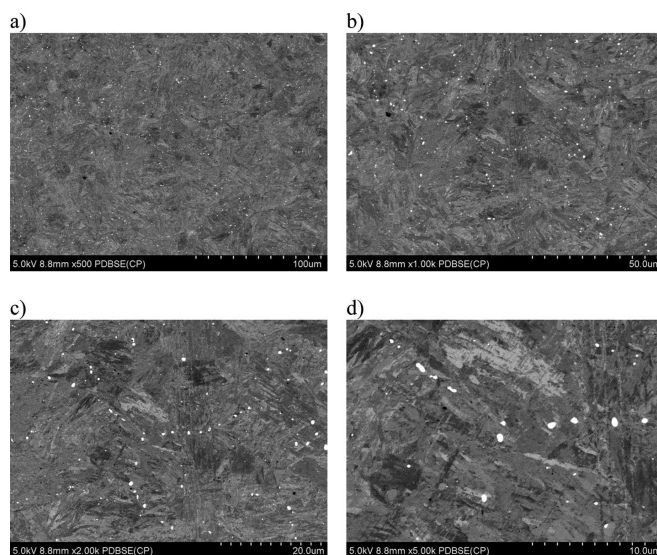
The die microstructure is typical for Dievar steel after quenching and tempering. Light microscopy studies did not confirm the presence of surface decarburisation or wear traces. It was confirmed that the surface and bulk microstructures are similar. SEM studies revealed carbides precipitated along the prior austenite grain boundaries, as shown in Fig. 9. The use of the higher accelerating voltage allowed observation of another type of carbides, precipitated inside the prior austenite grains – transgranular carbides (Fig. 10).

Fig. 9. SEM images of tempered martensite microstructure of investigated steel, accelerating voltage 5 kV

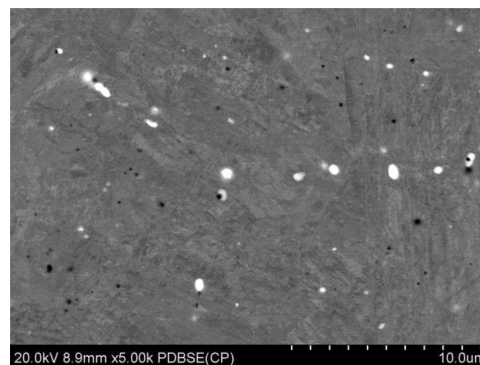
Fig. 10. SEM image of investigated microstructure presented in Fig. 9d with higher accelerating voltage 20 kV

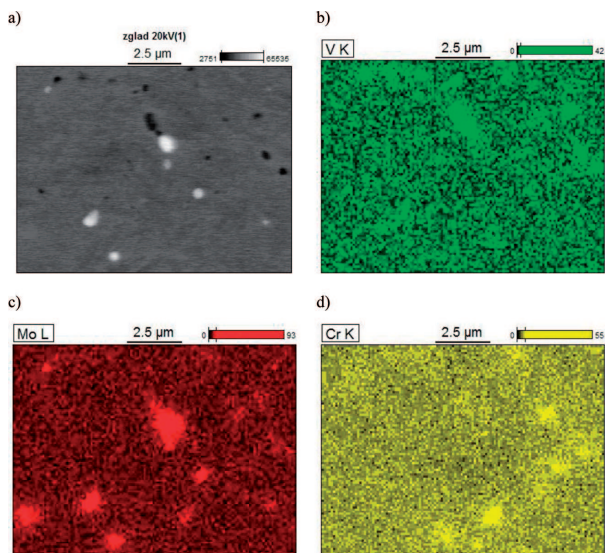
specimen), allowed the presence of vanadium carbides (MC, dark phase in Fig. 11a) and molybdenum carbides ( $M_2C$  – light phase in Fig. 11a) to be determined. The presence of the chromium rich regions shown in Fig. 11d, forced the authors to perform similar studies for the etched specimen (Fig. 12); however, in Fig. 11a, a non-etched specimen, the chromium carbides were not seen. In Fig. 12a, it can be observed that there is a large amount of coarsened chromium carbides (Fig. 12d), probably of type  $M_{23}C_6$  and/or  $M_7C_3$ .

Fig. 11. Energy dispersive element mapping performed of area shown in Fig. 10, a) microstructure, b) vanadium mapping, c) molybdenum mapping, d) chromium mapping

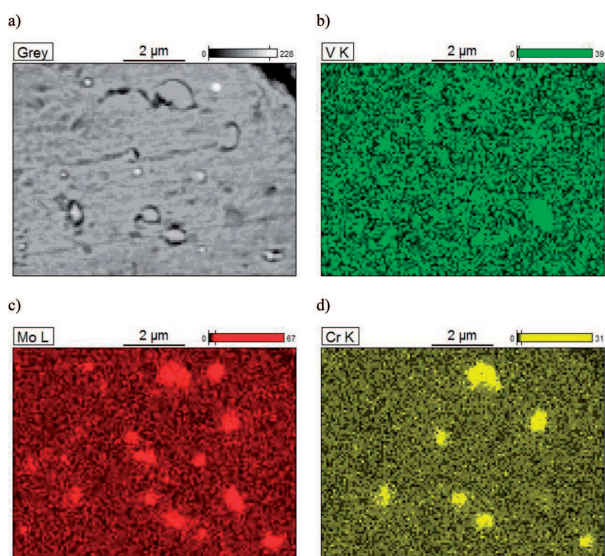
Fig. 12. Energy dispersive element mapping performed for etched specimen, a) microstructure, b) vanadium mapping, c) molybdenum mapping, d) chromium mapping

According to [13], the presence of chromium  $M_{23}C_6$  and  $M_7C_3$  carbides in Dievar steel microstructure is because of the high austenitising temperature. As stated in [13], a tempering resistance test of Dievar steel at four different heat treatments: 1020, 1060, 1100 and 1150°C, showed that an increased austenitising temperature improves the temper resistance (after hardening, all investigated materials were tempered to an equal hardness  $470 \pm 10$  HV30).

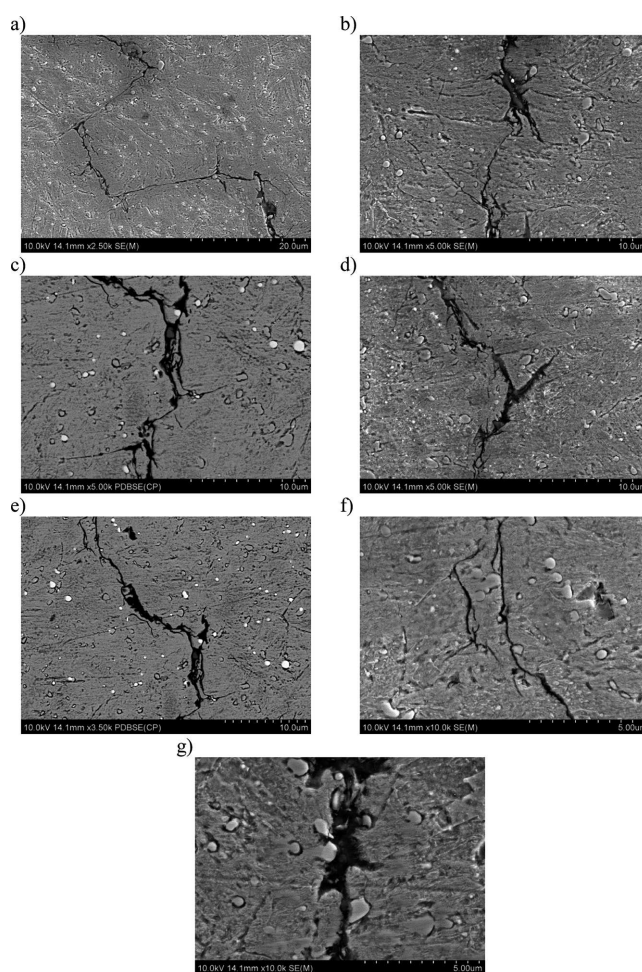
The results of microscopic examinations show that cracks presented in Fig. 7 propagate along prior austenite grain boundaries and/or tempered martensite lath boundaries, as shown in Fig. 13.

Fig. 13. SEM images of propagation path of crack presented in Fig. 7, a-g) different crack areas

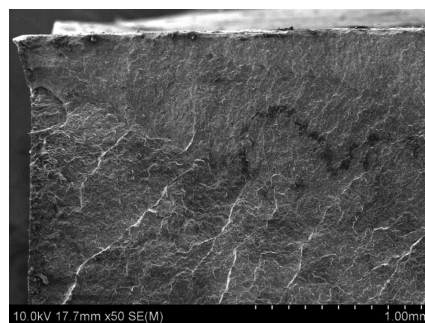
SEM observations were also made for the fracture surface at the origin of the crack presented in Fig. 7. The results of this investigation are shown in Fig. 14 and Fig. 15. As can be observed, the crack initiation occurred at the edge of the cooling hole and further crack propagation took place in stages, probably corresponding to the die-casting cycles (the so-called “shots”). Fig. 16 shows a transgranular fracture mode of the above-mentioned stages, separated by a dimple fracture area (Fig. 16a) with friction traces (Fig. 16b).

Fig. 14. SEM image of fracture surface of crack presented in Fig. 7, close to the cooling hole (crack origin)

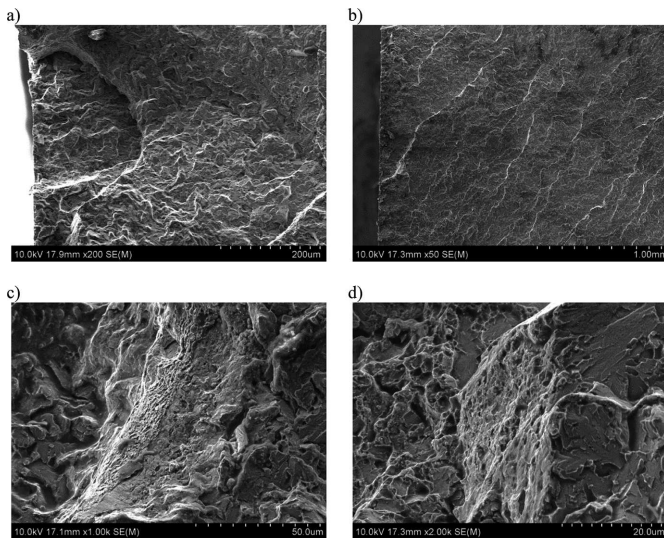
Fig. 15. SEM images of transgranular fracture mode separated by dimple fracture area, a) general view, b) crack origin, c-d) transition region

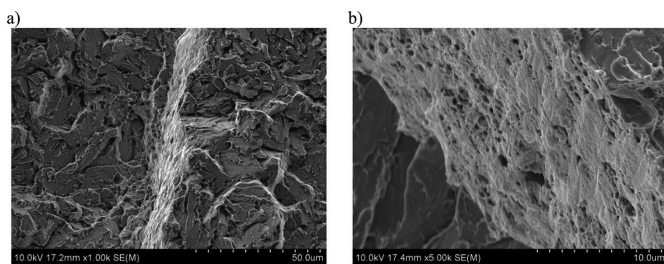
Fig. 16. SEM images of fracture surface a) brittle crack propagation stages, b) dimple fracture transition area
