SELECTED ISSUES CONCERNING RECONSTRUCTION OF THE PALACE COMPLEX IN GORZANOW

Abstract

The paper discusses an assessment of the technical condition of the historic Palace Complex in Gorzanow, and the reasons behind the damage incurred to its structure. The research has been carried out by the authors. The article presents the scope of implemented repair work intended to secure the building against further degradation, as well as a work plan that would make it possible to fully reconstruct the most valuable qualities of the palace in Gorzanow. The primary focus of the article has been applied to technical and organisational issues, regarding an ambitious endeavour to restore the building in question to full functionality and serviceability.

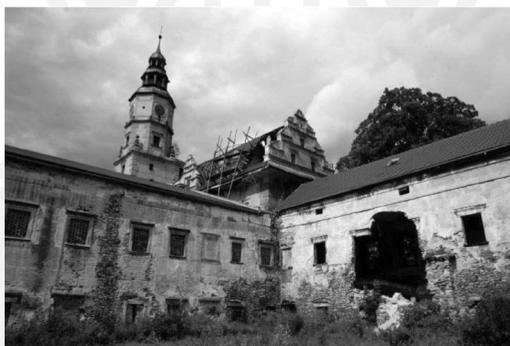
The highest level of damage was recorded in the central part of the palace – the east wing (Fig. 1), where incorrect repair work resulted in destroying parts of the roof. The original roof was covered with red shingles, and then roof tiles. The roof was later covered with ceramic tiles during repair work. The scope of repair work did not include reinforcing the wooden structure of the rafter framing, which demonstrated symptoms of biological corrosion that resulted from numerous areas of damp, which was almost certainly due to the effect of the bad technical condition of the roofing. The excessive loading on the rafter framing, due to much heavier ceramic tiles being placed upon it, led to the collapse of that part of the roof. Load-bearing walls of the building were all that remained in the area of that construction disaster. The east wing that did not collapse was however leaky and each successive storey downstairs demonstrated numerous defects, which was a result of the impact of the precipitation of water. The following can be listed as the most frequently recorded types of defects: partial and complete failure of floors; significant development of biological corrosion on dampened materials; damage to stucco decorations on ceilings; damp in load-bearing walls, including loosening of plaster, and degraded structure and painting decoration on the crowning cornice. A large number of defects have also been discovered in the west section of the building – which contained residential rooms, as recently as 2011. The defects resulted from lack of roofing, both wooden elements and the masonry structure.

Fig. 1. View of the facade and roofing in the east wing, on the day of August, 2011 [2]

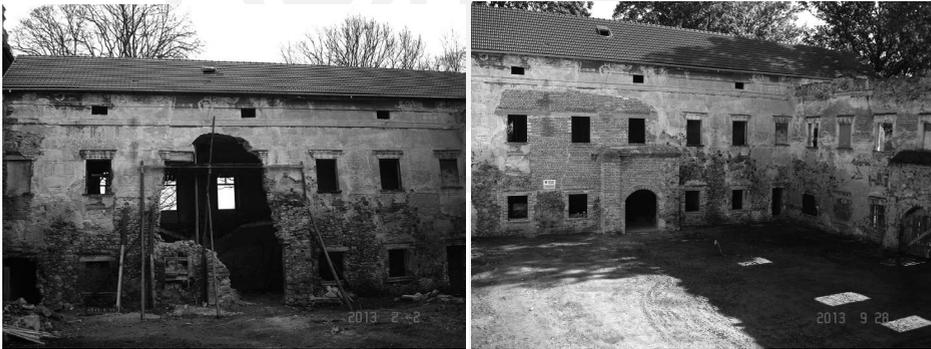
The majority of the roof had collapsed under its own weight, resulting from a lack of maintenance and poor technical condition of the rafter framing. Severe damage was also observed in the staircase in the west wing, which could possibly lead to a dangerous failure. Thanks to the good condition of the roofing (modern roofing systems), the north and south wings have been preserved in significantly better condition. The south wing features a number of modern structural solutions, while many elements of the wooden floors have been cut out (removed), due to poor technical condition. As for the brick vaults on the ground floor, they required securing. The polychrome Renaissance ceilings in the north wing have been well preserved. The defects recorded in the north wing primarily consist of large cracks on the external walls, looking from the north side. This structure contains buttresses, which were added some time after the palace itself had been built. This led to the conclusion that the cracks in that part of the building have been present for a long time. The reason for that could be an unstable foundation, which demonstrates significant damp and a high level of underground waters, on that side of the palace. The administration wing has also demonstrated numerous cracks.

Fig. 2. View of the administration wing and repairs which have been made using ceramic brick. Left side is a view on the day of February 2nd, 2013 to the right as at September 28th, 2013

Securing of the structure included carrying out of 500 m³ of rebuilding (bricklaying), which was primarily related to the elements that demonstrated significant fracturing, cracking and defects. The work seldom involved reconstructing entire wall elements, but in some cases, load-bearing walls and ceilings were rebuilt. All repairs were carried out using ceramic brick, regardless of the different types of materials used to erect the original wall structures in the palace (Fig. 2). The dormer windows on the roof in the east wing have also been restored and filled in, during masonry work.

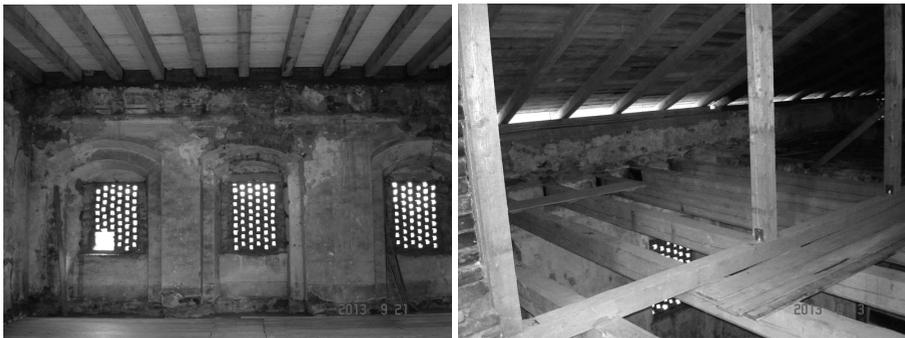
Fig. 3. Wooden beam-framed floors restored in the north wing of the palace

In addition, the securing of the building consisted of repairing and restoring the wooden beam-framed floors present in the palace (Fig. 3). All wooden elements were surveyed, based on which it was possible to select which elements could be left in place or reinforced, and the ones which had to be replaced. Some wooden floors have been replaced with floors based on pre-tensioned pre-stressed concrete, placed in the existing pockets, which enabled work to be completed more quickly.

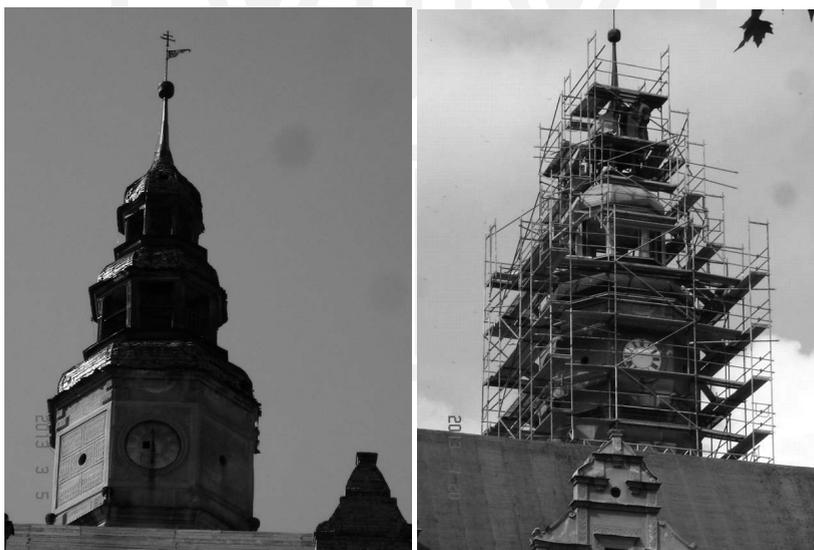
The condition of wooden beams and all other structural elements of the palace's tower cupola turned out to be far worse than initially thought (Fig. 4). Similarly, the rafter framing in the main building turned out to be in far worse condition than was expected after the initial assessment. Additionally, the weather at the end of 2012 and the beginning of 2013, as well as in the first months of 2013, did not permit the covering of the decked roof over the main wing with roofing paper, which extended the period in which the interior was soaking with water, and rendered it impossible to undertake work which was necessary in order to secure Baroque ceilings covered with stuccowork. This brought about many concerns, regarding the soaking walls which still contained precious decorations, including among others the ones in the *Sala Terrena*.

The scaffolding required to repair the palace's tower made it impossible to provide the proper protection of the joints between the roof and walls of the tower, during repair work (Fig. 4). Therefore, the mentioned joints were only temporarily protected against the weather, until the scaffolding was removed.

Fig. 4. View of the clock tower. On the left before renovation, to the right during the renovation

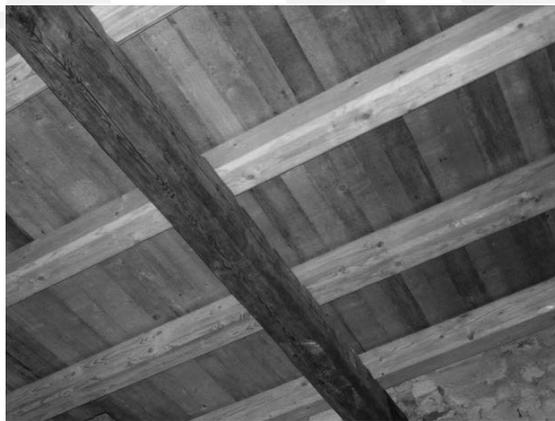
The philosophy behind the repair work was to ensure a significant level of “recovering” building materials, to re-use them in the future. However, only around 15.0% of stones and wooden structural beams have been recovered. Re-cut wooden elements will or have been re-used in the rooms of lesser spans (Fig. 5).

Fig. 5. New and old (recovered) structural elements used as part of the ceilings
