## PRE-WAR PUBLIC UTILITY BUILDINGS – RESULTS OF SURVEYS

The paper summarizes the results of surveys conducted in three pre-war public utility buildings: a children's home, a forensic medicine department and a nursing home. The study examined the indoor air quality, airtightness, ventilation efficiency and thermal insulation of building envelope. The buildings were surveyed before, during or after modernization works were undertaken.

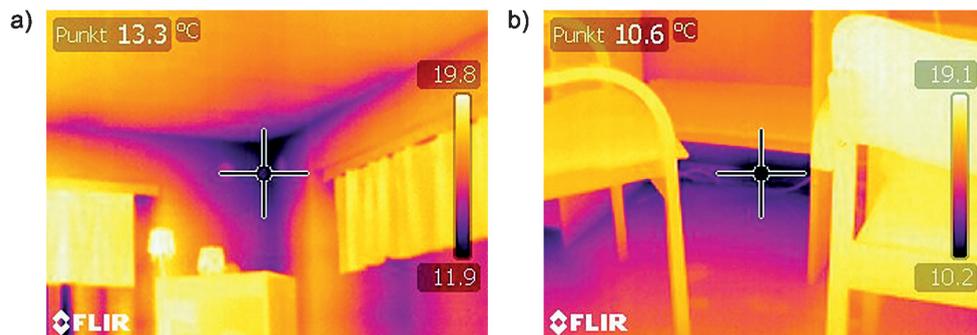
External wall insulation had a positive effect in terms of increasing internal surface temperatures. The lowest temperature measured in one corner on the first floor was 19.5°C (where the internal air temperature was about 23°C). Unfortunately the renovation works had no discernible effect on the second floor. Figure 1 clearly shows a significant decrease in surface temperature in the corner and also under a computer table in the computer room on the second floor. The temperatures were recorded as 11.9°C and 10.2°C respectively, with an internal air temperature of about 20°C. Such a situation presents the risk of mould growth – where the surface temperature falls below 12.7°C (at 20°C and with 50% relative air humidity).

Fig. 1. The computer room on the second floor: a) the corner – at the juncture of the external wall and the second floor ceiling, b) under the computer table – at the juncture of the external wall and second level flooring

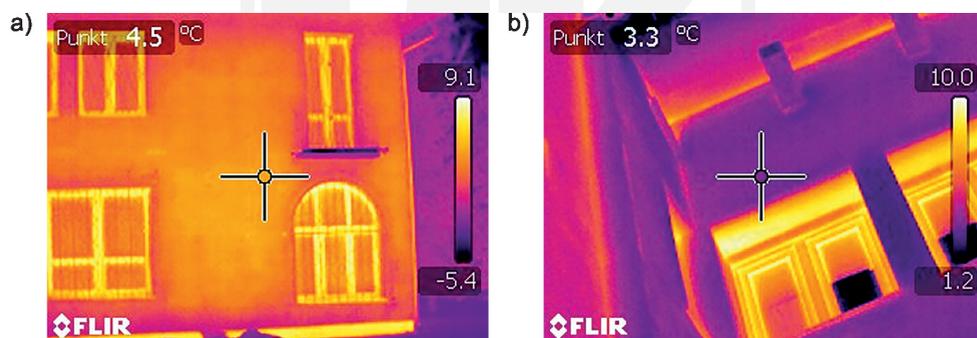
The temperature of the external wall surface was  $4,5^{\circ}\text{C}$  (Fig. 2a.) when the outside air temperature was  $0^{\circ}\text{C}$ . The 4.5 K difference illustrates that the thermal insulation of the walls could be improved. The U-value following renovation was  $0.34 \text{ W/m}^2\text{K}$ , but according to current regulations it should be no higher than  $0.25 \text{ W/m}^2\text{K}$ . Figure 2a and 2b also show there to be a lack of insulation around window openings, on the basement walls and in the thermal bridge caused by the eaves. The readings have confirmed a reduction of heat loss through the building facade but at the same time have allowed for construction errors to be identified. The insulation is not contiguous which allows thermal bridges to form. The most significant error is that the second floor mansard roof is insufficiently insulated. As a result, heat loss on the second floor is much greater than elsewhere. In such a situation, the interior air and internal surface temperatures decrease. In addition, mould can grow or condensation and rising damp can occur.

Fig. 2. Termogram of: a) external wall, b) windows openings

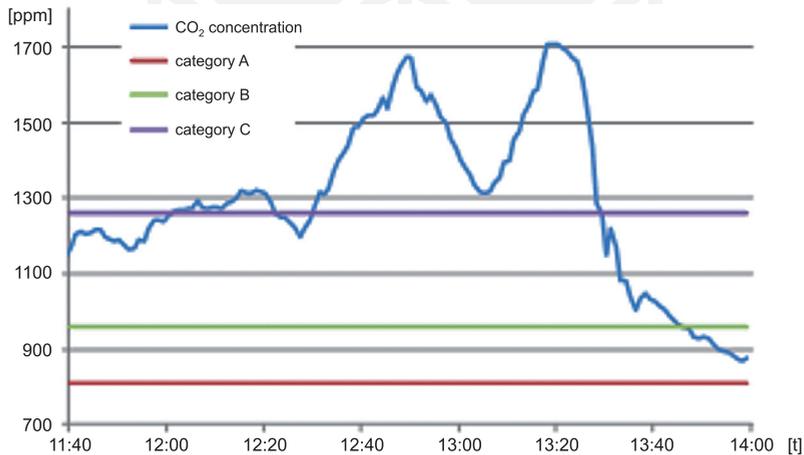
Fig. 3. Change of CO<sub>2</sub> concentration levels in the dining room with PN-EN 15251 categories A, B & C marked

Indoor air quality was assessed on the basis of CO<sub>2</sub> concentration levels, in relation to the PN-EN 15251 [2] categories (A, B & C). The highest concentrations in each category are shown in the graph: 810 ppm for A, 960 ppm for B and 1260 ppm for C. Air quality readings exceeded all categories for a significant period of time. CO<sub>2</sub> concentration levels decreased only after the residents had left the dining room, firstly dropping below the category C threshold and then the category B limit.

These measurements show that indoor air quality (CO<sub>2</sub> concentration) levels are unsatisfactory, despite optimal measures to control indoor air parameters in regard to

temperature and relative humidity. A further indication that the ventilation system is failing is that the relative humidity levels in wintertime are at the 50% level, when humidification does not occur.

The outdoor CO<sub>2</sub> concentration level ( $C_o$ ) was 460 ppm. The maximum indoor concentration level ( $C_{io}$ ) was 1707 ppm. The decline rate ( $\tau$ ) was 38 min. The lowest indoor concentration level ( $C_{i(\tau)}$ ) was 868 ppm. The estimated air exchange rate ( $n$ ) was 1.76 h<sup>-1</sup>. The ventilation rate in the dining room is below adequate standards. Accordingly, it is recommended [3] that the air exchange rate should be between 5–10 h<sup>-1</sup>.

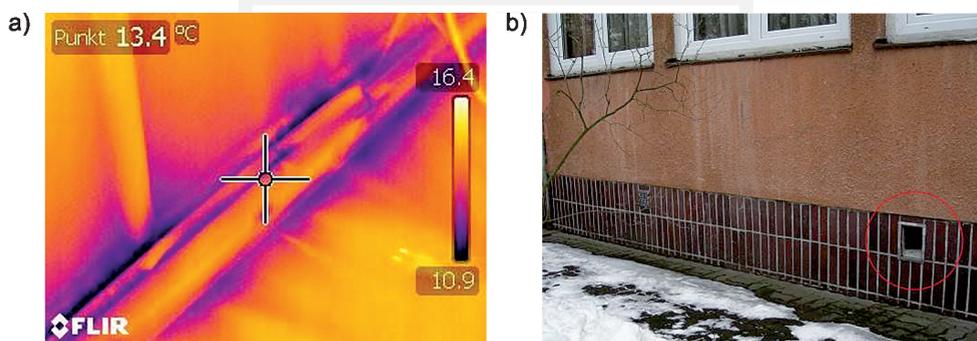
Fig. 4. Leaks: a) at connection of external wall with floor and their source, b) ventilation space under the floor – marked the vent in the socle

Air leaks (Fig. 4a.) were detected around the perimeter of the room and were caused by poor flushing between the floor and the external wall. The air penetrated into the room from ventilated spaces under the floor (Fig. 4b.). Carpeting provided the only sealing layer, which had been taken up for the test. Other leaks were also detected in gaps between the old wooden window frame and the external wall (Fig. 5a.). New plastic windows were installed in old

The results obtained show that the room has a very low score in terms of its airtightness. According to the WT2014 requirements,  $n_{50}$  should be lower than  $3.0 \text{ h}^{-1}$  in a building with natural ventilation. The test result was almost four times higher. The estimated exchange rate resulting from air infiltration can be calculated using the following formula:  $n = n_{50}/20 = 0,58 \text{ h}^{-1}$ . The air flow rate attributable to air infiltration is about  $52,6 \text{ m}^3/\text{h}$ . Two people occupy the director's office so the air flow rate should be about  $40 \text{ m}^3/\text{h}$  ( $20 \text{ m}^3/\text{h}$  per person). The tests show that in spite of the lack of ventilation ducts, excessive infiltration of air occurs in the room. This is an undesirable situation, because ventilation should be controlled. Moreover, air entering the room through the cracks and gaps lead to a decrease in thermal comfort levels. Measurements show that measures to make the Nursing Home more airtight need to be taken before the ventilation system is modernized. Only if that is done can there be any improvement in the effectiveness of the ventilation in the building.

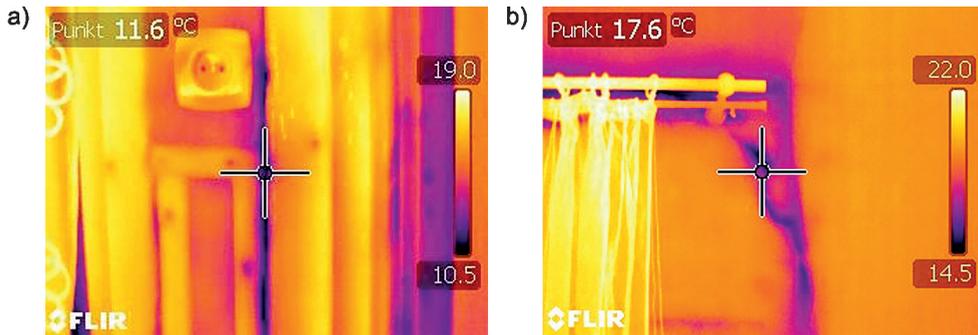
Fig. 5. Leaks: a) in a gap between the old wooden window frame and the external wall, b) in a crack in the external wall in a corner of the room

wooden frames. A crack in the external wall in a corner (Fig. 5b) also enabled air to leak into the room.
