PIOTR BĘTKOWSKI*, ŁUKASZ BEDNARSKI**, RAFAŁ SIEŃKO***

STRUCTURAL HEALTH MONITORING OF A RAIL BRIDGE STRUCTURE IMPACTED BY MINING OPERATION

The bridge is located on the 23.449 km railway line No. 159 Orzesze–Wodzisław Śląski, trail Warszowice-Studzionka station branch. On the bridge, or rather two parallel bridges, two railway tracks are laid – one track on each of the structures.

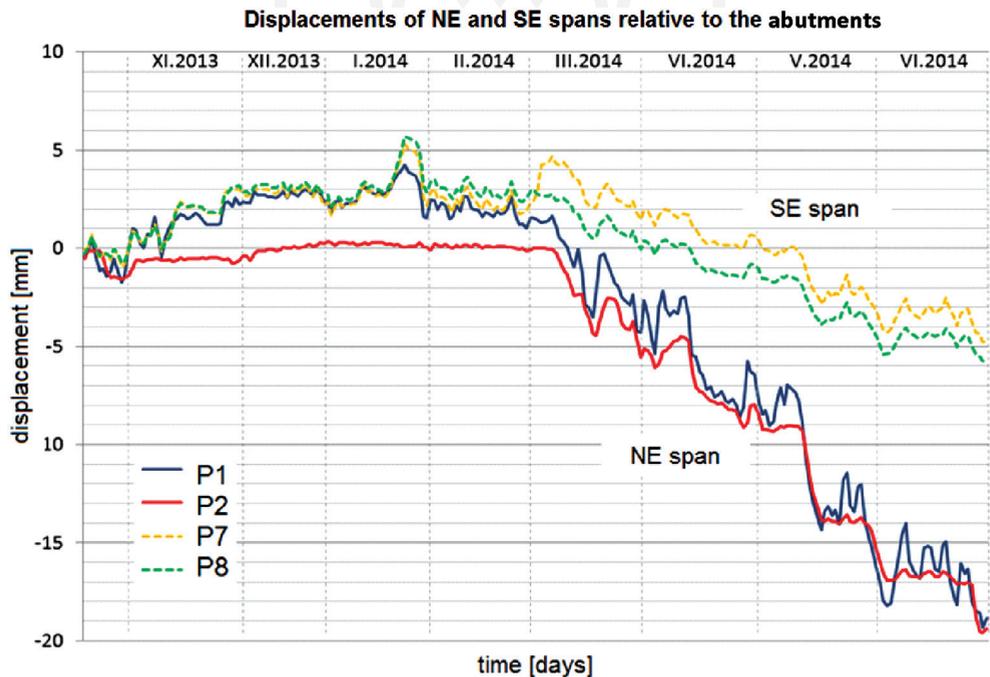
Fig. 6. Graph of horizontal displacements (along the axis of the structure) NE and SE spans relative to abutments

The negative sign in measurements on the charts below indicates closing of the expansion gaps. The increase in horizontal displacements is particularly visible on the northern abutment (sensors P1 and P2 in Fig. 6).

The non-existence of a linear relationship between of displacements recorded by sensor P2 with temperature changes demonstrates either locking of or permanent damage to the bearings on the support of the structure.

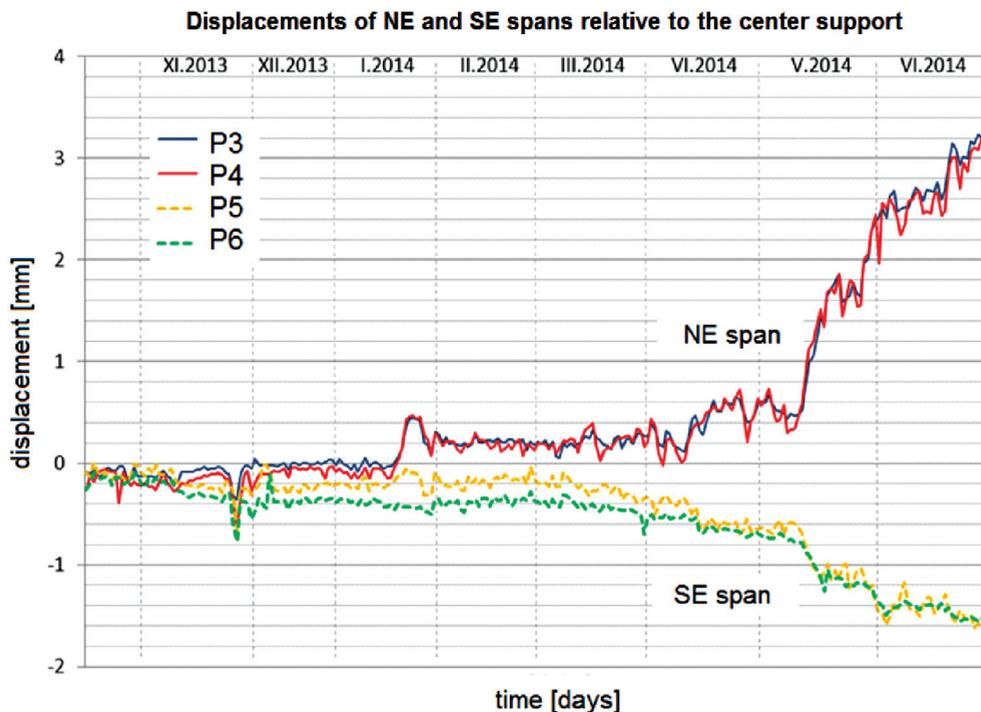
Fig. 7. Graph of horizontal displacements (along the axis of the structure) NE and SE spans relative to center support

Displacements of spans relative to immovable intermediate support (the pillar) were observed. Values added for the NE span prove displacement towards the abutments. Part of the measured horizontal displacements are related to the depletion of slack in connections between the plate girders of the bridge, the steel support and the reinforced concrete pillar. Unfortunately, there is certainly deformation and twisting of the pillar relative to its axis.

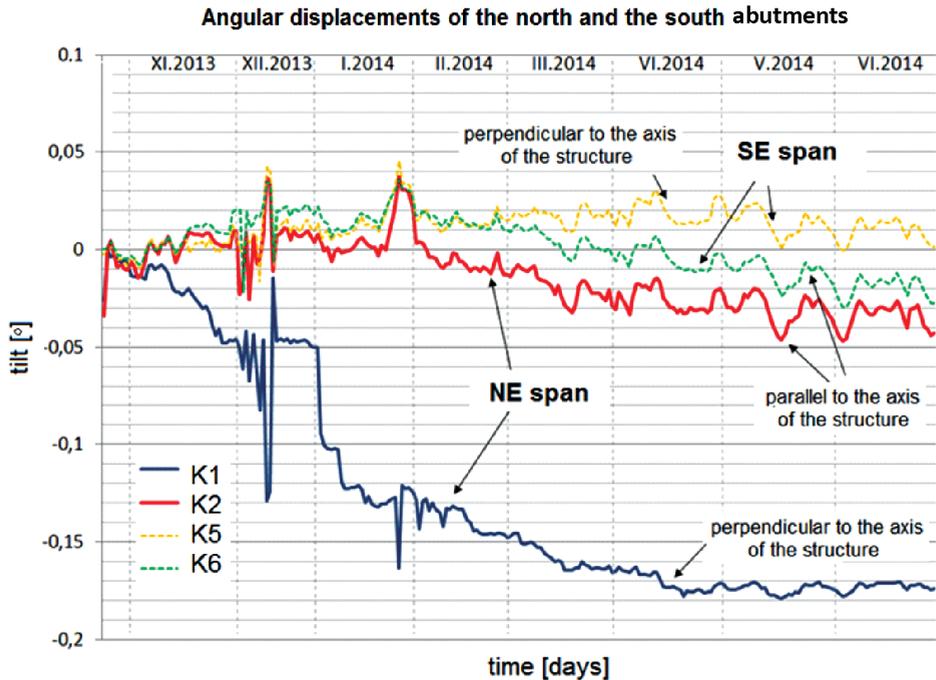
Fig. 8. Chart of tilting of the northern and southern abutments in a plane parallel and perpendicular to the axis of the structure

Figure 8 shows changes in the inclination of the north-east and south-east abutments in the period from November 2013 to June 2014. Analysis in a vertical plane parallel to the axis of the structure's angular displacement values (sensors K2 and K6), together with the values of horizontal displacements relative to the abutments and measured with sensors P1, P2, P7 and P8 shows that the abutments are getting closer. The value of this approximation in the foundation level is greater than in the level of the support platform. The horizontal displacement of the north and south abutments, resulting from their rotation, assuming the theoretical height from ground level of $H = 8$ m, is suitably $X_N = 7.0$ mm (in direction N) and $X_S = 4.2$ mm (in direction S). Displacements resulting from horizontal movement of abutments are respectively equal to $P_{NE} \approx 20$ mm

and $P_{SE} \approx 5 \text{ mm}$, wherein $P_{NE} = 0,5(P1 + P2)$ and $P_{SE} = 0,5(P7 + P8)$. If we sum up the values of displacements resulting from the horizontal movement and the rotation of the abutments, we calculate the value of creeping at ground level at 36.2 mm. Projected deformation of land is forecasted to be approximately -1.2 mm/m , which at a distance of approximately 45 m between the abutments, allows assessment of their horizontal displacement at around 54 mm. This means that at present, creeping is already about 67% of the forecasted figure.

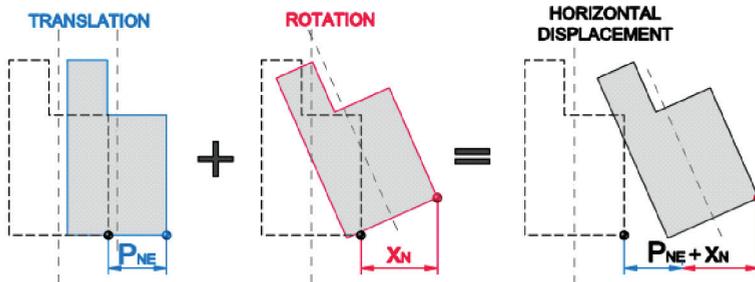
Fig. 9. Horizontal displacement of the north abutment resulting from translation and rotation

An interesting observation is the measurement of the tilt of the northeastern abutment in a plane perpendicular to the axis of the tracks. The value of the measured angle is now $K1 \approx -0.18^\circ$. This means that the abutment (assuming the theoretical amount $H = 8$ m) is tilted so that the upper part of the structure has moved approximately 25 mm to the west. Such behaviour of the northeastern support may result in the observed locking (wedging) of rolling bearings (probe P2).

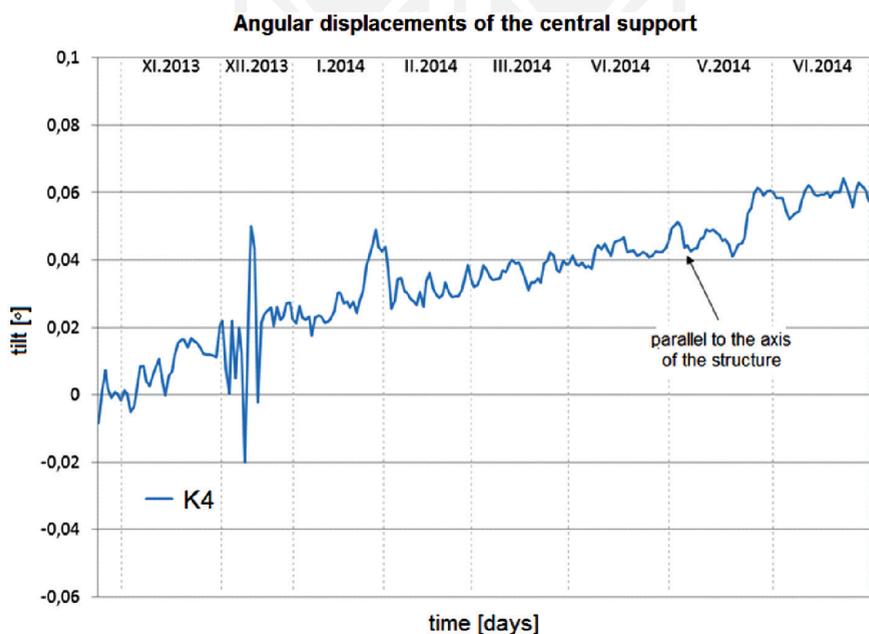
Fig. 11. Chart of tilting support in plane parallel to the axis of the structure ('+' denotes a tilt towards the north)

The measurement of the tilt of intermediate support (the pillar) in the plane of the object's axis (Fig. 11) indicates that the pillar tilted towards the north so that the horizontal displacement of its head is currently approximately 8.4 mm.
