ARCHIVES
of
FOUNDRY ENGINEERING

ISSN (2299-2944)
Volume 21
Issue 1/2021

Comparing of High-Cycle Fatigue Lifetimes in Un-corroded and Corroded Piston Aluminum Alloys in Diesel Engine Applications

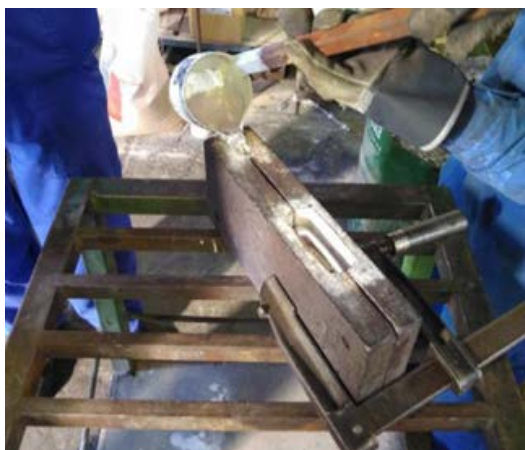
Fig. 1. The gravity casting procedure of initial samples

The fabrication technique of the alloy for high-cycle fatigue testing was the gravity casting approach, which is shown in Figure 1. Then, all standard samples were gravity-casted in the cast-iron mold. Moreover, all these casted cylinders were quenched in the air at 23 °C of the temperature, after the casting process.

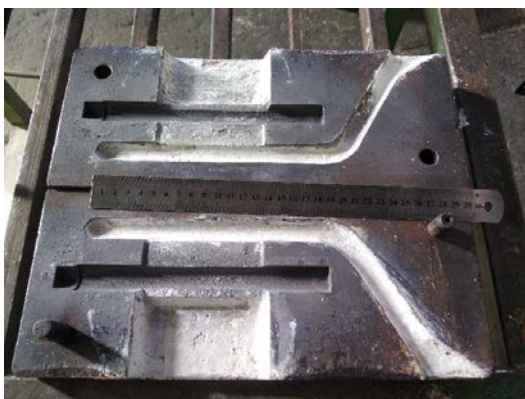
Fig. 2. The geometry of the casting mold

For fabricating standard cylindrical samples, aluminum bars or ingots were initially melted. As a note, no master alloys were added. The melt was held for 2 hours at 700 °C of the temperature [10]. It is worth noting that in the casting process, the mold temperature was kept constant at 265 °C with a deviation of 10 °C [10]. In order to minimize the presence of any foreign objects in the melt that causes cavities or pores, after the melt has reached to a stable temperature in the mold, degassing and removing the slag were performed using the argon gas and special tablets. And also, it should be noted that all casting tools were coated and preheated before starting the casting process. The casting mold, which was used in this research, is shown in Figure 2. More details of casting could be found in the literature [10].

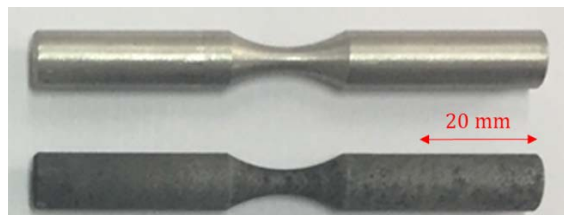
Fig. 4. Fatigue test samples, including before (the above one) and after (the bottom one) the pre-corrosion process

fabricated by the SANTAM Company). This device is shown in Figure 3. The bending stress (120, 150, 180, 210 MPa) was controlled under cyclic loadings. This was done through the high-cycle fatigue regime, based on the ISO-1143 standard [11]. For corrosion-fatigue tests, samples were pre-corroded in the 0.00235% H_2SO_4 , which was based on the maximum sulfur gasoline in diesel engines [12] for 100 and 200 hours [9,12]. Due to consider the diesel engine application in this article, the environment type is almost different from the literature [4,6,8], where the NaCl environment influence was studied. Standard specimens after and before the pre-corrosion process are depicted in Figure 4. The sample after the pre-corrosion seemed to be darker, compared to the initial specimen.

The image of the field-emission scanning electron microscopy from corroded surfaces for aluminum-silicon alloys after 200 hours of the immersion time in the acidic environment before fatigue testing is shown in Figure 6. Besides this microscopic image, as it could be also seen in Figure 4, some macroscopic pits could be seen on the sample surface due to the corrosion phenomenon. These sites have potentials for the crack initiation under cyclic bending loadings.
