ARCHIVES  
of  
FOUNDRY ENGINEERING

# Microstructure and Microhardness of Ti6Al4V Alloy Treated by GTAW SiC Alloying

W. Bochnowski\*

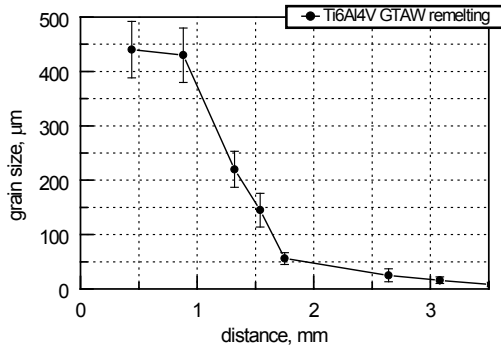
Fig. 4. Grain size of prior  $\beta$  phase in remelted zone

of the grain was about 440  $\mu\text{m}$ . Diameter of the grain decreased in the direction of substrate, as shown in Fig. 4. Bottom remelted zone the diameter of grain was average 50  $\mu\text{m}$ . The microstructure of grains at the top of remelted zone is shown in Fig. 5a. As a result of fast cooling an  $\alpha$  phase titanium (shown light) structure was formed in matrix of  $\beta$  metastable solution. The plates of  $\alpha$  phase are thin, have less than 1  $\mu\text{m}$  thick.

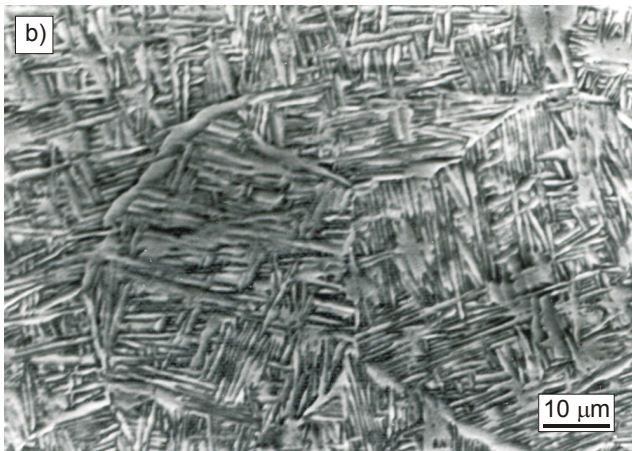
Fig. 5. Remelted zone, a) the grain boundaries of prior  $\alpha$  phase is visible, b) bottom structure of RZ

Following the fast cooling no deposition of grain boundary  $\alpha$  was recognized. In the bottom of RZ where cooling rate was lower, on the borders of prior  $\beta$  grains an  $\alpha$  grain boundary are formed (Fig. 5b). Inside of the grain of prior  $\beta$  phase are visible colony or basket weave of lamellar structures  $\alpha + \beta$ ,  $\alpha$  - shown light,  $\beta$  - shown dark. The bottom region of the GTAW treatment is dominated by colonies of lamellae starting at grain boundaries. The value and gradient of temperature and slow cooling rate, no influenced on the explicit change of the microstructure in the second area - HAZ (heat affected zone). The microstructure on the border RZ and HAZ is shown in Fig. 6. Microstructure of HAZ is similar to the microstructure of substrate, consist of colonies of primary  $\alpha$  and lamellar  $\alpha + \beta$ , with an average grain size of less than 10  $\mu\text{m}$ .

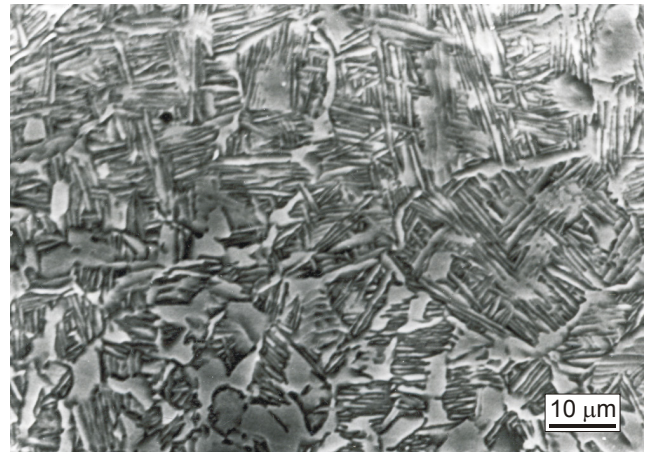
Fig. 6. Microstructure on the border RZ and HAZ

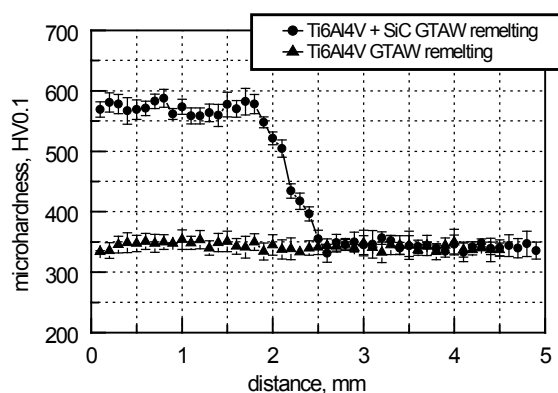
Fig. 10. Microhardness HV<sub>0,1</sub> of the Ti6Al4V after remelting and alloying by arc plasma treatment

The microhardness HV<sub>0,1</sub> of the remelting zone and of the alloying zone in dependence on the depth is shown in Fig. 10.

For the remelting, lower values (330 HV<sub>0,1</sub>) are recorded near the surface remelted (at a depth of to 200  $\mu\text{m}$ ), then the hardness in RZ, HAZ and SUB is maintained at a constant level – 350HV<sub>0,1</sub>. The hardness depends on the cooling rate, which is determined by the process parameters. In the literature [11] depending on process parameters remelting (at higher cooling rate) an increase of hardness in the RZ and HAZ of was recorded. Performance of SiC alloying resulted in increase of hardness in the alloyed zone. The difference in hardness between the alloyed zone and the base metal is 220HV<sub>0,1</sub>.

On the bottom alloyed zone and in border of zone alloyed and HAZ (on the 500 mm length) a continuous decline of the hardness was showed in fig 10. The hardness HAZ in alloyed specimens was on level hardness of substrate.
