Z. STANIK\*

## TYPICAL FAILURES IN THE DAMAGED ROLLING ELEMENTS MADE OF DIFFERENT MATERIALS IN THE MOST IMPORTANT VEHICLE UNITS

Bearings are widely used in motor vehicles. The operations of natural causes wear on the bearing components. However, the rolling bearing wear often results in damage to other elements or components throughout the vehicle. The paper presents examples of typical and untypical consequence damage bearings used in vehicles. Damage are described in elements made of different materials.

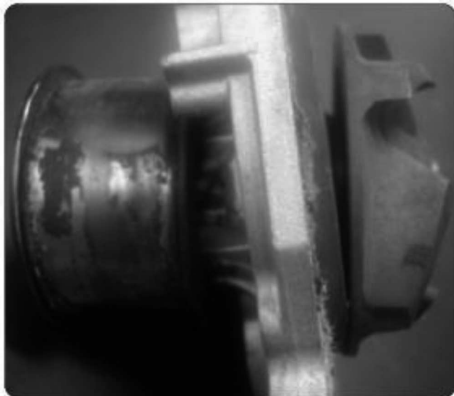
Figures 1 and 2 show seriously damaged water pump in effect of blocking the rotor shaft. This situation was caused by lack of collinear as a result of connecting rotor to frame. This failure results from damage to bearing race way which was excessively radial loaded by shaft. The fitting errors, for example too high tension of timing belt or wrong reparation may cause such a failure. For example, according to repair technology there is need to replace the water pump and timing belt. The new belt may cause more tension in timing system and thus the pump bearing (which is not in good condition) is not able to carry the increased radial loads.

Fig. 1. Damaged water pump

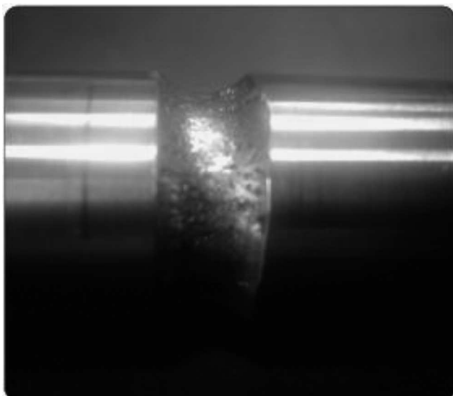
Fig. 2. Damaged roller of water pump

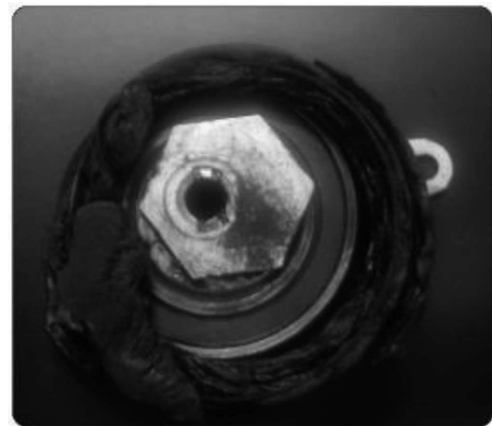
The next example is damage to tension shaft, which tighten the belt timing. A belt pulley of tension shaft was fused because of too high temperature (Fig. 3). A high temperature as a result of increasing the friction coefficient causes fusion of plastic on belt pulley. Defect of bearing seal and the same decrease in lubricant of tension shaft may causes fusion of shaft. It is because the higher coefficient of friction, the higher temperature. The cumulative effect of that situation is a seized up shaft, broken V-belt (wedge belt) and finally lack of power transmission of the basic auxiliary devices.

Fig. 3. Fused belt pulley of tension shaft

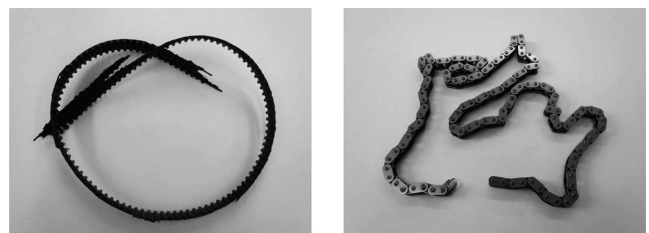
Fig. 4. Damage to belt and chain of timing system

In case of blocking any of timing system elements, some stresses may appear, which are unpredictable even by the constructors. In effect, a timing belt or chain is slid or broken. It may causes (especially if the engine is earlier damaged a serious and expensive damage to transmission unit, such as distortion of valves, damage to pistons (as a result of their collision) or damage to timing shaft, which may then leads to damage to car head. At present, after this kind of failure is impossible to repair the damaged engine, especially because of a distinct lack of repair technology (made professionally by

Author proposes a possible solution to this situation. According to the author, a continuous monitoring of the technical condition or diagnosis those elements of which damage could lead to failure units as well as sub-units of vehicle.

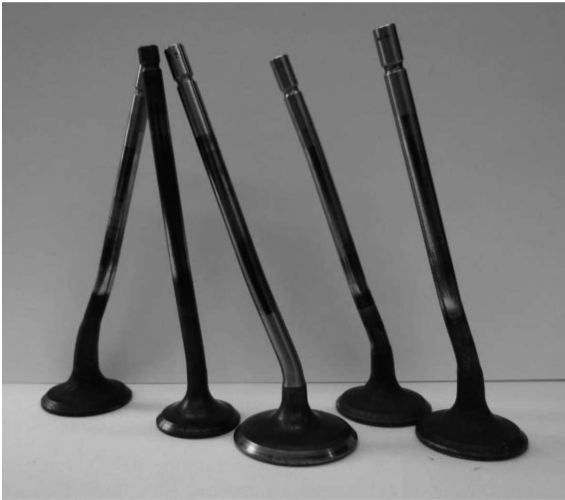
Fig. 5. Distortion of valves

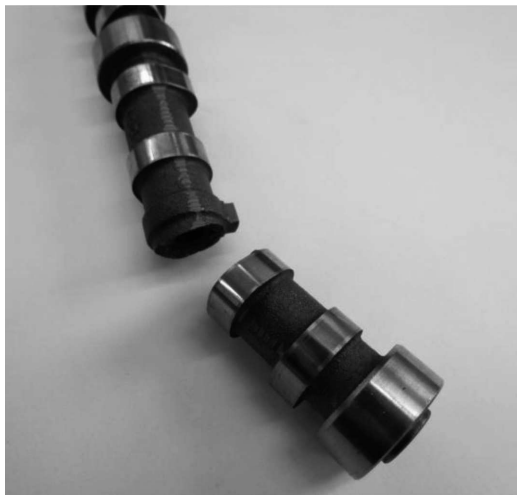
Fig. 6. Camshaft broken

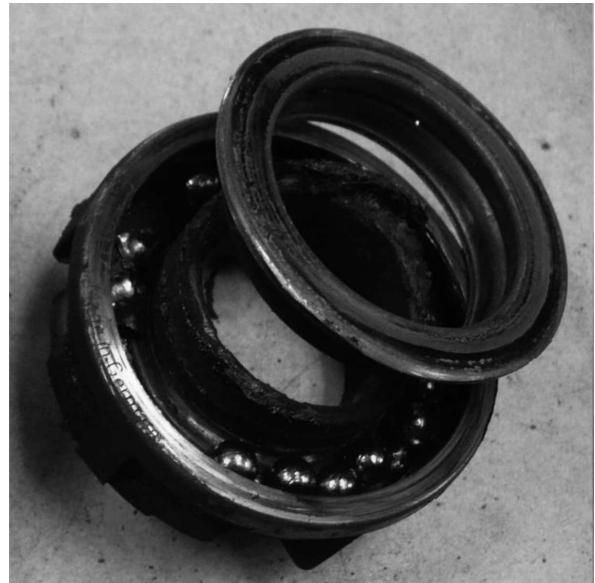
The next example (Fig. 7, 8) shows the damaged thrust bearing of clutch set. This kind of failure causes the noise when pressing on the accelerator pedal, for example in order to change gear. After pressing on pedal, thrust bearing works under pressure only when it is pushed axially to pressure disk. Bearing, which is damaged is able to generate the noise after pressing on pedal.

Fig. 7. Worn thrust bearing

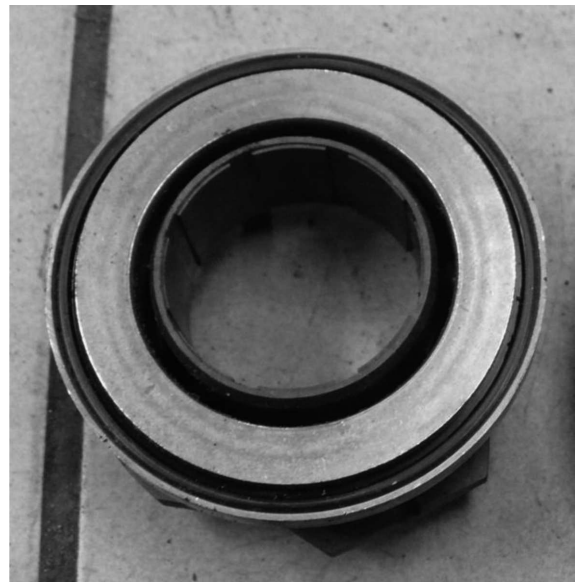
Fig. 8. New bearing

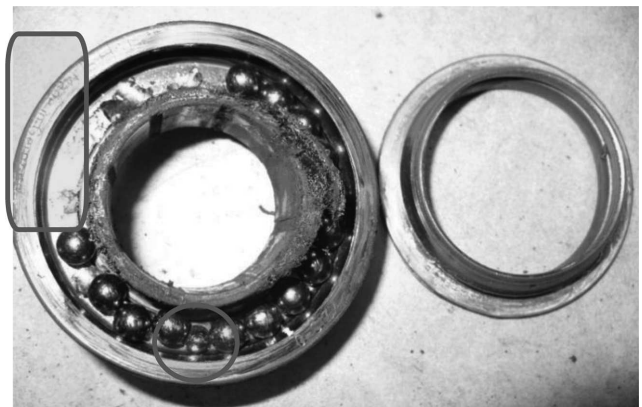
In Figure 9, the compressed material is marked by red rectangle. This material originate from damaged both elements

Fig. 9. Degradation of rolling elements of thrust bearing

and race way of bearing. This kind of failure is caused by inappropriate hardness of individual rolling elements. This leads to total degradation of the bearing elements. Rolling element

marked by circle in the same picture changed completely its dimension by being worn. It is seen by comparison its diameter to the other rolling elements of bearing. Such a damage may cause appearance of the radial and axial clearances which significantly exceed design guidelines.

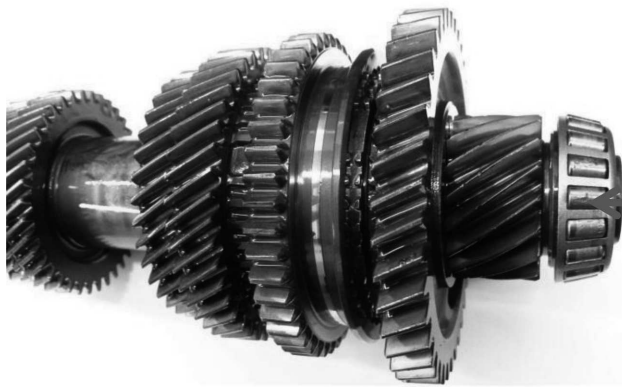
Figures 10 and 11 show a damage of tapered roller bearing of main shaft in gearbox. In this case, gearbox emitted high sound while driving when the power transmission system was variably loaded, for example while engine was braking and next accelerating.

Fig. 10. Main shaft of gearbox and damaged tapered roller bearing

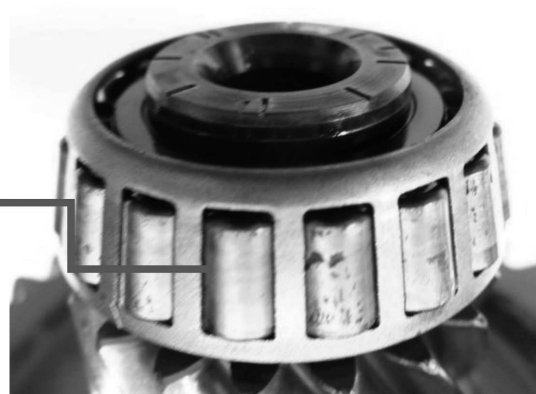
Fig. 11. Damaged roller element

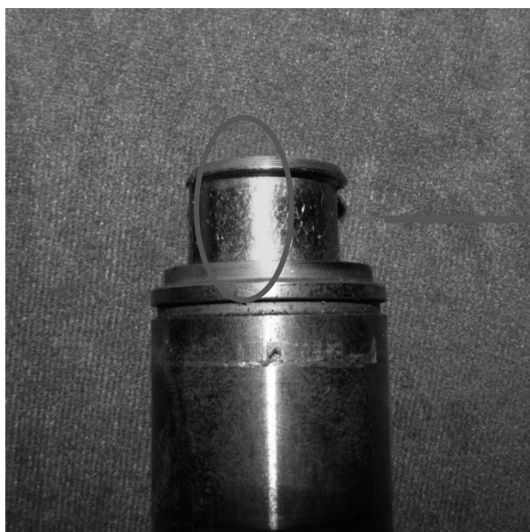
Figures 12 and 13 shown examples of worn main shaft of gearbox. In this case a pin, which is an integral part of the main shaft is destroyed. Destruction relates to the surface of rolling elements and the pin surface. This example points to the conclusion that it is rather a manufacturing defect, because a vehicle had respectively low mileage. The reason for it could result from for example faulty heat treatment both the rolling elements and the pin itself. In effect, the bearing race way was defected, i.e. a nominal pin diameter decreased significantly as a result of loss of the material (wearing of surface).

Fig. 12. Damage to main shaft bearing pin of gearbox

This kind of defect is manifested as an increased noise as a result of clearance on the shaft. In effect, the toothed wheels of gearbox don't mesh properly. This failure can't be repaired because there is no possibility of changing the rolling bearing because it's inside track is on shaft. It may be resolved only by buying new shaft which is very expensive in comparison to the price of the single rolling bearing. Also, regeneration padding is rather a short-term solution. A structural solution described above is very often apply by the many manufactures of different vehicles brand.

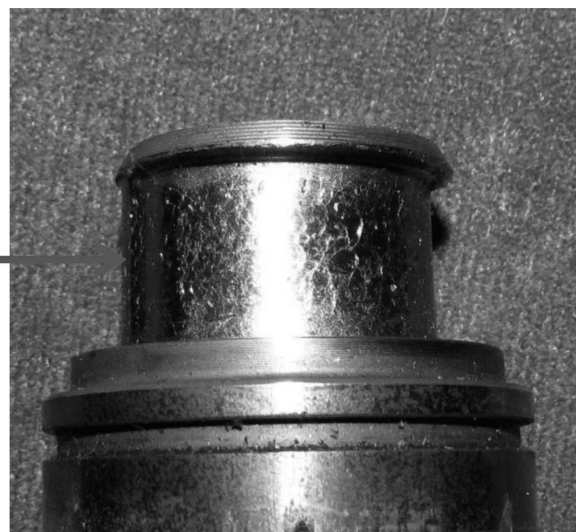
Fig. 13. Material wearing and change in diameter of pin

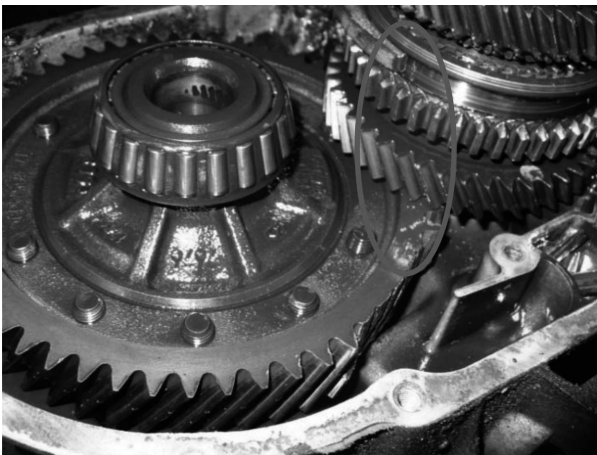
The examples of defects in main transmission gear are presented in figures 14 and 15. The totally damaged tooth of toothed wheel in main transmission gear are there shown. This kind of damage is caused by the rolling bearing (of main shaft) failure. In effect, toothed wheels of main gearbox don't mesh properly.

Fig. 14. Damaged bearing of main shaft

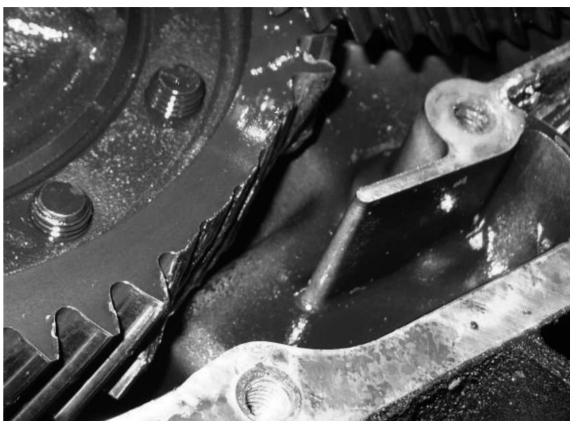
Fig. 15. Defected toothed wheels of main shaft

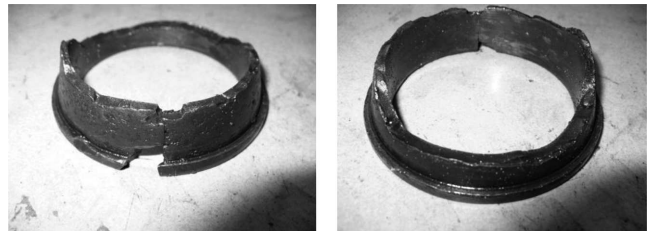
Figure 16 shows a totally damaged inside track of roller bearing that was located in driving axle of lorry. This severe structural damage indicates that a user of vehicle was not interested in the reason of specific voice that indicated improper work of main transmission gear. The scale of destruction indicates that a lorry was regularly overloaded, for example a maximum vehicle capacity was exceeded.

Fig. 16. Totally damaged inside track of roller bearing in lorry

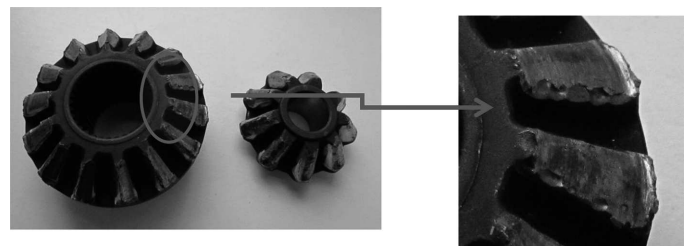
Figure 17 shows the damaged toothed wheels of differential gear. That kind of damage is caused by destruction of the bearings race-way of main transmission that is shown in figure 16. The toothed wheels are seriously damaged because of a large deviation from the nominal geometric parameters of the axis position.

Fig. 17. Damaged elements of differential gear

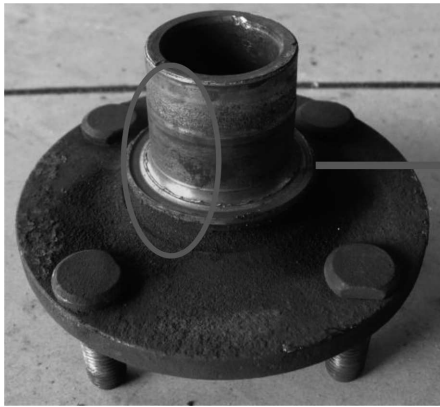
The next example (Figure 18 and 19) shows destruction of wheel bearing pin. This kind of failure is caused by a very little bearing preload. As a result of it, an inside track is displaced relative to the pin. An operation in such adverse conditions caused loss of material of co-operated elements. As a result of process of surface grinding, an operation in such adverse conditions caused loss of material of co-operated elements.

Fig. 18. Hub with bearing pin

All the examples of damaged elements, given above pointed to the conclusion that these elements, without doubt should be exchanged. This example of failures for sure causes irregular distribution both stresses and surface pressure in the bearing elements. Finally, because of it the wheel may be blocked. This may then lead to the dangerous situations, considering the fact that at the present time vehicles are able to achieve high speed.

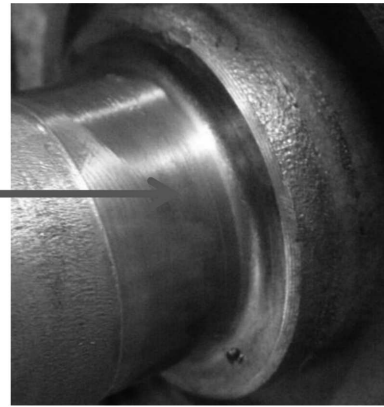
Fig. 19. Worn surface of pin in hub

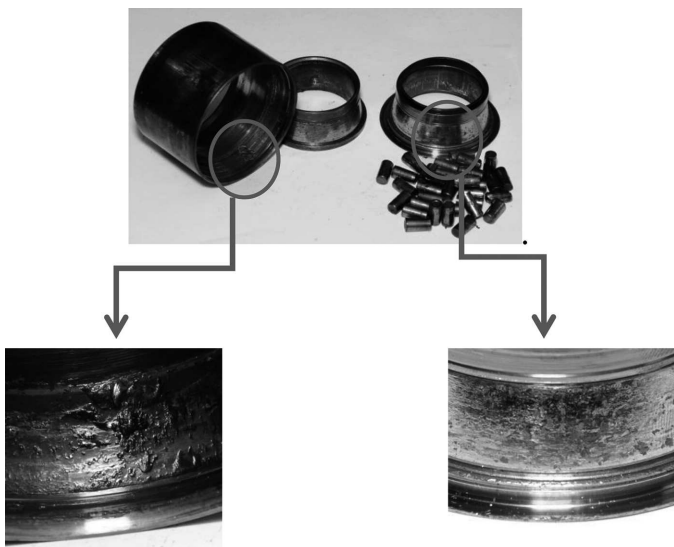
Figure 20 shows damaged wheel bearing. In that case both bearing races were destructive because of operating. The condition of race was estimated to be completely destroyed. This means that exploitation of vehicle in such bad condition would be highly dangerous for its users.

Fig. 20. Damaged race of wheel
