Z. GRONOSTAJSKI\*#, M. KASZUBA\*, H. PASCHKE\*\*, T. ZAKRZEWSKI\*\*\*, G. ROGALIŃSKI\*\*\*

## IMPROVEMENT OF TOOLS DURABILITY BY APPLICATION OF HYBRID LAYER OF NITRIDED/PECVD COATING.

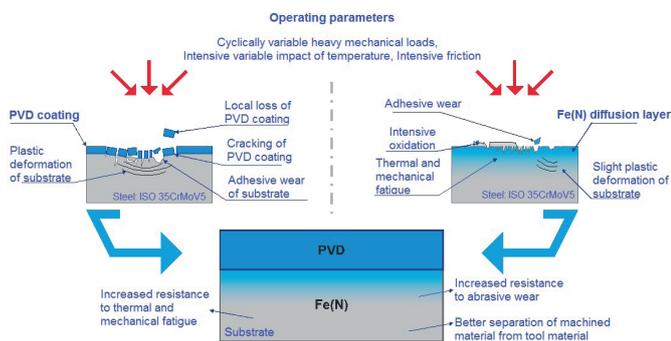
Fig. 1. Functions of particular components of hybrid layer of nitrided layer/PVD coating type [15]

The most commonly used hybrid systems are of the nitrided layer/PVD or a CVD coating type. The multilayer systems consist of a properly prepared substrate (a nitrided layer) and a properly matched adhesion coating produced on the surface of the substrate. The nitrided layer alone would not sufficiently protect the surface layer of the tools against harmful factors, such as thermal shocks, intensive friction and heavy mechanical loads. The primary function of the nitrided layer is to increase the substrate's hardness and resistance to plastic deformation. This protects the hard PVD or CVD coating against the loss of its adherence to the substrate. PVD and CVD coatings effectively insulate the substrate from external harmful effects during service. Fig. 1 illustrates the function of the particular components of such a hybrid layer [16, 17].

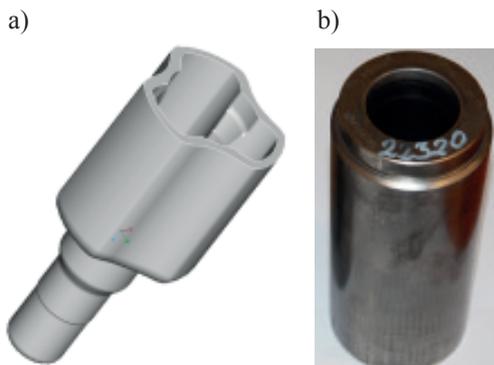
Fig. 2. Constant velocity joint body a) forging b) tools

The constant velocity joint body (CVJ body) transmit torque from the gearbox to the front wheel (Fig. 2).

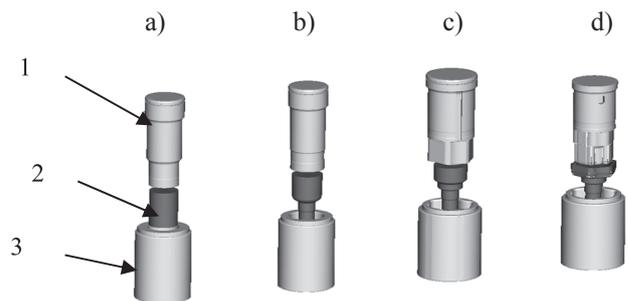
Fig. 3. Schematic of tools used in investigation of successive operations: 1 – punches, 2 – preforms, 3 – dies

The hot forging of the CVJ body consists of several operations. In considered processes there were four forging operations. In the first process the arched die and perform with diameter of 55 mm and height of 76.45 mm were used and in the second process the conical die and perform with diameter of 50 mm and height of 91.75 mm were applied. A scheme of the tools and preforms for different operation is shown in Fig. 3. The second operation is the most crucial as regards the durability of tools therefore it was analyzed in the paper. The process is described in more detail in [17, 18]. Operational studies of the dies used in the second operation of forging a CV joint were carried out in industrial conditions in the GKN Driveline Polska in Oleśnica.

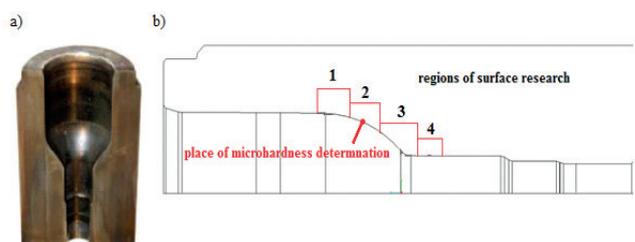
Fig. 4. The tools a) half of die and b) Longitudinal section of die with marked places where microhardness and structure of the working surfaces were analysed

In order to determine wear in the particular places on the tools a GOMATOS II optical scanner was used. Unfortunately, one of the scanner's limitations is that it cannot be used to measure deep holes. Therefore prior to the scanning of the worn out tools the latter were cut in two in order to reveal their inner surfaces (Fig. 4a).

The microhardness HV 0.1 were determined in the point marked by red in the Fig. 4b whereas the structure of the working surfaces of the tools were examined using a TESCAN VEGA 3 scanning electron microscope in 4 regions.

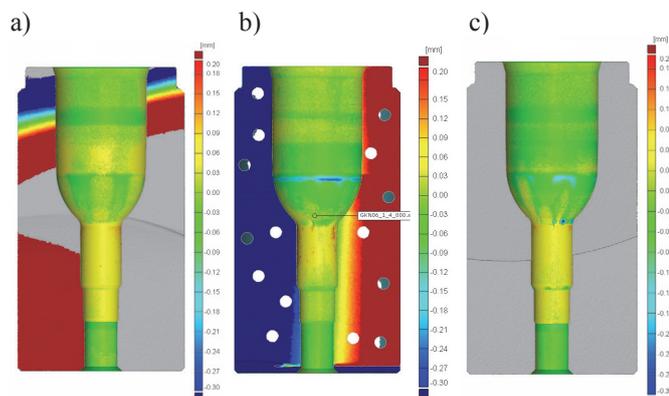
Fig. 5. Comparison of scanned images of die after a) 7044 b) 8371 and c) 17054 forgings with CAD model

No significant geometrical material loss was found of the die after 7044 forgings. After 8371 forgings the heaviest wear of the die was found to occur in the place of transition of the cylindrical part into the arched part where the so-called step forms. In addition, in the part where the forging's leg is formed one can discern traces of material (possibly oxides of the material being formed and remnants of the lubricant) adherence (Fig. 5b). Similarly as after 17054 forgings, one can see traces of wear on the die in the place of transition of its cylindrical part into its arched part, but the amount of this wear is smaller (fig. 5c). In the area of the first reduction in cross section also traces of longitudinal cracks are visible. The cracks will be described in detail later in this work. The measurements performed by means of the optical scanner showed that regardless of the number of forged units, the heaviest wear occurs in the place where the reduction in cross section begins, i.e. in the place of transition of the die's cylindrical part into its arched part. The heaviest wear in this area was found to occur in the die used to forge 8371 pieces. This was due to the fact that this die was characterized by the lowest hardness (Fig. 6). Moreover, material adherence in the part in which the forging's leg is formed was observed for all the tools regions of surface research

Fig. 5 presents the results of scanning the tools after a specified number of forged units with comparison with CAD model.

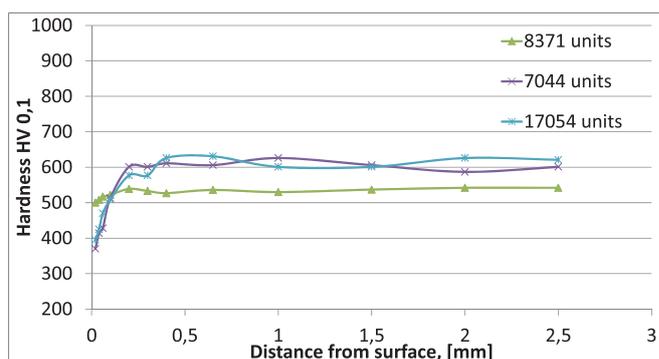
Fig. 6. Profiles of HV 0.1 microhardness on longitudinal cross section of tools

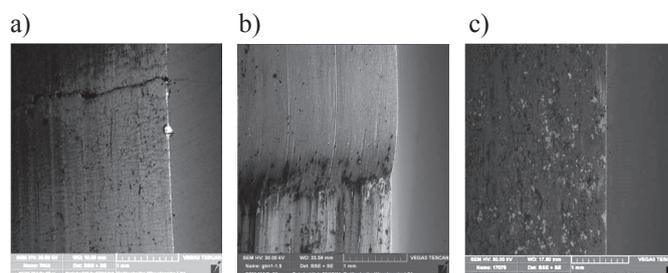
After the forging of 7044 units a single large crack and a network of fine cracks (extending mainly circumferentially) with small spalls are visible in area 1 (Fig. 7a). In the die after 8371 forging cycles a “step” forms in the area of transition of the circular part into the arched part (fig. 7b), which is confirmed by measurements performed using the optical scanner. Wear in this place amounts to about 0.2 mm. Moreover, above and below the “step” one can see a network of fine cracks running circumferentially. The die's surface in this area after the forging of 17054 pieces is covered with a layer of oxides, which makes examination difficult (Fig. 7c), but the network of fine cracks is still visible.

Fig. 7. Working surface in area 1 of dies after forging: a) 7044 units, b) 8371 units, c) 17054 units

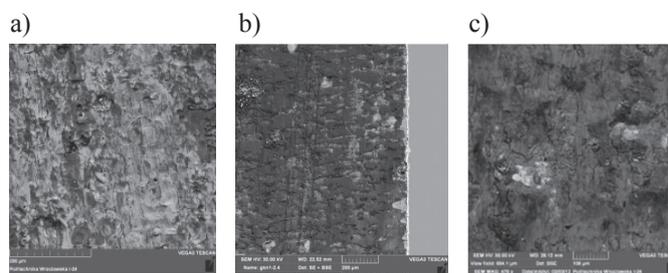
A network of fine cracks (mainly circumferential) is also visible in area 2 (Fig. 8).

Fig. 8. Working surface in area 2 of dies after forging: a) 7044 units, b) 8371 units, c) 17054 units

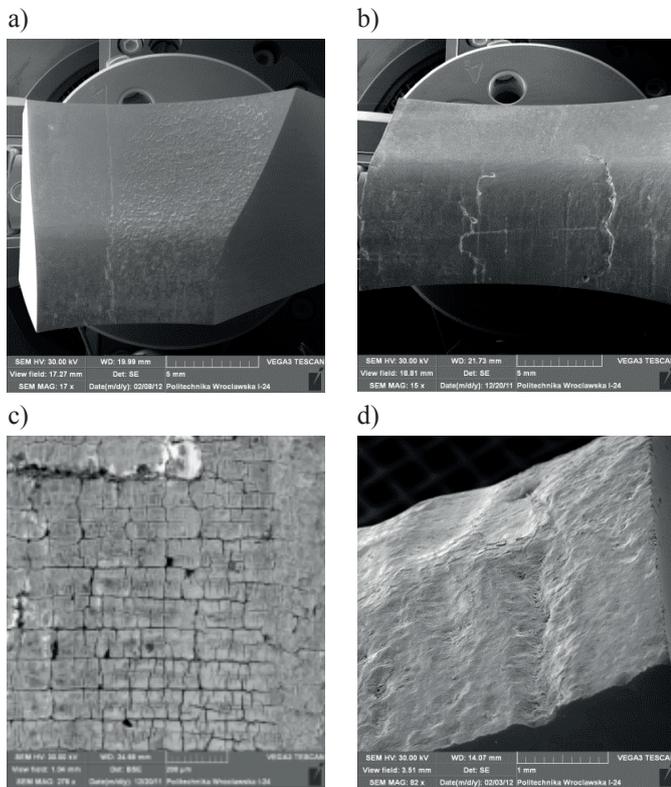
In the place where the reduction in cross section is largest (area 3) a longitudinal crack, caused by the heaviest circumferential stresses, appears already after the forging of 7044 units (Fig. 9a). Similar cracks as for the die after the

forging of 7044 pieces are observed for the die after 8731 cycles (Fig. 9b). A network of cracks typical for thermomechanical fatigue (fig. 9c) appears below the radius of reduction. As the number of forged units reaches 17054 units, the material weakens, which results in the development of cracks and the formation of grooves along the longitudinal cracks on the surface of the die (fig. 9d).

Fig. 9. Working surface in area 3 of dies after forging of: a) 7044 units, b) 8731 units, c) and d) 17054 units

The network of thermomechanical cracks contributes to stress concentration, which combined with cyclically changing large circumferential stresses in the die may lead to mechanical fatigue and damage of the latter. Also the presence of scale contributes to the growth of cracks. Scale in a crack may act as a "wedge". This wear mechanism is most intensive in area 3 where the largest reduction in the cross section of the forging and the greatest hoop stresses occur.

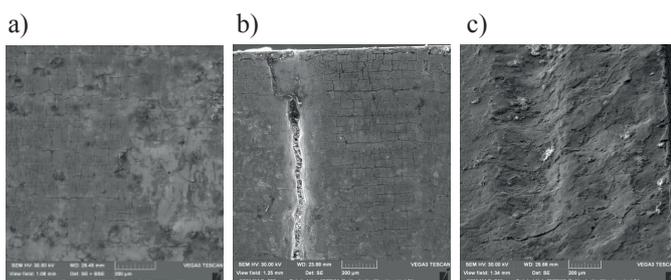
Below the radius of reduction in the cylindrical part (area 4) after 7044 forgings a network of fine thermomechanical cracks (Fig. 10a) is visible. On the cross section one can also discern a single longitudinal crack, which probably developed in area 3 and grew larger with the number of die work cycles. The die's surface in this area looks similarly after the forging of 8731 units: a network of thermomechanical cracks and a distinct longitudinal crack filled with scale are visible (Fig. 10b). After 17054 forgings the die's surface in this area is covered with a thick layer of oxides whereby the network of cracks is poorly visible. Grooves form along the longitudinal cracks (Fig. 10c).

Fig. 10. Working surface in area 4 of dies after forging: a) 7044 units, b) 8731 units and c) 17054 units

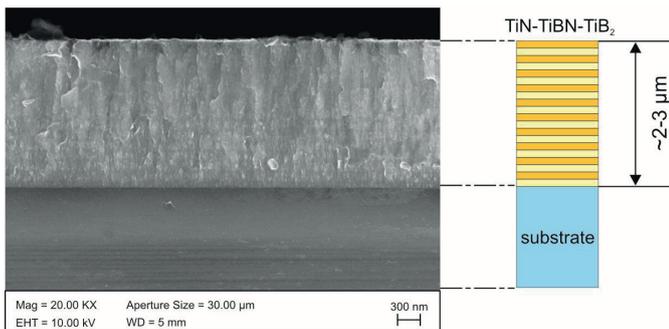
Fig. 11 shows a SEM image of the coating, which consists 25 Ti-TiBN-TiB<sub>2</sub> layers with an overall thickness of about 2-3  $\mu\text{m}$  and a hardness of 3200-4200 HV0.005. Moreover, the coating is characterized by thermal stability in a range of 500-700°C.

Fig. 11. Image of applied coating

The hybrid layer applied to the tested tools had been designed and produced in the Fraunhofer Institute for Surface Engineering and Thin Films in Germany. The multilayer coating is based on Ti-B-N and it was produced using the PN 100/150 device made by RÜBIG. Procedure is described in [19]

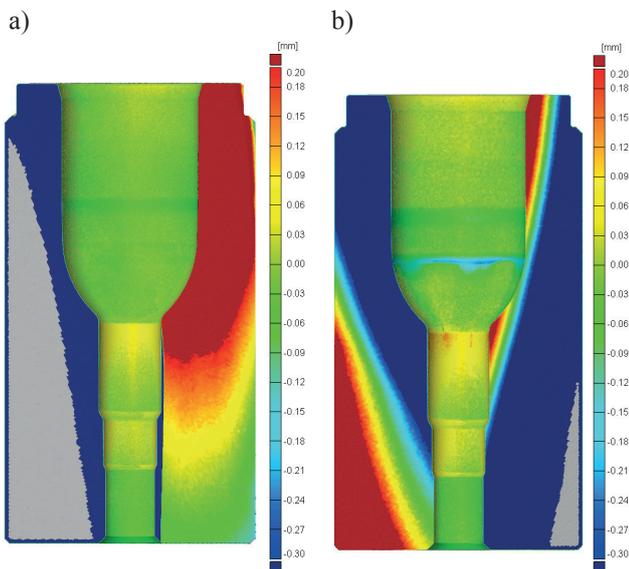
The measurements of the tools performed using the optical scanner were confirmed by the macroscopic examinations which showed very small wear of the tools coated with the hybrid layer after the forging of 5000 units (Fig. 12a). Material adherence occurs, but it is much less intensive than in the case of the previously analyzed tools without the hybrid layer.

Fig. 12. Comparison of scanned images of die after a) 5000 and b) 23078 forgings with CAD model

After the forging of 23078 units a material loss in the place of transition of the cylindrical part into the arched part is clearly visible (a "step" forms there) (Fig. 12b). The wear in this place is not uniform on the whole circumference and it is considerably smaller than in the case of the dies without the coating. Nonuniform wear can also be noticed below the "step" on the die's arched part. This form of wear is probably due to the nonuniform lubrication and cooling of the die.

Traces of material adherence are visible below the first reduction step. For a smaller number of forgings material adherence did not occur.

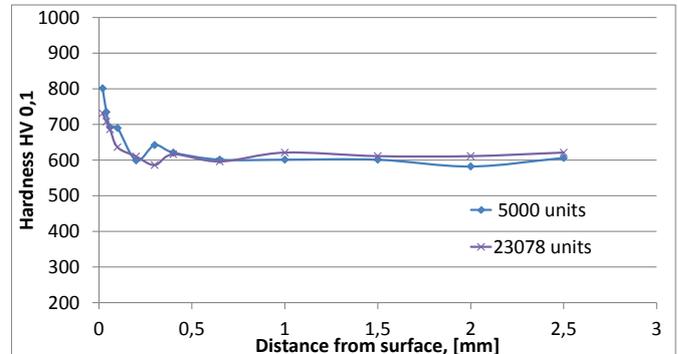
According to the microhardness distributions for the dies with the hybrid layer, there is no significant decrease in microhardness during the whole process [Fig. 13].

Fig. 13. Profiles of microhardness HV 0.1 on longitudinal section of tools coated with hybrid layer

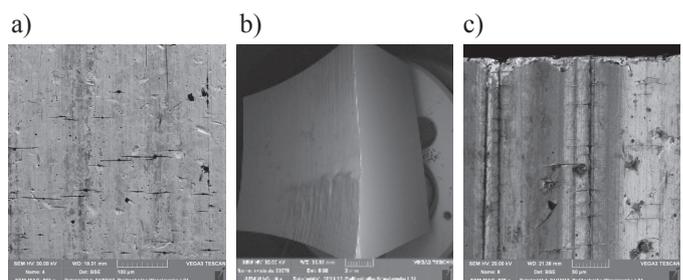
After the forging of 5000 units one can notice irregular fine cracks and shallow longitudinal cracks in area 1 (Fig. 14a). The fine cracks occur only in the circumferential direction.

After 23078 forging cycles a distinct "step" is visible in the place of transition of the circular part into the arched part (Fig. 14b). The "step" is also visible in the surface scan. Under a larger magnification short fine circumferential fractures, concentrated mainly along cracks become visible (Fig. 14c). One can suppose that they are thermal fractures caused by the cyclic changes in die temperature in the neighbourhood of cracks, i.e. where the Ti-B-N coating (constituting a thermal insulation) was damaged.

Fig. 14. Working surface in area 1 of dies with hybrid layer after forging: a) 5000 units, b) and c) 23078 units

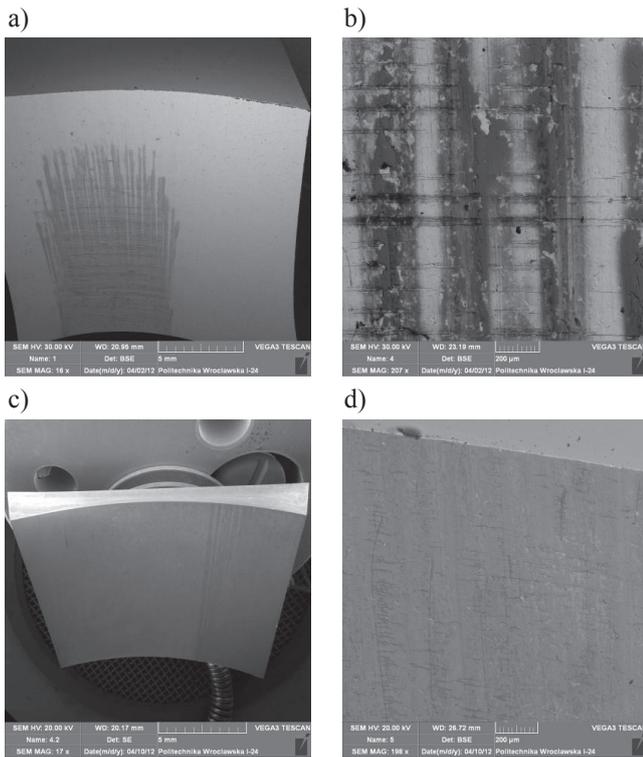
After the forging of 5000 units traces left after finishing are visible in the arched part (area 2). After the forging of 23078 units the traces left after finishing are no longer visible (Fig. 15c). The grooves left after finishing are the place of initiation of fine circumferential cracks appearing already after 5000 forging cycles (Fig. 15b). In the course of further operation the size and number of cracks increase (Fig. 15d). The cracks on the surface of the tools coated with Ti-B-N do not form a typical network of thermomechanical cracks, characteristic of the previously studied uncoated tools.

Fig. 15. Working surface in area 2 of dies with hybrid layer after forging: a), b) 5000 units, c), d) 23078 units

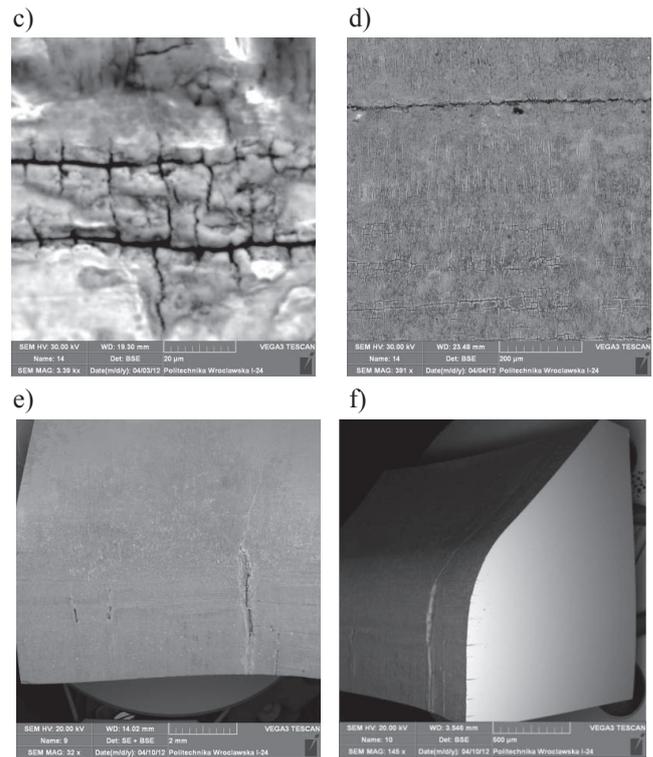
After the forging of 5000 units traces left after machining are visible in area 3 above the radius of reduction (Fig. 16a). Despite the coating's high resistance to high-temperature oxidation, after 23078 forging cycles a layer of oxides forms on the surface of the die, making observation difficult. After 5000 forgings, a network of typical thermomechanical cracks begins to form within the radius of reduction and below it (Fig. 16b). Under a larger magnification the circumferential cracks which appeared earlier become visible. New cracks originate from them in the longitudinal direction, later forming a dense network of thermomechanical cracks (Fig. 16c). The network of cracks grows larger with the number of forged units. After 23078 forgings deep circumferential cracks are visible on the die's longitudinal section (Fig. 16d). The cracks are straight (not inclined in the direction in which the deformed material flows) which indicates the absence of plastic deformations of the die's surface layer. As a result of material weakening and the action of cyclically variable large circumferential stresses the longitudinal cracks grow larger. This is accompanied by the spalling of the material in the vicinity of the cracks (Fig. 16e, f).

Fig. 16. Working surface in area 3 of dies with hybrid layer after forging: a), b), c), d), 5000 units, e), f), 23078 units

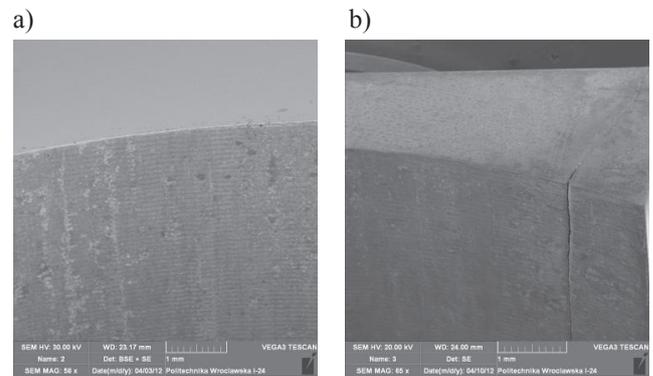
Regardless of the number of forgings, the surface in area 4 of the dies looks similar and shows no traces of wear (Fig. 17). Only on the sample cut out from the die after 23078 forgings one can see a longitudinal crack, which probably originates in area 3.

Fig. 17. Working surface in area 4 of dies with hybrid layer after forging: a) 5000 units, b) 23078 units.
