GRZEGORZ ŚLADOWSKI\*, ELŻBIETA RADZISZEWSKA-ZIELINA\*\*

## DESCRIPTION OF TECHNOLOGICAL AND ORGANISATIONAL PROBLEMS IN CONSTRUCTION WORKS USING THE EXAMPLE OF RESTORATION OF THE OUTER COURTYARD ON WAWEL HILL

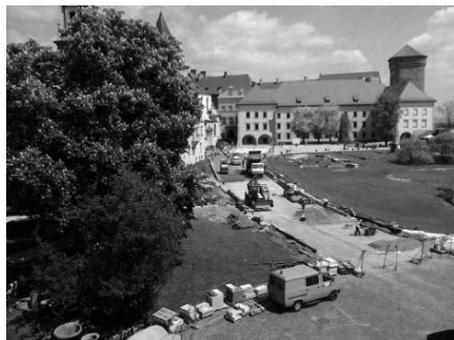
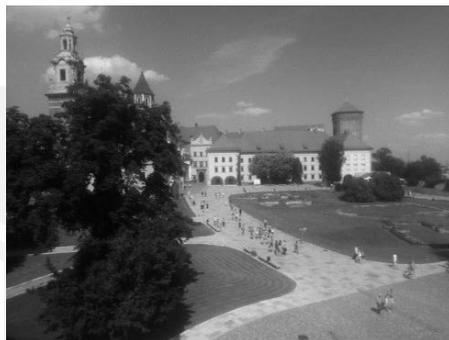
Fig. 1. View of a part of the outer courtyard along with access roads on Wawel Hill: a) during renovations, b) after renovations (source: Royal Castle on Wawel Hill archives)

Restoration of the outer courtyard and access roads (Fig. 1), included the following tasks:

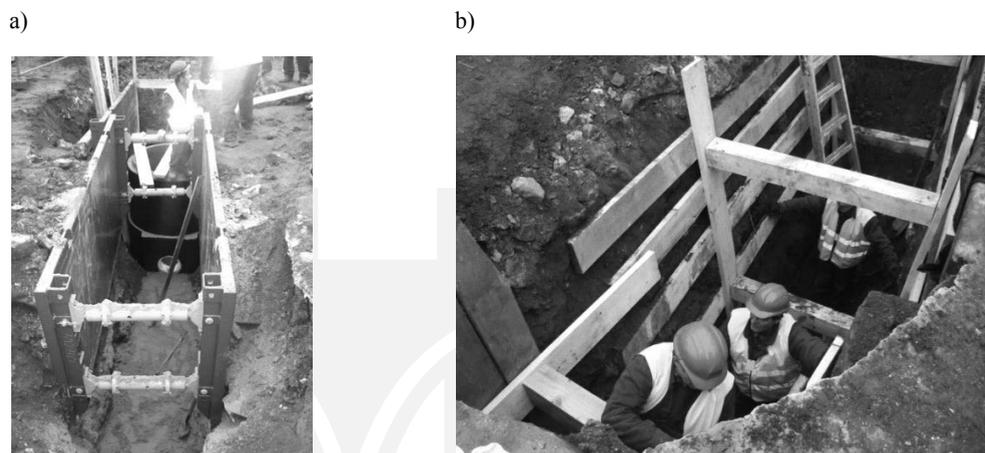
Fig. 2. Method of securing excavation walls: a) for reopened excavations b) for new excavations, with prior archaeological reconnaissance (source: Royal Castle on Wawel Hill archives)

this method allowed the contractor to maintain a high pace of work at relatively low cost of labour needed for its execution. However, during the course of the work it was found that this shoring technology could be used only in reopened excavations (i.e. on the route of the old sewerage network). In a situations when the route of the new sewerage network did not overlap with the existing one, the archaeological supervision forced the contractor to change the method of securing excavation walls using a (traditional) skeleton sheeting method (Fig. 2).

This change in shoring technology allowed archaeologists access to the side walls of the excavation and provided the opportunity to carry out a complete analysis of the stratigraphy of archaeological layers which had not yet been investigated on the new route of excavations. Unfortunately, from the contractor's point, changing the method of shoring the excavations generated much higher labour costs, heavy and costly wood consumption and unfortunately prolonged the time required for this type of work.

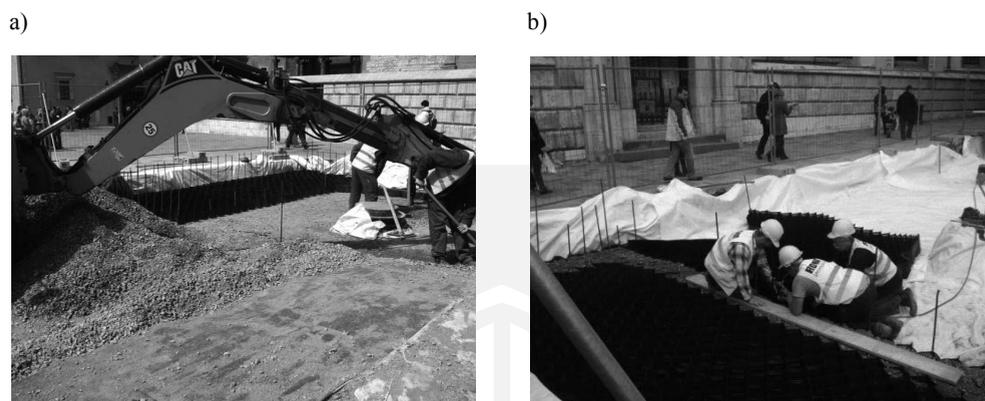
Fig. 3. Methods of strengthening weak soil: a) in the lower left corner the originally designed strengthening using geogrid can be seen, b) The said geocell (source: Royal Castle on Wawel Hill archives)

of 31.5 mm. However, the attempt to achieve the required strength at the level of the supporting bedding failed. Unfortunately, the replacement of the soil in order to improve its strength or its stabilisation using hydraulic binder as well as the attempt to improve soil gradation was not possible for archaeological reasons. As a consequence, it was decided to lay a geocell, i.e. a spatial system made of polyethylene tape in two layers, with a thickness of 20 cm each, with filling the space between “cells” using aggregate with a grain size of 31.5 (Fig. 3).

After the test on the trial plot, strength tests were carried out again, and this time results reached the designed value. Changing the method of strengthening the subgrade caused an increase in expenditures on labour and equipment as well as the execution time of one sq. m. of such reinforcement took much longer, not including the time needed to train workers for whom this solution was new. This spatial structure had to be laid manually. The method of compacting each layer of the geocell required the prior laying of a 5 cm layer of aggregate, whose task was to secure the top part of the geocell from mechanical damage due to rolling. After compacting and execution of verification tests, the protective layer had to be removed in order to implement another geocell layer. Thus, the level of producibility of the above solution meant that the implementation of such reinforcement was not easy in the existing production conditions.

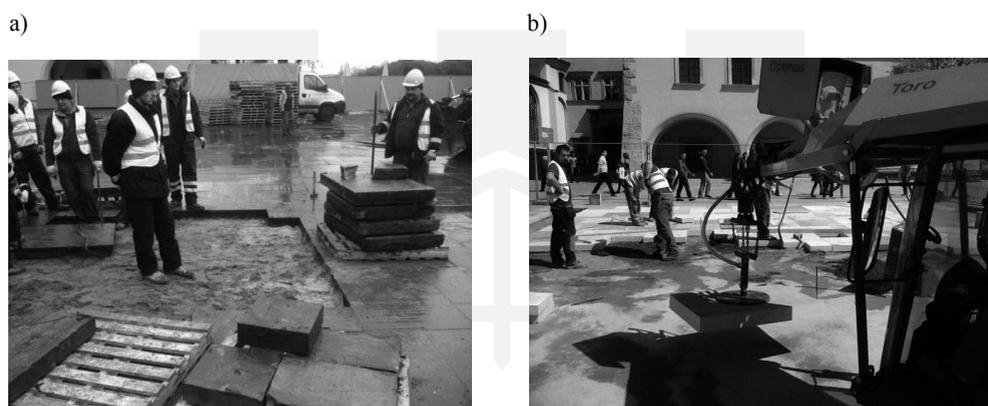
Fig. 4. Methods of dismantling stone slabs: a) Manual b) Mechanical  
(source: Royal Castle on Wawel Hill archives)

of their re-installation. This approach (the idea of maximum recovery of material) determined the need for their careful dismantling and moving onto hauling equipment, in order to take them to a place of possible further treatment. Attempting to manually disassemble slabs and their transfer to the designated place quickly proved to be inefficient due to heavy labour intensity, the consequence of which was the low efficiency of this operation. The large area of removed surface stone (over 4,500 sq. m.), the high cost of labour and time regime, demanded an immediate change of the technology and work plan through the use of special machines, whose pneumatic fittings allowed careful removal of stone slabs and efficient transfer onto hauling equipment. The investment in specialised equipment gave contractor tangible benefits in the form of high efficiency and much lower labour costs, and in the long term the equipment proved to be invaluable when laying new pavement (Fig. 4).

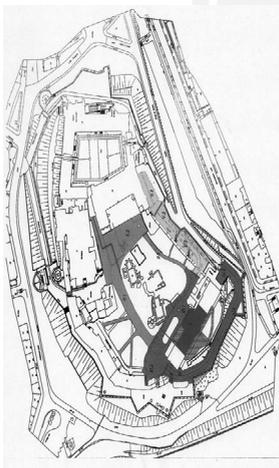
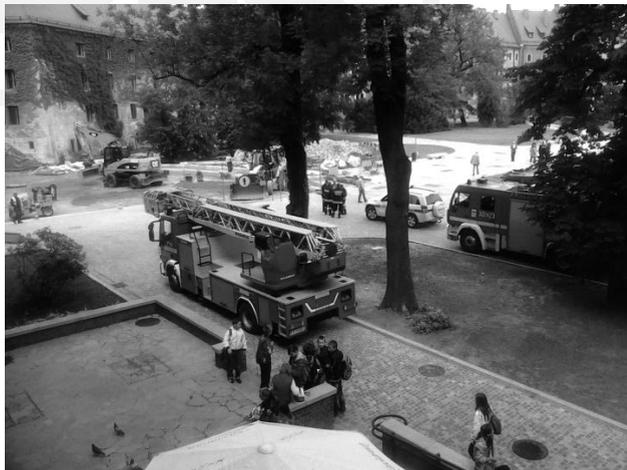
Fig. 5. a) Plan of renovation stages, b) Fire fighter exercises during construction works (source: Royal Castle on Wawel Hill archives)

Restoration works had to be carried out with constant tourist traffic and for the entire duration of the renovation it was necessary to ensure access for fire fighters and other services to Wawel Hill buildings. To meet these demands, the entire project has been divided into 12 stages, the order of implementation of which was strictly specified in the baseline schedule. The division of the project into stages resulted in a lack of continuity in the performance of similar construction processes and uneven demand for means of production as well as problems in the planning of employment (Fig. 5).
