HENRYK NOWAK*, ŁUKASZ NOWAK*

THE USE OF ACTIVE THERMOGRAPHY TO DETECT MATERIAL INCLUSIONS IN THE WALLS

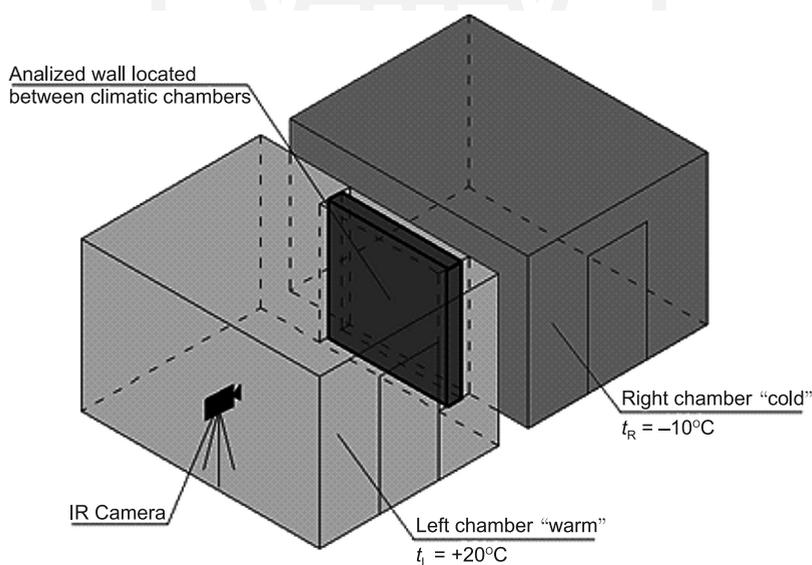
Fig. 1. Wall testing scheme in climatic chambers

The study was performed in climatic chambers in the laboratory of the Institute of Civil Engineering at Wrocław University of Technology. A wall made of concrete blocks (with dimensions of $120 \times 250 \times 380$ mm) with material inclusions ($100 \times 200 \times 20$ mm) was placed in the connecting sleeve between the ‘warm’ and ‘cold’ chamber (air temperatures respectively $+20^{\circ}\text{C}$ and -10°C) (Fig. 1).

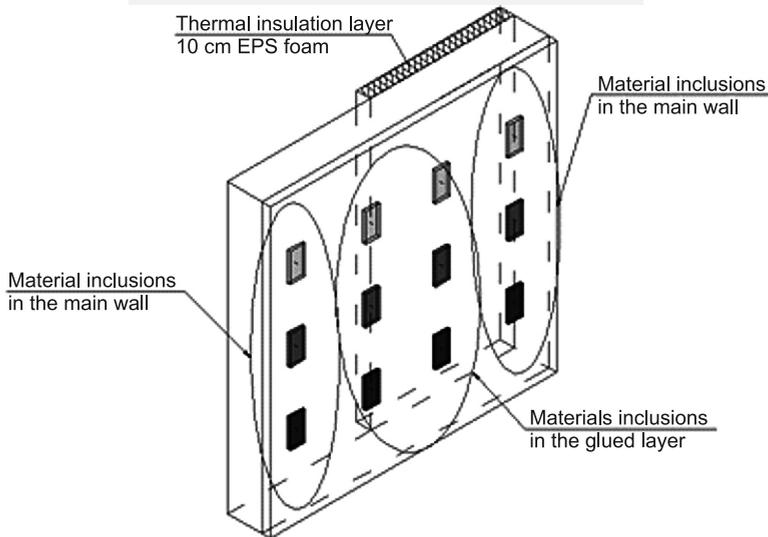
Fig. 2. Analyzed wall with material inclusions scheme

These were placed at two different depths in the concrete block wall. Inclusions were located, at two depths, 6 cm – in the existing wall layer, 4 cm – in the glued after thinner plate layer of the same material. Schematic layouts of material inclusions are shown on Fig. 2 and 3. During the measurements, the following were recorded:

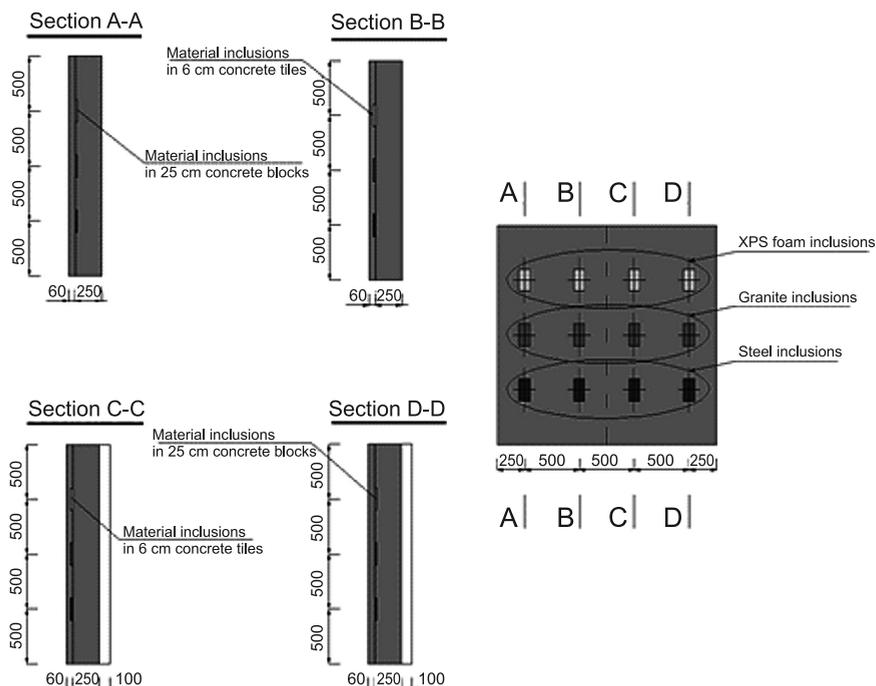
Fig. 3. Placement of XPS foam, granite and steel inclusions in wall made of concrete blocks

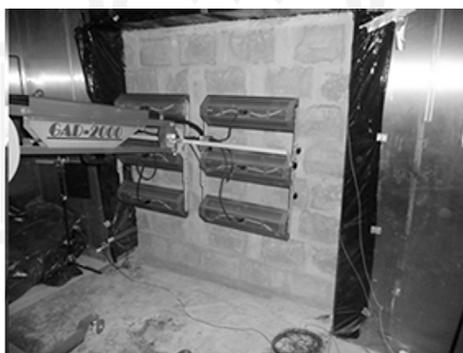
Fig. 4. Heating surface of the test wall by infrared radiators with power 7,2 kW

The research of the wall with inclusions started with heating their surface from the inclusions side (warm side) with infrared radiators with the summary power of 7.2 kW, shown on Fig. 4. The time of wall heating was 40 min and the uniformity of the heating surface of the wall of 2.0×2.0 m was carried out by placing an arm stand with infrared radiators in three positions in 5 min cycles.

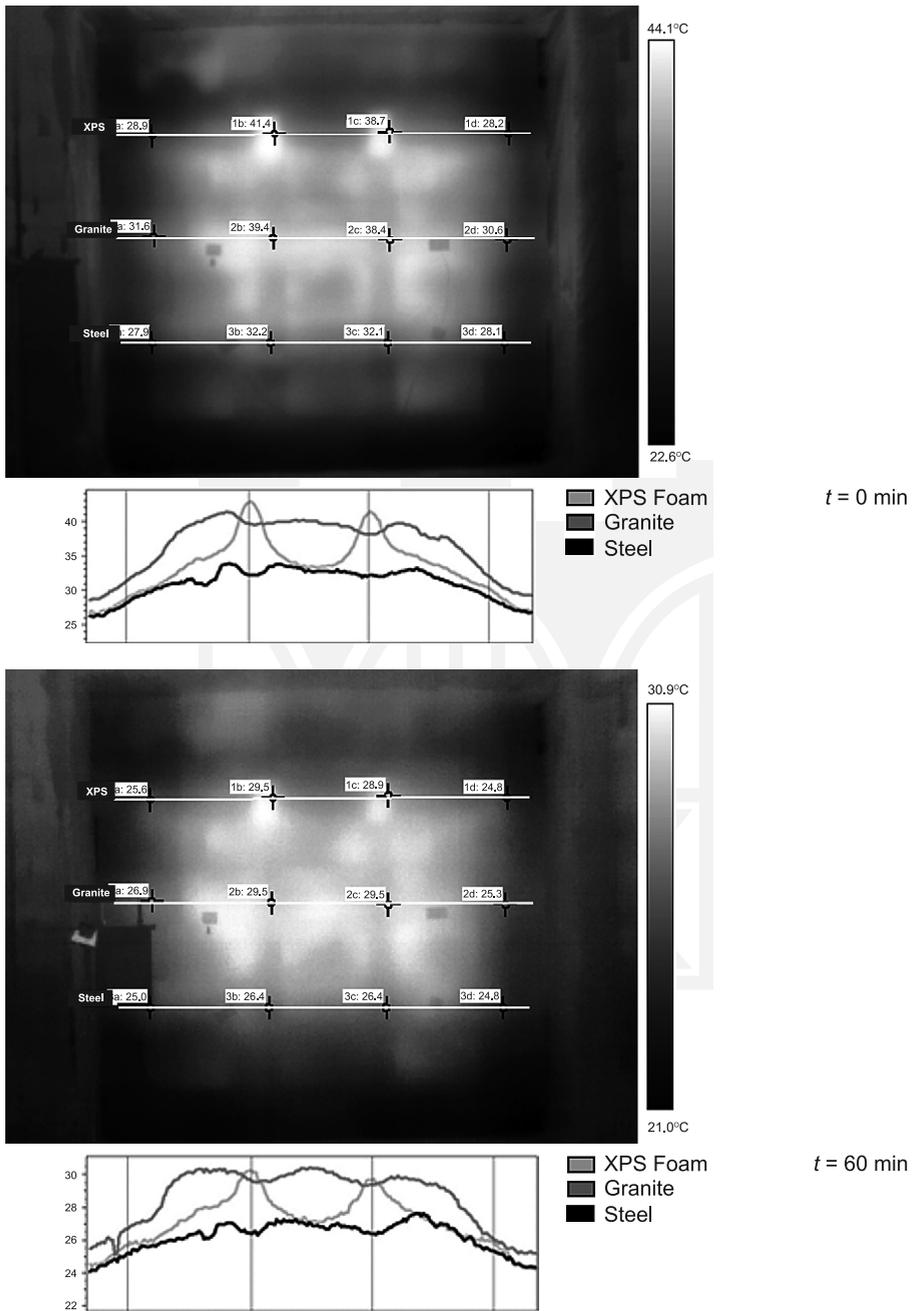
Fig. 5. Thermograms of analyzed wall with surface temperatures in place of material inclusions and temperature distribution along inclusion lines in time of wall cooling ($t = 0$ and $t = 60$ min)

Exemplary results of the study performed in climate chambers the concrete blocks wall with material inclusions are shown in Figs. 5 and 6, in which are thermograms of the wall after the infrared radiators were turned off ($t = 0$ min) and during the cooling of the wall after 60, 120 and 250 minutes. Additionally, under the thermograms are shown surface temperatures of the wall along the horizontal lines at the level of material inclusions.

- The surface temperature of the wall, at the place of inclusions, is depending on the type of material inclusion. For the inclusion material with better thermal properties than wall (e.g. extruded polystyrene) the surface temperature is always between the temperature lines for the inclusions with worse thermal properties than wall (e.g. granite, steel). It is seen in all graphs in the lower part drawings.

- The surface temperature of the wall, at the place of inclusions, for inclusions having worse thermal properties (e.g. granite, steel) is lower than the surface temperature of the remaining wall ('temperature peaks turned down' in the lower graphs on Fig. 5, 6).

- The surface temperature of the wall, at the place of inclusions, for inclusions having better thermal properties (e.g. extruded polystyrene) is higher than the surface temperature of the remaining wall ('temperature peaks turned up' in the lower graphs on Fig. 5, 6).

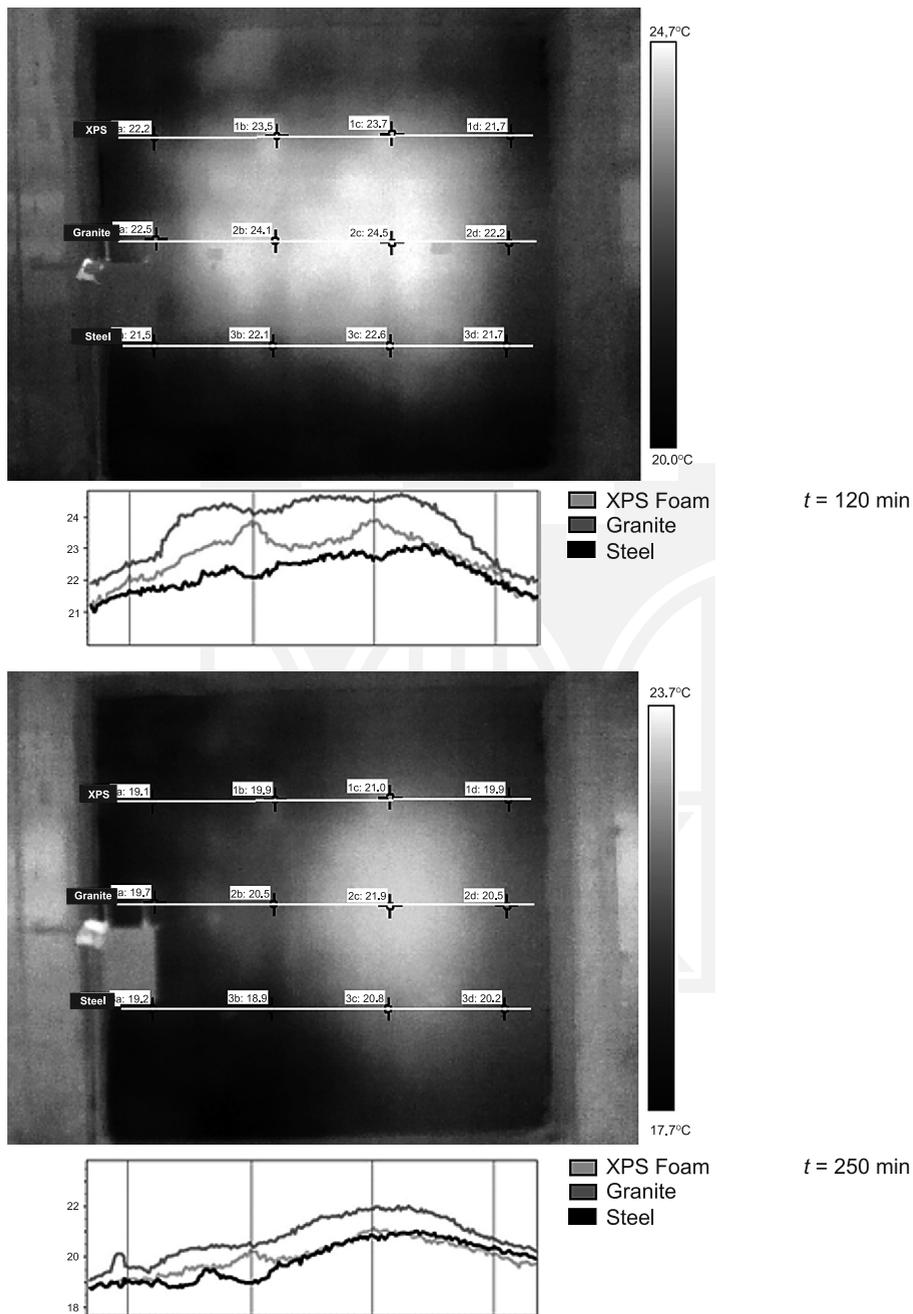
Fig. 6. Thermograms of analyzed wall with surface temperatures in place of material inclusions and temperature distribution along inclusion lines in time of wall cooling ($t = 120$ and $t = 250$ min)
