TOWARD A HOLISTIC HERITAGE CONSERVATION

Built in 1840, Caserma ‘Cascino’ was formerly used as a penal colony before it turned into a barrack for the soldiers of Italian Kingdom. It is located in the southeast of the Cagliari city, on the promontory of Sant’Ignazio, in the Sardegna region.

The paper presents the adaptive-reuse strategy of this old military complex, illustrating how to find a balance between conservation and rehabilitation.

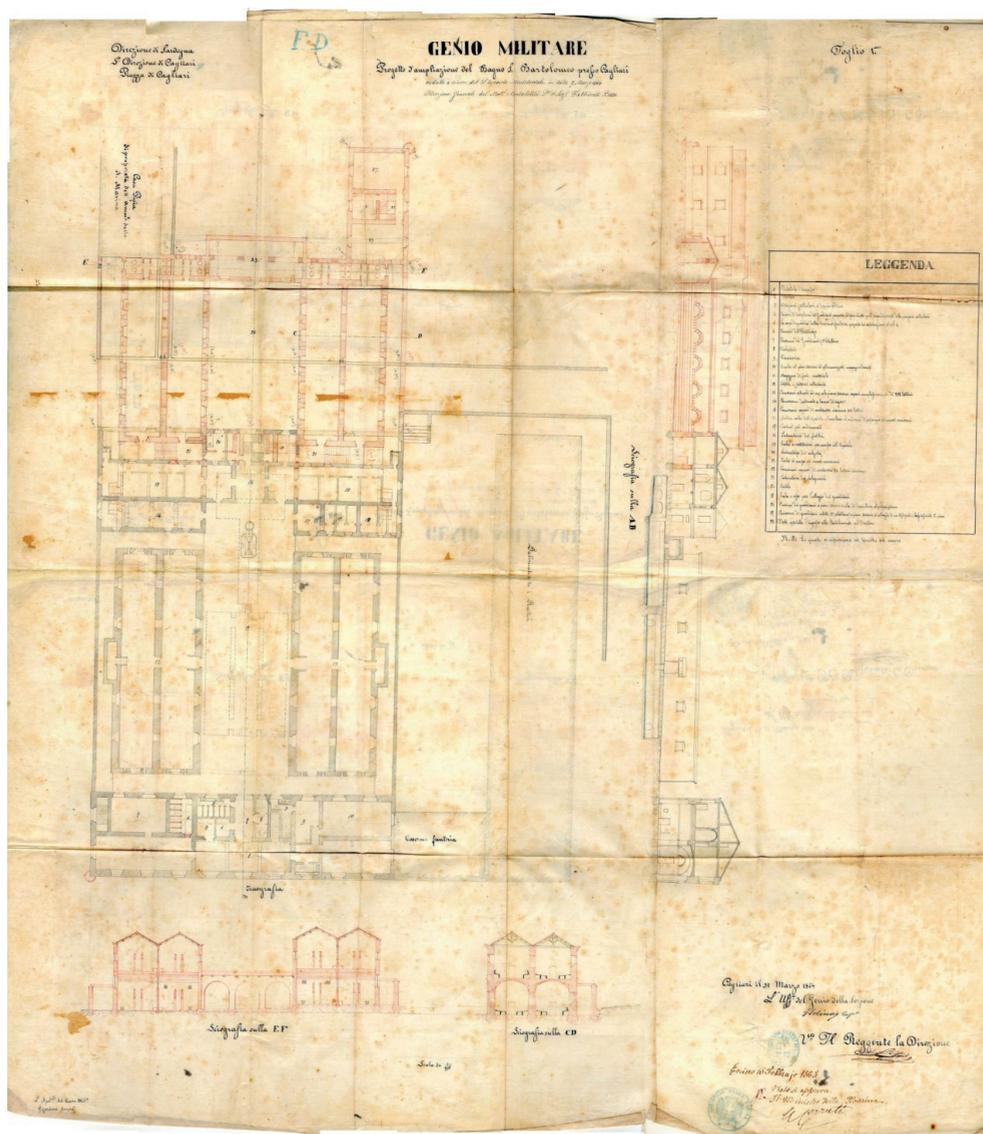
- III. 3. Expansion project of the penal colony San Bartolomeo – the current Caserma ‘Cascino’ (Source: Genio Militare. Progetto d’ampliamento del Bagno S(an) Bartolomeo presso Cagliari redatto a tenore del Dispaccio Ministeriale in data 7 Marzo 1864 Direzione Generale del Nat.e e Contabilità D(irezione) 1° Sez(ione) Fabbricati N° 1854”, 1864, ing. Solinas. A.S.Ca, Genio Civile, busta 319)
- II. 3. Projekt rozbudowy kolonii karnej San Bartolomeo – obecny Caserma ‘Cascino’ (Źródło: Genio Militare. Progetto d’ampliamento del Bagno S(an) Bartolomeo presso Cagliari redatto a tenore del Dispaccio Ministeriale in data 7 Marzo 1864 Direzione Generale del Nat.e e Contabilità D(irezione) 1° Sez(ione) Fabbricati N° 1854”, 1864, ing. Solinas. A.S.Ca, Genio Civile, busta 319)

Between 1861 and 1865, the complex went through another expansion. The engineer G. Solinas designed the new structure from the existing walls, transforming in depth the configuration of the existing buildings.

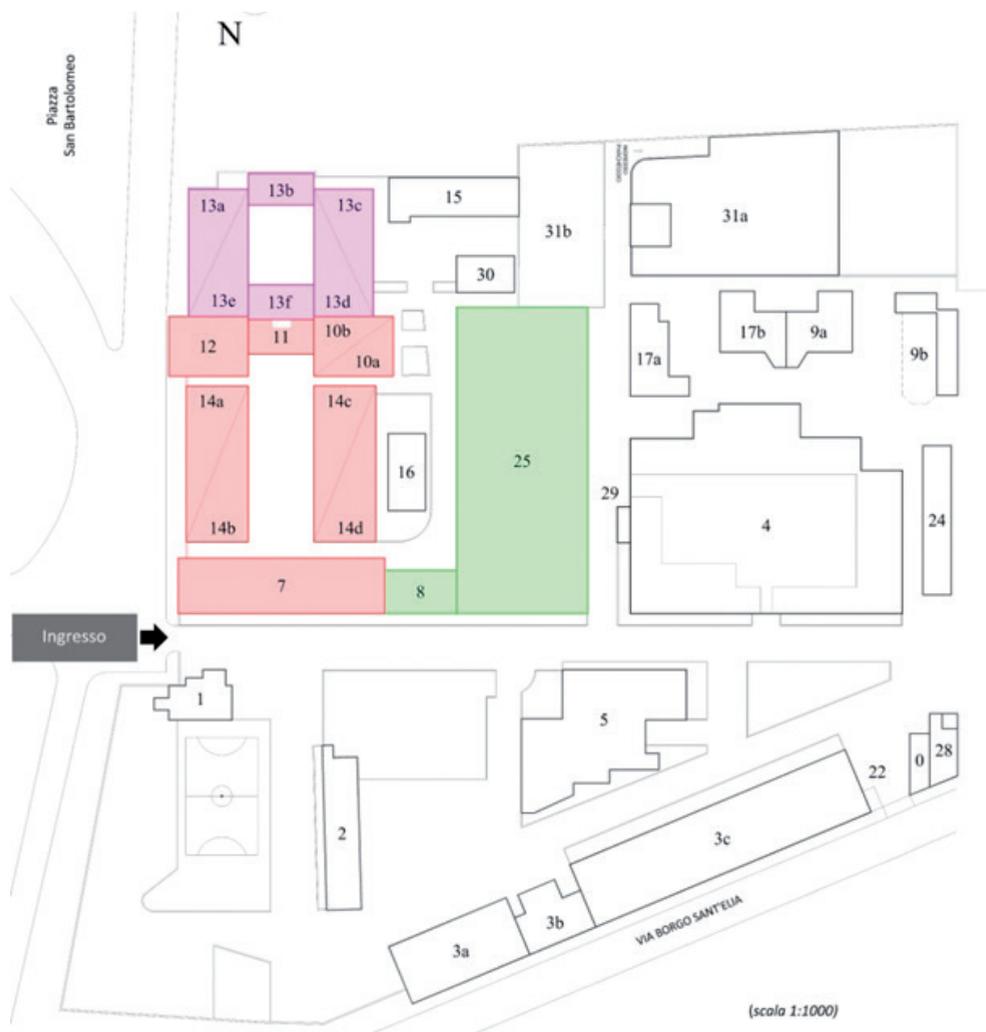
Planimetria Generale

Corpi architettonici dell'antico Bagno Penale - cronologie

- primo insediamento (prog. Domenico Carlo Barabino) - ante 1842
- primo ampliamento (prog. Efsio Crespo) - 1860 circa
- secondo ampliamento (progg. Boraggini, Solinas) - ante 1862-64 e 1869-70

III. 4. Map of Caserma 'Cascino' and its development phases over time

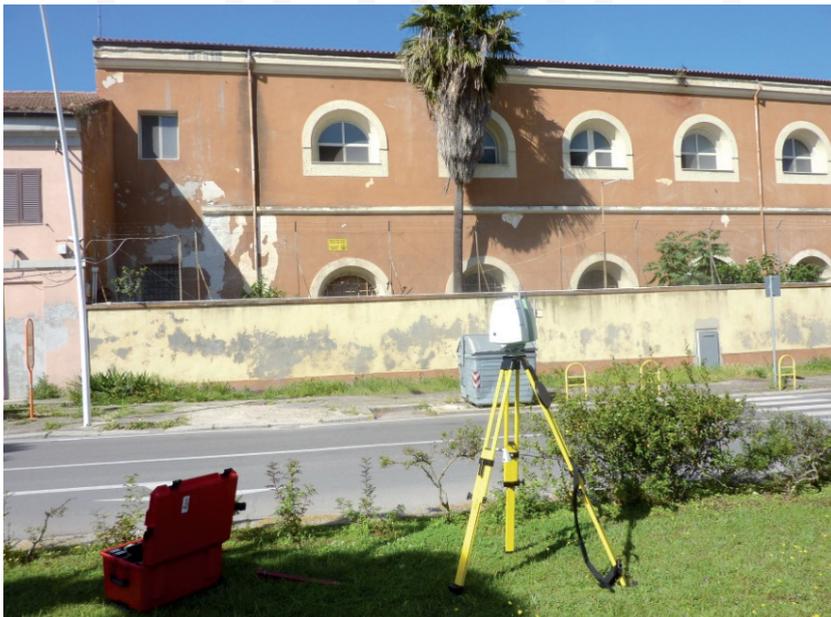
III. 6. The photo presents the capturing phase of the architectural survey using Laser Scanner 3D Leica C10 all-in-one

Topographic and architectural survey were conducted through manual recording and EDM measurement. The equipment adopted the EDM measurement were Laser Scanner 3D Leica C10 all-in-one with an accuracy of $\pm 4\text{mm}$ and a DISTO.

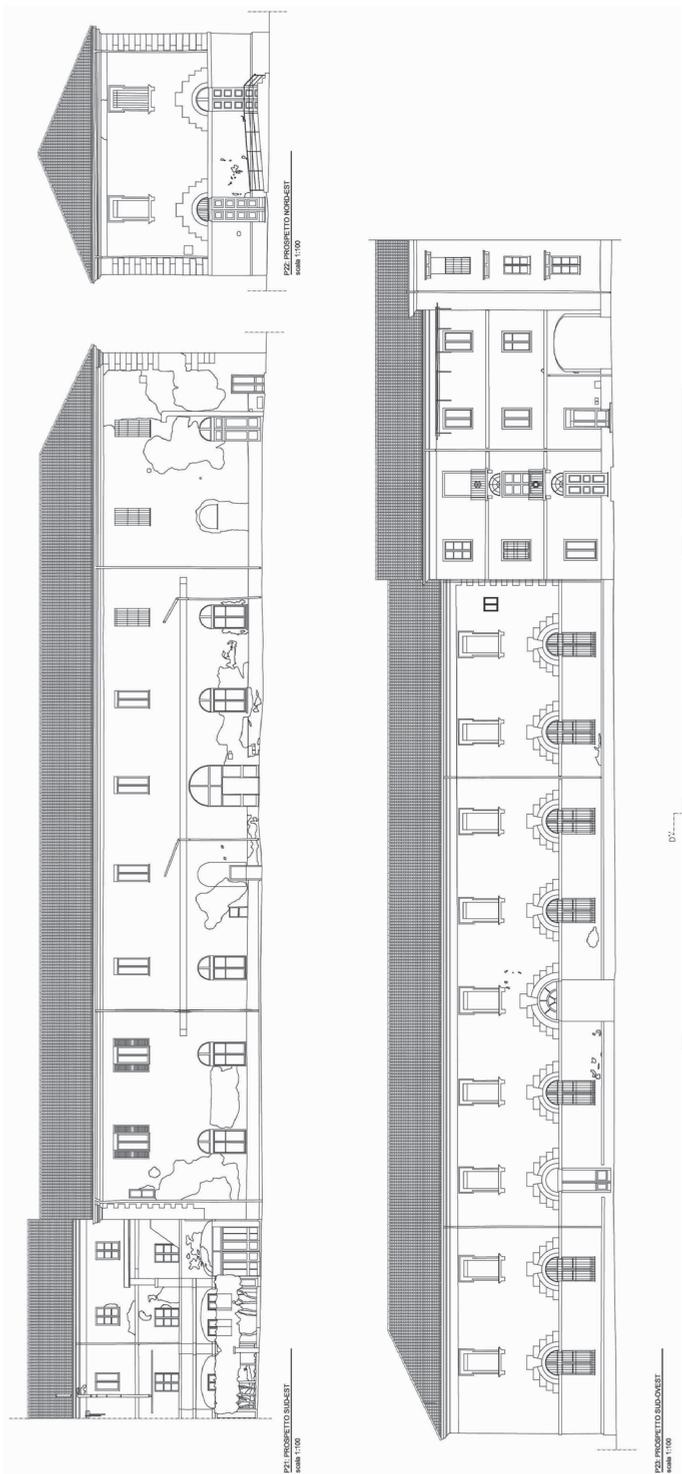
III. 7. Images of the front elevations of the building n.7 of Caserma 'Cascino', scale 1:100

These data had been processed to produce 2-dimensional drawings of the site plan, floor plans, cross sections, elevations, and details.

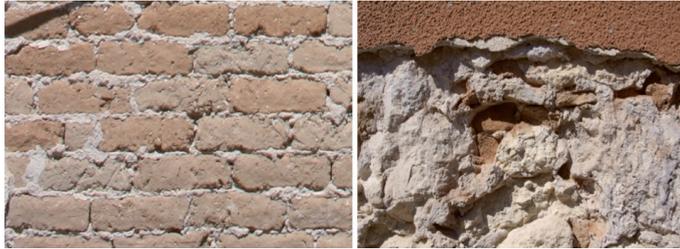
III. 8. Photos present the deterioration of the masonry structure of the external walls

The primary cause of deterioration was connected with humidity. Capillary action resulted in the raising moisture from the ground is affecting the lower portion of the building. Groundwater aquifer was likely to be the cause of this problem. This phenomenon was homogeneous across the entire complex (usually observed in the internal wall, where the evaporation is slower). From a visual analysis, the effects of the described form of deterioration are evident. Indeed, chromatic alteration, erosion of the mortar, as well as deterioration of the plaster are visible on the surface of the masonry wall. Moreover, the one-meter-tall concrete layer on the exterior wall, due to its impermeability and incompatibility with the masonry structure above, caused the moisture to travel up on the wall surface. Other forms of decay are of anthropic nature. For example, the presence of concrete plaster in the façade of the building (due to interventions of routine maintenance) was incompatible with the wall support. Other problems had been caused by using impermeable materials such as plastic quarts as the finishing layer, resulted in bulging and cracks of the surface materials due to the lack of perspiration.

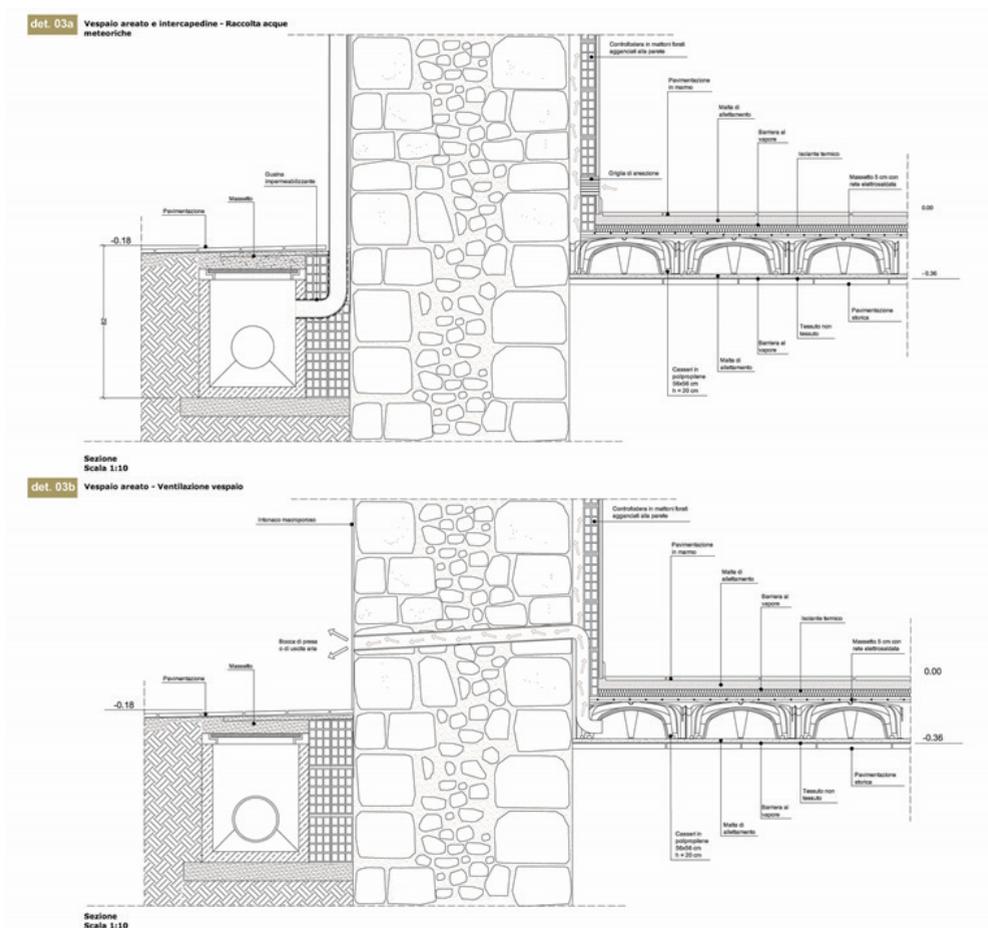
III. 9. Detail of the solution adopted for the replacement of ground floors with a coffered floor (vespaio areato), relocating the original tiles on its top, detail in scale 1:10

One aspect of the conservation project dealt with effective solutions to the humidity problems. Dynamic Buffer Zone (DBZ) was one of the strategies deployed during the intervention. The system consisted of an additional interior wall partition offset from the original masonry wall in order to promote a constant airflow between the cavity. With the same intention as the DBZ, a coffered system (vespaio areato) was installed on grade to provide rooms for air circulation underneath the floor. The original tiles – in graniglia and gres porcellanato – were fully preserved and relocated on top of the system.

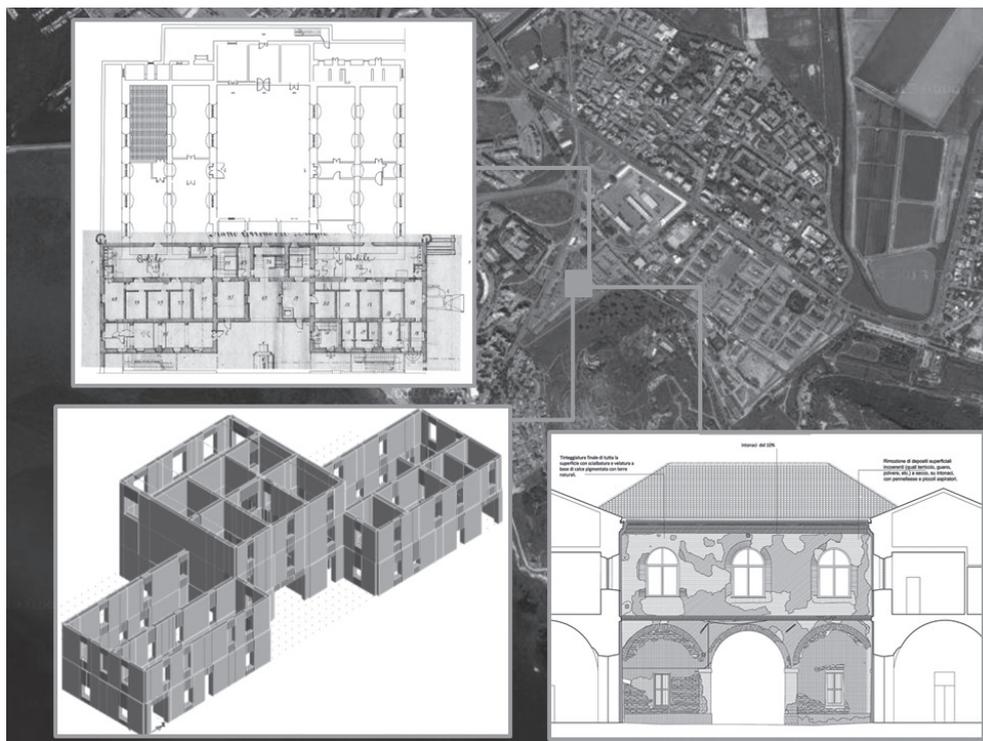
III. 10. The image presents the analysis developed for the adaptive re-use of the complex with respect to the compatibility and authenticity issues

The adaptive-reuse of the building was oriented to combine the needs of the owner (Comando dei Carabinieri di Cagliari), at the same time respected the structural integrity of the building. Notably, the transversal axis of the inner core and the scheme of the original project were preserved.
