MANFRED WEHDORN\*

## RESTORATION OF THE LIECHTENSTEIN PALACE

#### Abstract

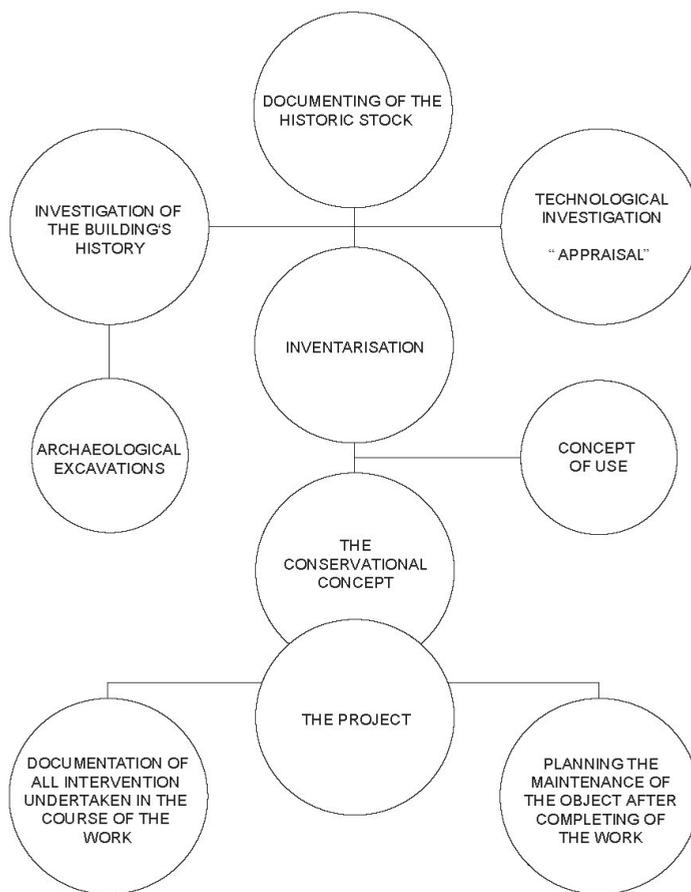
III. 1. Schematic scene of a conservation project

The basic principle underlying the work was the consideration and realization of the monument’s value in accordance with the Management Guidelines for Cultural Heritage Sites. The development and management of a conservation project cannot be compared to other construction projects; as shown by the relevant schematic (Ill. 1).

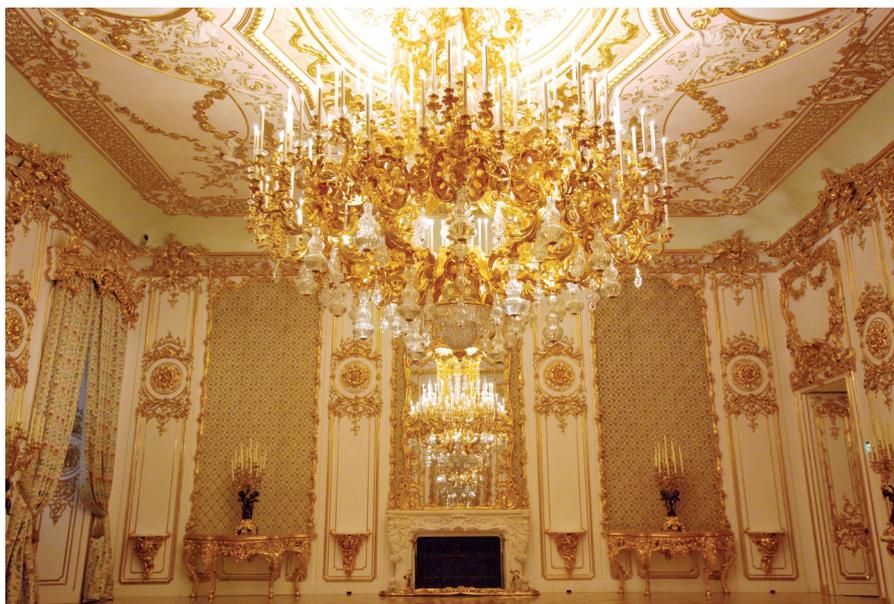
III. 2. Quadratsaal chandelier  
II. 2. Kandelabr w Sali Kwadratowej

The central chandelier has a diameter of approx. 3.40 m, a height of approx. 4 m and holds 288 candles; the room also contains four corner candelabras and wall lights, so that the room was originally lit by a total of 560 candles. It is immediately obvious that a reconstruction using traditional light sources is not possible, if only because of the heat that would be given off by such a large number of lights in the one room.

Even in the pre-planning stage – so more than five years ago – it was therefore decided that the state rooms at least should be fitted with LED lights, and this at a time when, although nobody was in any doubt as to the future of LED lighting, the necessary light sources were not yet available on the market. A significant factor in this brave decision was the knowledge

that LED light sources have an average life of 50,000 hours, making on-going maintenance considerably cheaper. As a result, lighting planners and companies first developed the required LED candle model in the course of the restoration work, creating an optical and light pattern which could be compared to that of candles in the Biedermeier era in terms of both the brightness and the colour of light. – Today around 1,200 LED candles cast the right light on the state rooms<sup>5</sup>.

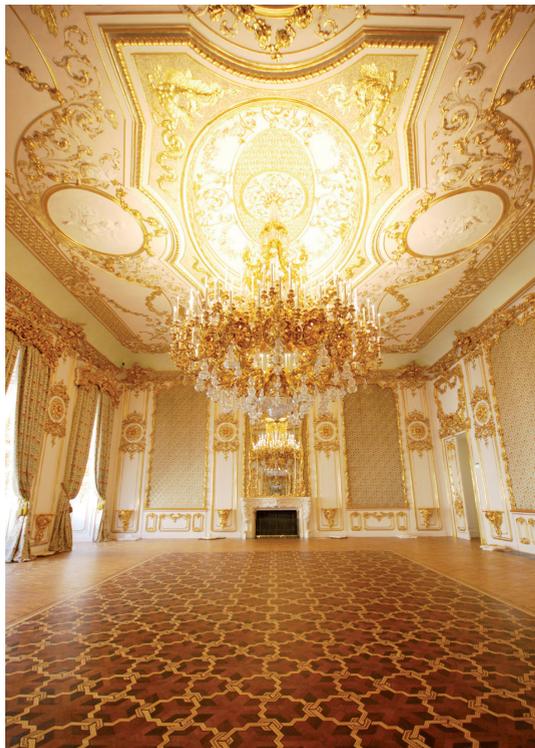
III. 4. Thonetfloor before and after restoration: a) Quadratsaal 2<sup>nd</sup> floor after restoration; b) Thonetfloor Bouquetsaal 2<sup>nd</sup> floor before restoration; c) Thonetfloor Bouquetsaal 2<sup>nd</sup> floor after restoration

The state of the floors prior to the restoration work was frankly catastrophic: a large part had simply been left unrestored and covered by a second floor after the Second World War and only the Quadratsaal had been treated to “renovation” by means of the sanding and varnishing of the intarsia surface.

The reconstruction of the damaged areas was undertaken using the same technique as Thonet. The individual sections of precious wood were softened in a steam pipe and bent precisely into the original shapes made by Thonet with the aid of custom-made bending

jigs, glued into parcels and, once cut, inserted into the damaged areas. In order to achieve something close to the tone of the historic maple, a vacuum overpressure method was used to colour the prepared maple blocks throughout with a light-fast stain.

However, the most important procedure employed for the historic recovery of the original aesthetic character was the prior cleaning of the entire surface by means of the so-called dry ice procedure. For this the surface was not sanded, but the old, dirty wax, which had been absorbed deep into the pores of the wood, was removed. Since the dry ice sublimates immediately without leaving any residue, there is no exposure to dust caused by a blasting abrasive. The removed wax is simply sucked away.

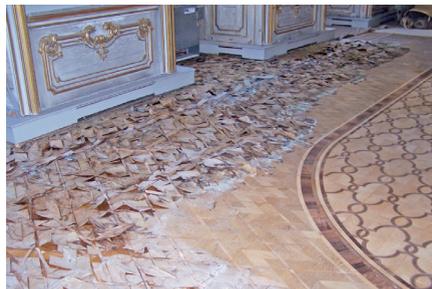
b)

The damage to the unrestored floors was also considerable thanks to the war and general use. In addition to shards of shrapnel, the intarsia work in the individual rooms often included damage covering several square metres and in many rooms up to 50% of the intarsia and marquetry work was coming away from the oak subfloor. In some places the subfloors were worn through. The removal and replacement at the right level of approx. 20% of the parquet tiles which was necessary for the technical improvements also posed a serious challenge. For this we had to unglue considerable sections of Thonet’s ornamental, laminated marquetry, carefully remove the parquet tiles, open up the subfloor, and then, once the technology had been built in, re-lay and laminate everything exactly as before at the original level.
