TECHNICAL CONDITION ASSESSMENT AND CONSTRUCTION SOLUTION OF RC DIGESTION CHAMBER STRENGTHENING

This paper presents the technical condition assessment of a RC digestion dome chamber after fourteen years of exploitation. The authors conducted experimental investigations, i.e. tests of concrete compressive strength using a scleroscope, concrete chemical analysis in the laboratory and detections of reinforcement. On the basis of the obtained results and cracks morphology, static-strength calculations were conducted. The results of the FEM numerical analysis indicated deficiencies in the bearing capacity of the dome. The widths of the calculated cracks exceeded allowable values. The authors proposed two alternative methods of chamber strengthening: pouring additional RC dome cover or post-tensioning the dome with external unbonded tendons.

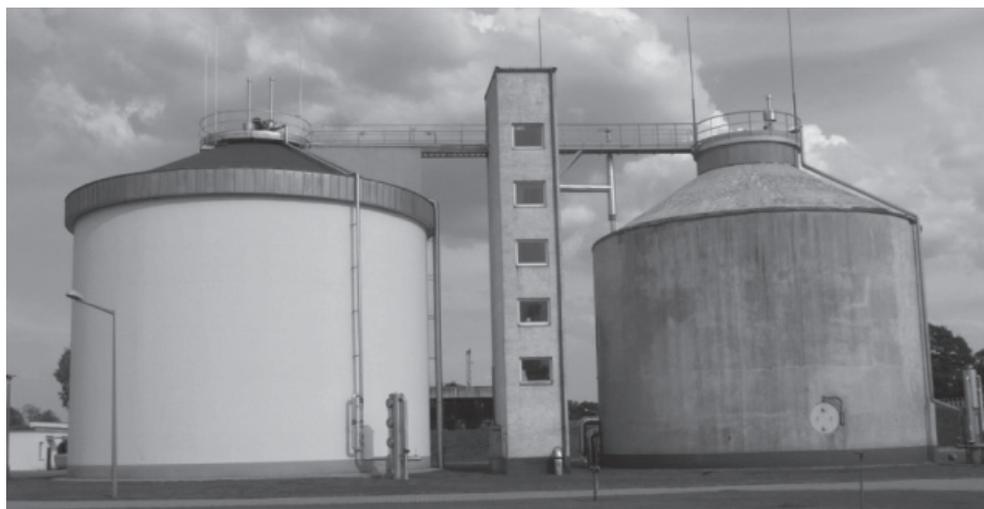
The analysed digestion chamber tank (Fig. 1) was erected in the time period between September 1997 and May 1999. The tank has been in use for more than eleven years. The flood in May 2010 resulted in long-term facility downtime (over two years), causing sludge sedimentation and clogged pipelines. In July 2012, the renovation work began which involved the mechanical removal of the old coatings by abrasive blasting (sandblasting) from the walls and the dome and the laying of a new two-component epoxy resin without any additional sealing. The contractors did not prepare the technical condition assessment of the dome surface before placing the resin coating. The repair works lasted until the end of August 2012. In October 2012, the engineers decided to fill the tank with the water at a rate of 10 m³/h for a period of around eight hours per day. In November 2012, the first leaks on the dome surface were noticed and the administrator was forced to stop the process of tank filling. After a partial outcrop of the dome external surface, numerous cracks were discovered. The two widest cracks were oriented in a circumferential direction. Smaller cracks were located in a radial direction.

Fig. 1. The view of the two digestion chamber tanks (analysed tank on the right)

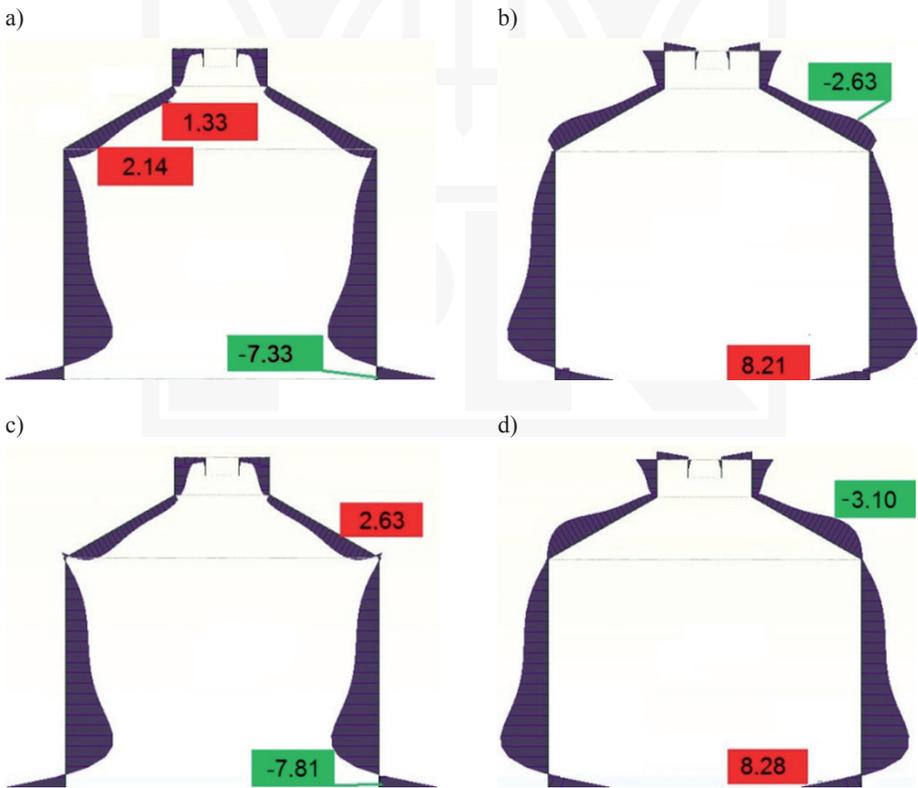
The distribution of radial stresses on the dome's inner and outer surfaces under operation and emergency (tank overflow) loading are shown in Fig. 5. The distribution of circumferential stresses on the dome's inner and outer surfaces under operation and accidental loading are shown in Fig. 6.

Fig. 5. The distribution of radial stresses: a), b) on the inner and outer surface during operation; c), d) on the inner and outer surface in the accidental (tank overflow) situation

The maximum tensile stresses in a radial direction on the outer surface of the dome were $\sigma_r = 3.10\text{MPa}$ and $\sigma_r = 2.63\text{MPa}$ during operation and emergency situation. In both situations, maximum tensile stresses occurred approximately 2.4 m from the outer edge of the tank wall and exceed the tensile strength of the concrete ($f_{ctm} = 2.6\text{ MPa}$ for C25/30). In a circumferential direction, only loads acting in the emergency situation caused an excess of stresses: $\sigma_\phi = 3.01\text{ MPa}$ over the medium concrete tensile strength.

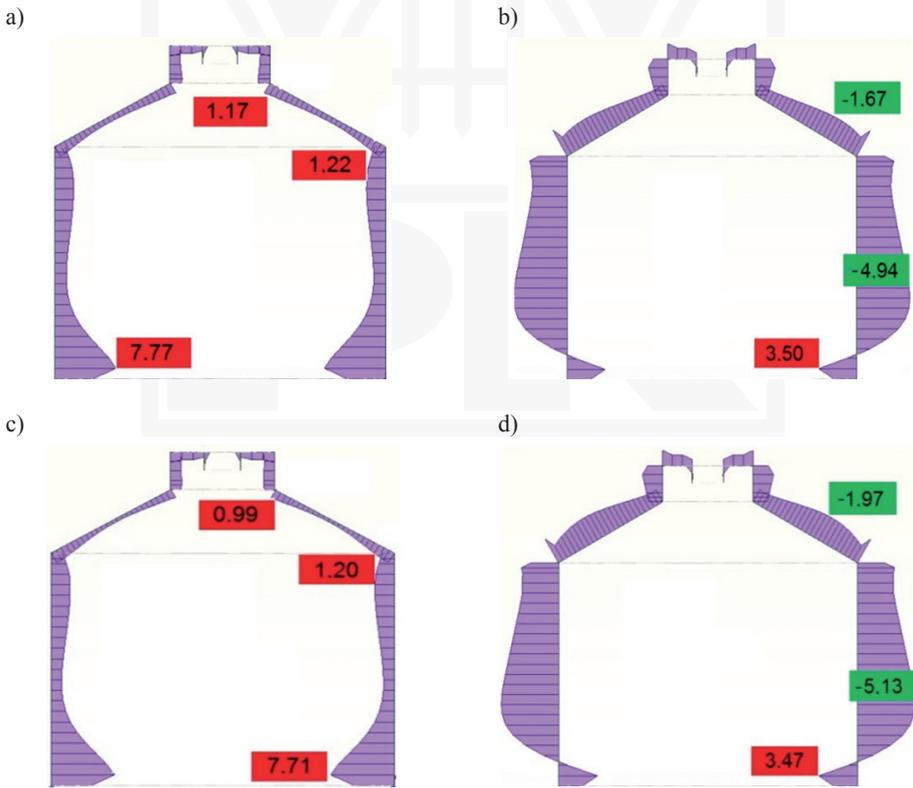
Fig. 9. The distribution of radial stresses in composite cross-section: a), b) on the inner and outer surfaces during operation; c), d) on the inner and outer surfaces in the emergency situation

In order to investigate the behaviour of the composite cross-section consisting of a RC dome (250 mm thick) and additional RC shell (+100 mm thick) static calculations have been prepared. The distribution of the radial stresses in the composite cross-section of the dome's inner and outer surfaces under operation and emergency (tank overflow) loading are shown in Fig. 9. The distribution of the circumferential stresses in the composite cross-section on the inner and outer dome's surface under operation and emergency loading are shown in Fig. 10.

The maximum tensile stresses on the outer surface of the composite cross-section in a radial direction were $\sigma_r = 1.67$ MPa (during operation) and $\sigma_r = 1.97$ MPa (in emergency situation). In a circumferential direction, the maximum stresses were $\sigma_\phi = 2.05$ MPa and $\sigma_\phi = 2.27$ MPa respectively during operation and the emergency situation. The stresses in the concrete composite shell do not exceed the mean value of concrete tensile strength ($f_{ctm} = 2.9$ MPa for the concrete class C30/37). Moreover, pouring an additional RC dome cover does not result in a significant increase of tensile forces in the circumferential ring around the tank's dome.

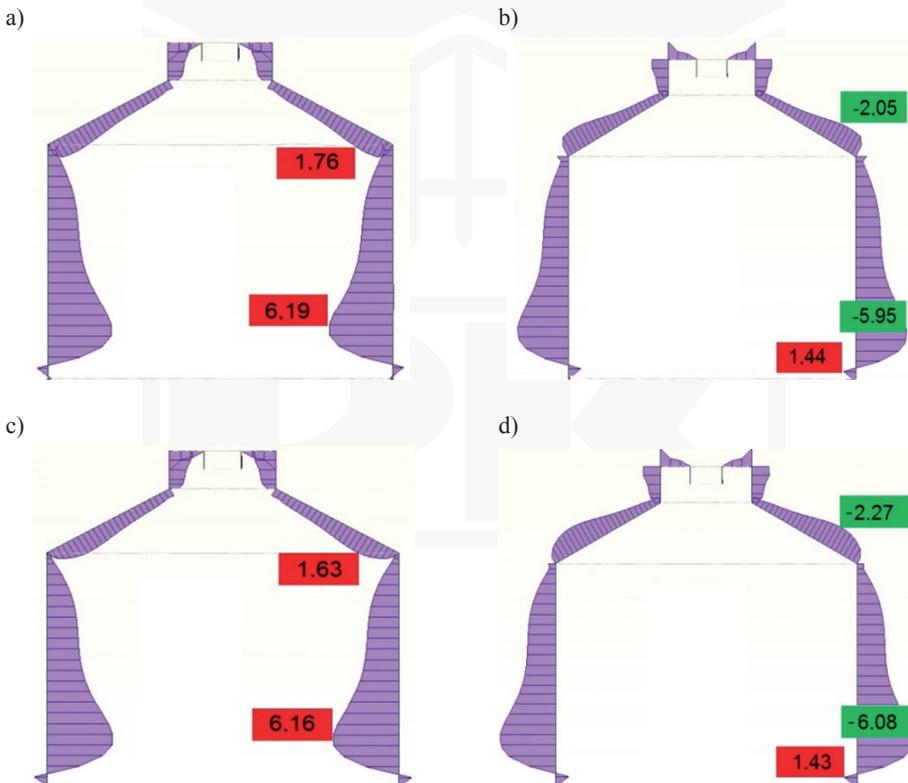
Fig. 10. The distribution of circumferential stresses in composite cross-section: a), b) on the inner and outer surfaces during operation; c), d) on the inner and outer surfaces in the emergency situation
