## Condensed water in the dryline water trap system of capnography as a potential source of infection: a case report

Capnometry is the measurement of carbon dioxide (CO<sub>2</sub>) in a sample of gas. Capnography is continuous monitoring of the concentration or partial pressure of CO<sub>2</sub> in respiratory gases. Here, we are reporting two cases of bacterial isolation from the water trap being used in the intensive care unit (ICU) and in one case was admitted to COVID ICU whose sample from the collected water trap was sterile. In all three of these patients a side stream capnography monitoring was being used. On close inspection of water trap chamber of capnograph we saw some collection of condensed water in all the three chambers. We sent the samples of all three patients for culture sensitivity out of which two was positive and one was sterile later on. The ICU- acquired infections are becoming a challenging health concern especially when caused by multi drug resistant pathogens and in current COVID 19 pandemic risks to health care worker are even more and it always warrants a close observation. In our case contamination of breathing systems may occurred because of complian

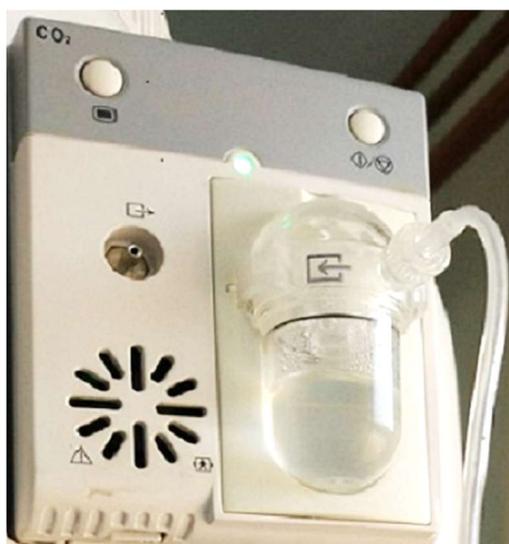
In all three of these patients a side stream capnography monitoring was being used. On close inspection of the water trap chamber of capnograph we saw some collection of condensed water in all the three chambers as shown in Figure 1. We sent the samples of all three patients for culture sensitivity to confirm whether the water present inside the trap is a contaminant or not. The samples were sent to department of microbiology and then the sample was plated on blood agar and MacConkey agar and incubated at 37 °C aerobically for 24 hours. The Colonies derived from Case sample A was non hemolytic on blood agar plate and lactose non-fermenter on MacConkey agar while the Case sample B gives non hemolytic mucoid colonies on blood agar plate and lactose fermenting pink colonies on MacConkey agar. The Case Sample C has shown no growth and it was sterile on blood and MacConkey agar, and other two colonies was further evaluated using Gram Stain and several other biochemical tests. Based on the Gram stain properties and biochemical reactions the non-fermenter, non-hemolytic colonies were identified as *Acinetaobacter baumannii* strain (Case sample A) and the mucoid colonies were identified as *Klebseilla pneumoniae* (Case sample B).

**Figure 1.** Dryline water trap system filled with condensed water.

In our case contamination of breathing systems may occurred because of the compliance failure possibly due to improper inspection and functional testing of the sampling tube and exhaust tube which may lead to the reversal of the direction of flow through the sampling tube in a diverting respiratory gas monitor (RGM). The second reason for breathing system contamination may be due to non-functioning of breathing system filter as it is not a component of RGM with high-integrity characteristics. There is an unacceptable

So, it is recommended that daily inspection, functional testing and routine check for all breathing system filter should be made mandatory and never ignore any condensed water collection in the dry trap system as they may behave as a potential source of cross contamination and infection. As these are not suitable for mechanical re-processing or sterilization, but we can reuse this dry trap system at the time of crisis by cleaning with moist wipes using 70% solution of isopropyl alcohol during current COVID-19 pandemic.
