B. PAWŁOWSKI\*, P. BAŁA\*, T. TOKARSKI\*, J. KRAWCZYK\*

**PREMATURE CRACKING OF DIES FOR ALUMINIUM ALLOY DIE-CASTING**

Two identical dies for aluminium alloy die-casting failed prematurely because of a number of parallel cracks on the working surface. These cracks were of a mechanical nature related to incorrect microstructural banding orientation of the die core and related to improper heat treatment. The microstructural banding orientation was determined by metallographic examination of the specimens, which were cut from the dies along the three axes of the coordinate system. Scanning electron microscopy (SEM) examination of the fracture surfaces and along the crack path (including energy dispersive spectroscopy (EDS) analysis) indicated that the root cause of the premature cracking of the dies was improper heat treatment (quenching and tempering conditions). Additionally, resistance to fracture of the investigated specimens, as measured by the Charpy V-notch test, was five times lower than that required for the desired hardness.

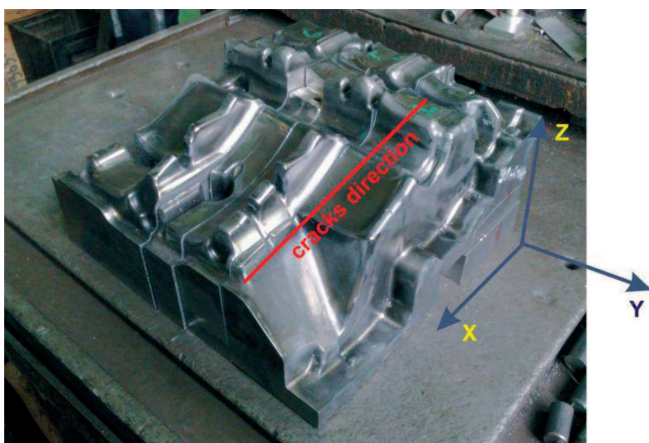
Samples from the damaged dies were cut for metallographic, scanning electron microscope (SEM), dilatometric and fracture toughness investigations. For both dies, the samples were geometrically oriented along the three axes of the coordinate system, in which the X-axis was parallel to the direction of the cracks, as shown in Fig. 4.

Fig. 4. Coordinate system orientation with respect to direction of surface cracks (red line)
