PIOTR BĘTKOWSKI*, ŁUKASZ BEDNARSKI**, RAFAŁ SIEŃKO***

STRUCTURAL HEALTH MONITORING OF A RAIL BRIDGE STRUCTURE IMPACTED BY MINING OPERATION

The bridge is located on the 23.449 km railway line No. 159 Orzesze–Wodzisław Śląski, trail Warszowice-Studzionka station branch. On the bridge, or rather two parallel bridges, two railway tracks are laid – one track on each of the structures.

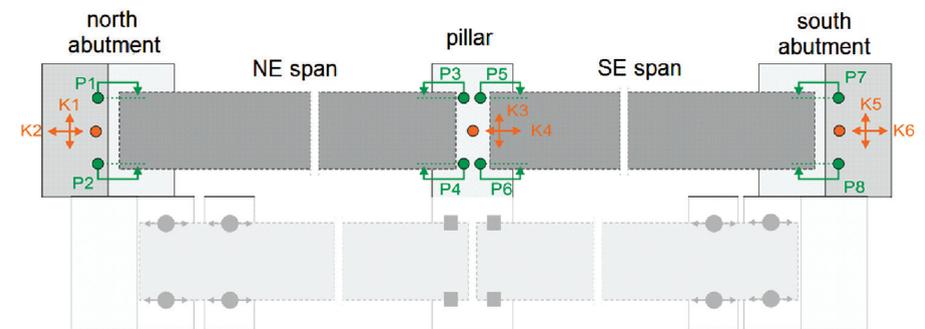
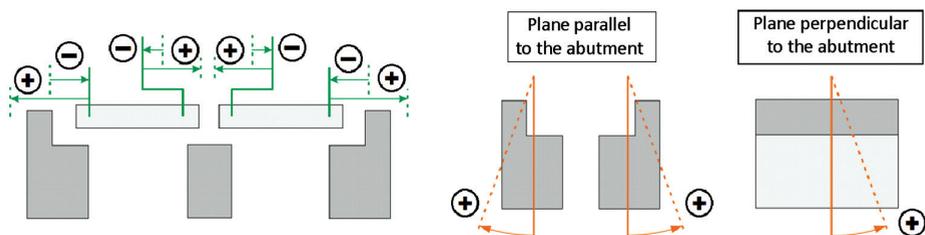
Fig. 4. Distribution of measurement points: P – measurements of horizontal displacement, K – measurements of supports angles

The principle of signing the values of linear (P1-P8) and angular (K1-K6) displacements

The non-existence of a linear relationship between of displacements recorded by sensor P2 with temperature changes demonstrates either locking of or permanent damage to the bearings on the support of the structure.

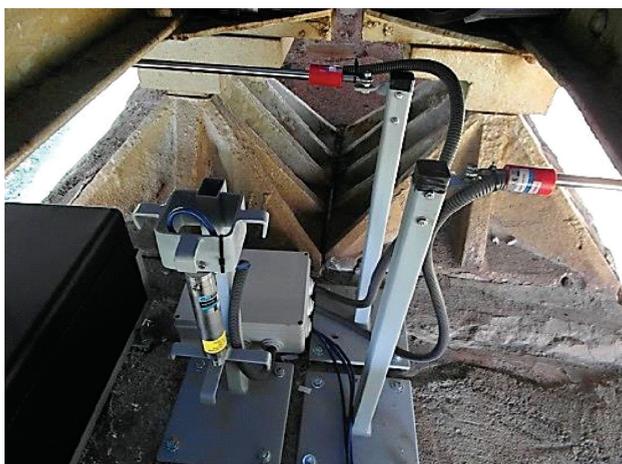
Fig. 5. Support structures for mounting angle sensors and displacement sensors at the intermediate support (view on the west side)

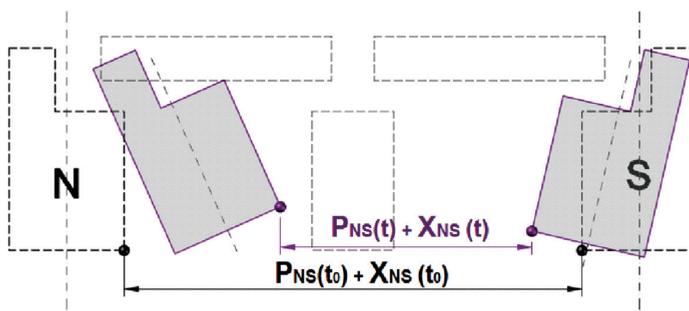
Fig. 10. Relative displacement of abutments – visual drawing

An interesting observation is the measurement of the tilt of the northeastern abutment in a plane perpendicular to the axis of the tracks. The value of the measured angle is now $K1 \approx -0.18^\circ$. This means that the abutment (assuming the theoretical amount $H = 8$ m) is tilted so that the upper part of the structure has moved approximately 25 mm to the west. Such behaviour of the northeastern support may result in the observed locking (wedging) of rolling bearings (probe P2).
