Can Historic Interiors with Large Cubature
be Turned Acoustically Correct?Tadeusz KAMISIŃSKI⁽¹⁾, Andrzej KULOWSKI⁽²⁾, Roman KINASH⁽³⁾

The paper is a presentation of architectural interference in three historic interiors with large cubature leading to changes in their acoustic qualities. In two cases, the changes were beneficial to the functional qualities of the halls to satisfaction of the investors carrying out the renovation work. In the third instance, the architectural interference aimed at showing off the monumental valor of the interior resulted in significant degradation of its acoustics. To remedy the situation impairing the functional program of the facility, corrective measures are proposed neutral with respect to its historic character.

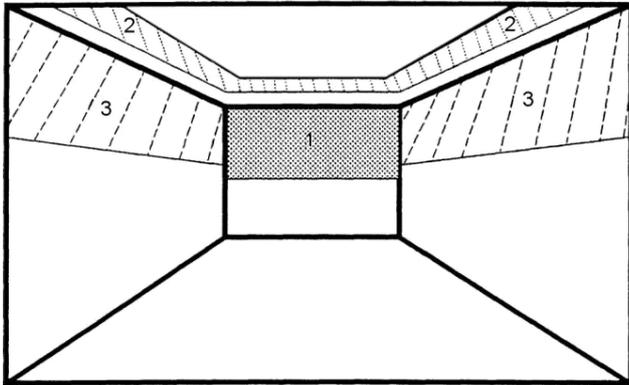
Fig. 3. The recommended sequence in which the sound-absorbing materials should be applied, in the order corresponding to increasing effect on the room acoustics: 1 – rear wall; 2 – ceiling portions bordering to walls, 3 – upper portions of side walls (KULOWSKI, 2011; FASOLD, WINKLER, 1976).

Historical character of the interior excluded the use of typical materials (such as mineral or glass wool lined with fabric), but it was possible to hang window curtains and additionally, cover the floor with fitted carpet in case of certain events. Presence of 11 large paintings unexpectedly turned out to be a favorable circumstance – they could be lined on the back side with a 50-mm thick layer of mineral wool with density of about 60 kg/m³. The canvas surfaces covered with a thick layer of oil paint, stretched on thick frames filled in with sound-absorbing materials, have formed a box-shaped acoustic structures absorbing effectively low-frequency sound components. Location of the paintings in upper portions of the walls was also a favorable circumstance (Fig. 3). Acoustic properties of the used materials are listed in Table 1.

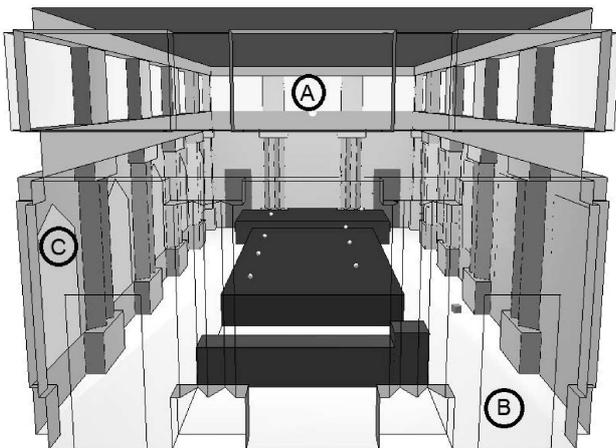
Fig. 4. The Assembly Hall model developed in CATT-Acoustic with arrangement of sound-absorbing materials listed in Table 1.

A graphical representation of the model used to simulate the hall in CATT-Acoustic programming environment is shown in Fig. 4. The model was developed with geometrical dimensions of the hall taken into account together with sound absorption and diffusion coefficients characterizing the existing finishing materials and furniture (4 long tables, a lectern, and 160 upholstered chairs). The model has been calibrated based on the measured reverberation time values.

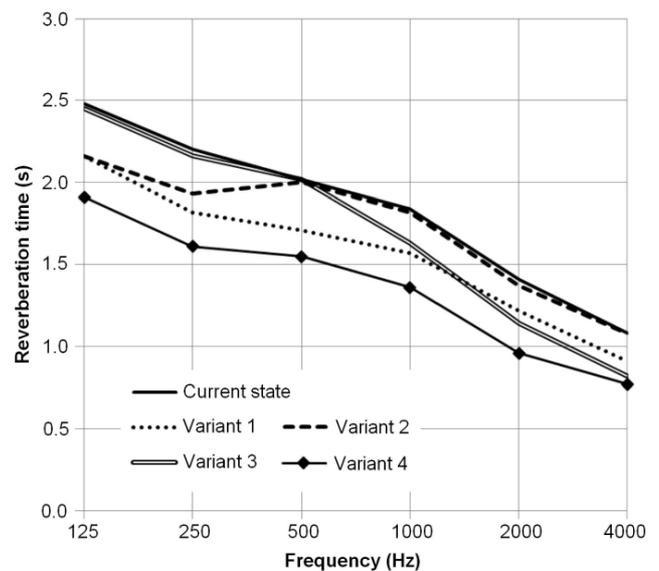
Fig. 5. Reverberation time frequency characteristics for the LUT Assembly Hall (unoccupied, computer simulation).

Simulation results closest to the design assumptions correspond to the use of all measures admissible in the hall in view of heritage conservation restrictions (cf. Table 2, Variant 4). The obtained value of $STI = 0.57$ corresponds to a good speech intelligibility (the reverberation time value for frequency 500–1000 Hz is 1.45 s). An interesting feature is the favorable behavior of the sound absorbing material used as lining under the paintings, thanks to which a significant reduction of the reverberation time in the low-frequency range has been obtained.

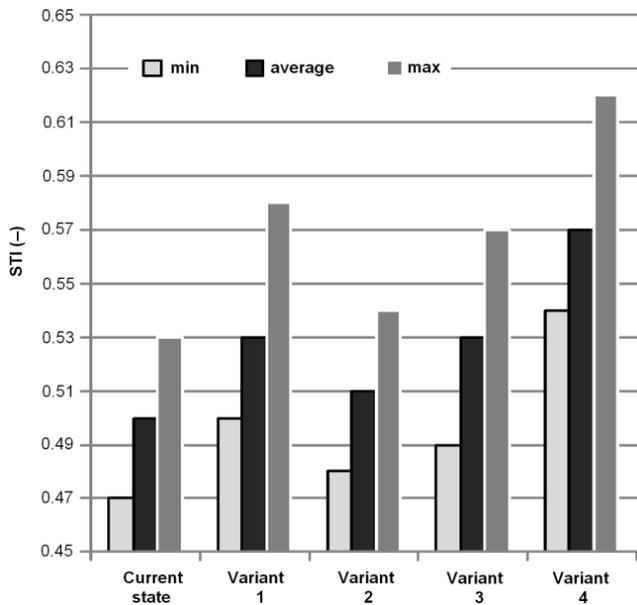
Fig. 6. The sound transmission index in the LUT Assembly Hall (unoccupied, computer simulation).

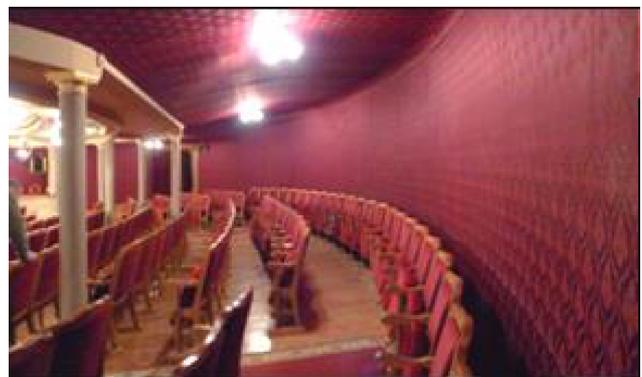
Fig. 8. The underbalcony space in the Lviv Opera House hall prior to installing the sound diffusing structures. The walls and ceiling were covered with a textile tapestry.

The hall has a horseshoe-shaped layout typical for opera houses, with level floor in the stalls and rows of boxes situated on the semicircular wall (Fig. 7). An acoustically difficult element in rooms of this specific shape are concave underbalcony cavities situated along the rear wall in the stalls. In case of walls being finished with hard materials, such as plaster or wallpaper put up on a hard substrate, the sound reflected from the rear wall focuses in the rear part of the audience area which is considered an important acoustic flaw of any room. At some point in time, the user decided to soundproof the rear wall (Fig. 8) which was also unfortunate because of excessive sound damping in the higher frequency range observed in the last two rows of seats.

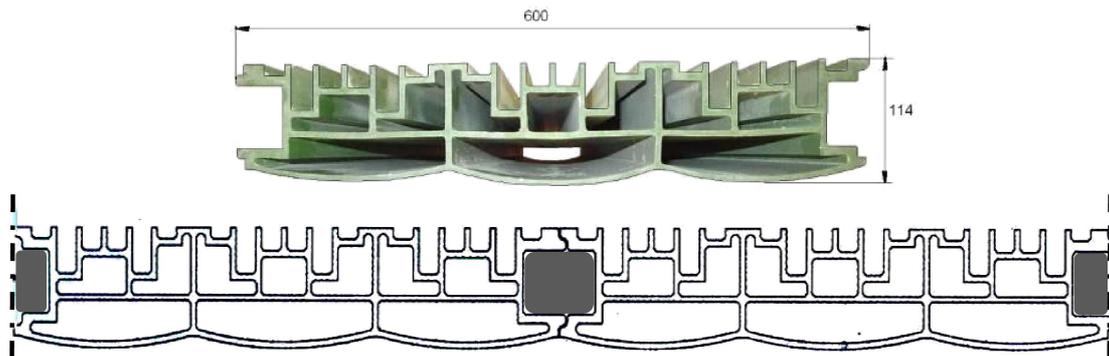
Fig. 9. A cross-section of the sound diffusers (dimensions in mm). The material and manufacturing process is protected as an industrial design (Community Designs Bulletin, 2012).

Structures of that type are composed of geometrical elements arranged in repeatable series. However, cyclical form and “technocratic” appearance of the diffusers impose serious limitations as far as their applicability to interiors with clearly exposed architectural style is concerned. Especially in rooms designed and finished in the eclectic style, where interiors are decorated with irregular carvings inspired by plant-like forms, pieces of figural sculpture, and highly diversified geometrical motifs following the canon of specific stylistics, any modern finishing element with highly technical form can be perceived as an alien feature. However, high efficiency of Schroeder diffusers invented four decades ago encourages designers to use them to correct acoustics of highly renowned historic concert halls, such as the Carnegie Hall in New York which opened in 1891 (COX, D’ANTONIO, 2004). An important factor in this case is the technological awareness of contemporary architects and heritage conservation officers who, unlike their counterparts operating in the 19th century, accept interference of that kind into appearance of period halls. The economic aspects play also an important role in making such decisions, because when a hall representing the quality of a historic monument retains its original function and realizes it successfully in line with contemporary technical standards, it becomes very attractive to both the public and the owner.

Schroeder diffusers are usually constructed by craftsmen in the course of interior finishing work or are offered in short series by specialized manufacturers. A solution concerning both the material and technological process used to fabricate the diffuser elements on an industrial scale has been patented in the European Union as an industrial design (Fig. 9). The diffuser has a form of a pressing continuously extruded out of a composite based on epoxy resin (EPD) filled with wood dust. The system is mounted on 60 mm × 60 mm posts inserted into holes provided in the diffuser’s structure.

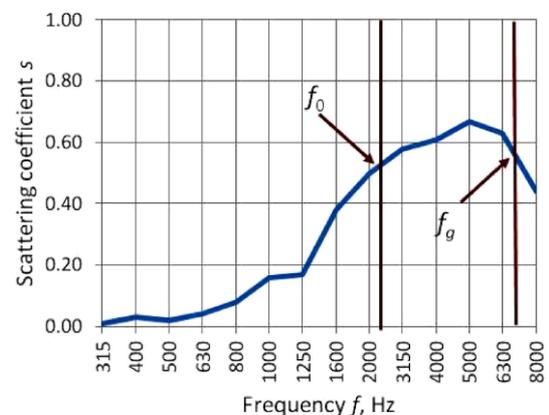
Fig. 10. The sound scattering coefficient s for the diffuser of Fig. 9 obtained from acoustics measurements (third-octave resolution, frequency range 314–8000 Hz). f_0 and f_g are the lower and the higher sound diffusion limiting frequencies, respectively. It is assumed that sound diffusion occurs at frequencies above $0.5 f_0$ (KAMISIŃSKI *et al.*, 2012b).

as the ratio of the sound energy reflected in the diffused way to the total reflected sound energy. Values of the coefficient s depend strongly on the sound frequency (Fig. 10). The frequency range $[f_0, f_g]$ within which the sound diffusion is particularly effective is a derivative of the sequence of wells constituting the structure. The sequence, i.e. the number of wells per cycle, their width, and depth, is determined by an algorithm developed by MANFRED SCHROEDER (1975). The lower limiting frequency f_0 is related to maximum depth of the wells. The value adopted in the present case (2234 Hz) followed from technological limitations and the fact that for deep wells, the diffuser is characterized with high absorption coefficient at low frequencies (KAMISIŃSKI *et al.*, 2012a).

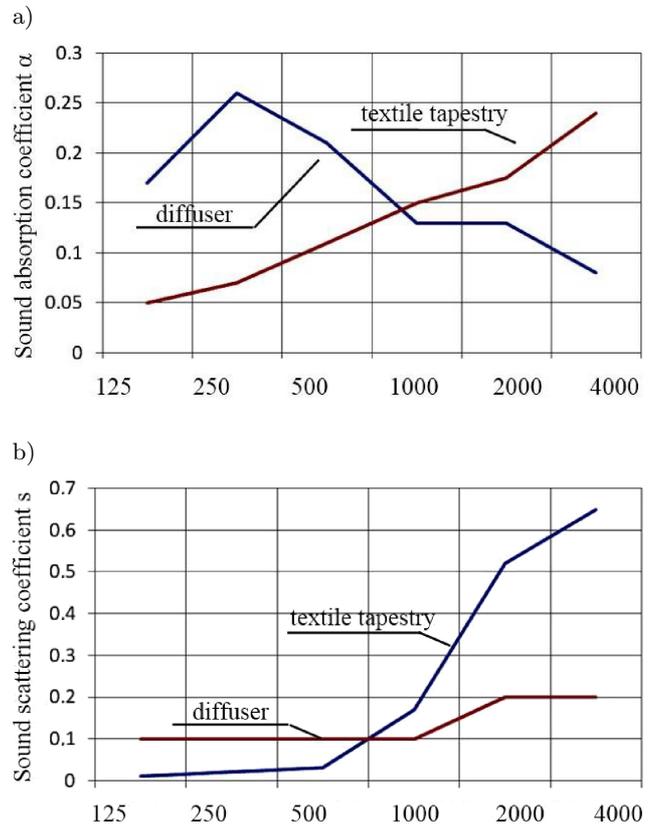
Fig. 11. Acoustic parameters of the textile tapestry and the diffuser of Fig. 9 used in computer simulation (octave resolution, frequency range 125–4000 Hz): a) sound absorption coefficient α , b) sound scattering coefficient s (KAMISIŃSKI *et al.*, 2012b).

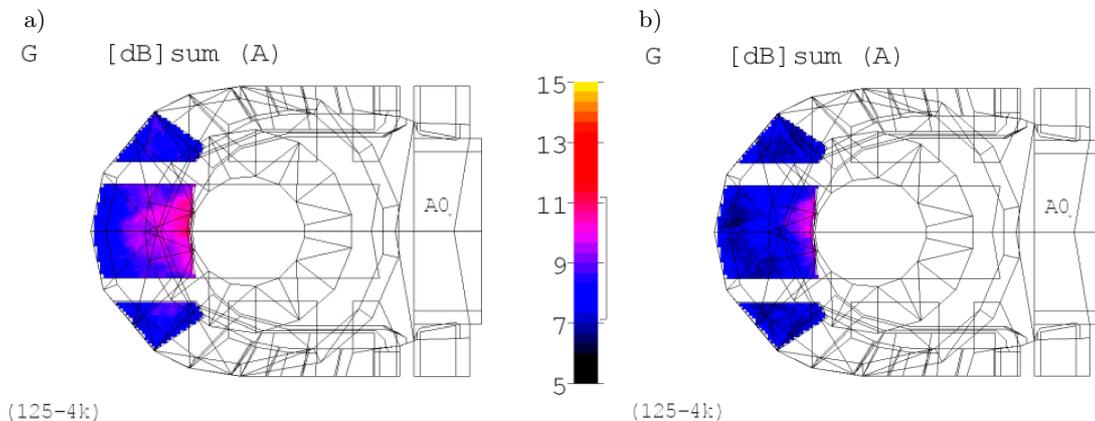
Fig. 12. The forecasted distribution of G values in the underbalcony area for the rear wall covered with: a) textile tapestry, b) sound diffuser.

smooth and hard rear wall with a sound scattering structure, distribution of the parameter became significantly more even (Fig. 12). The effect is particularly prominent for frequencies above 1 kHz, as in this very range, the sound absorption introduced by the diffuser is lower, while the scattering effect is stronger (Fig. 11). Even more favorable is the forecasted change in the clarity factor C_{80} (Fig. 13). This is especially

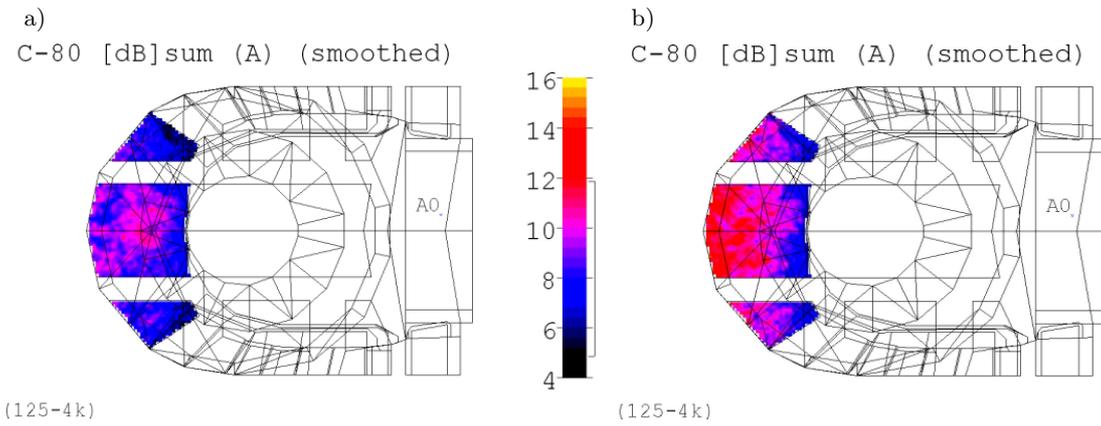
Fig. 13. The forecasted distribution of C_{80} values in the underbalcony area for the rear wall covered with: a) textile tapestry, b) sound diffuser.

true for the last rear rows where acoustic deficiencies were most uncomfortable. In this area, C_{80} increases by as much as 5 dB, and what is more, distribution of this increased value remains even in the whole underbalcony zone. In view of the complex measurement procedure (ISO 17497-1, ISO 17497-2), sound scattering coefficients are rarely published. Graphs shown in Fig. 11 a come from the authors' own measurements (KAMIŃSKI *et al.*, 2012b), while scattering coefficients of other materials have been adopted as suggested in the instructions for the program CATT-Acoustic.

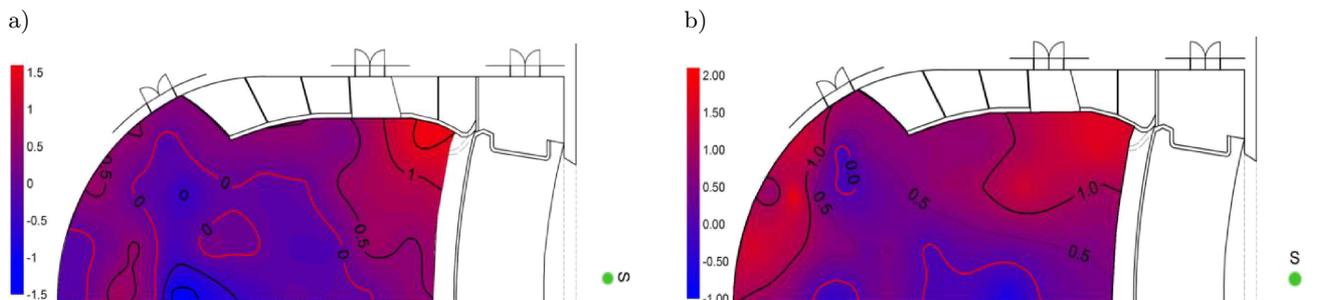
Fig. 14. The effect of mounting the diffusers on the sound strength G in octave bands: (a) 0.5–1 kHz and (b) 4 kHz.

the whole impulse response decay period (cf. Fig. 15a and 14b, respectively). This means that the impression of sound strength in the auditorium and the parameter G corresponding to sensation related to this quantity is created in the initial stage of formation of the impulse response. The observation is consistent with the generally accepted regularity concerning enhanced response of the human ear to early high-energy sound reflections.

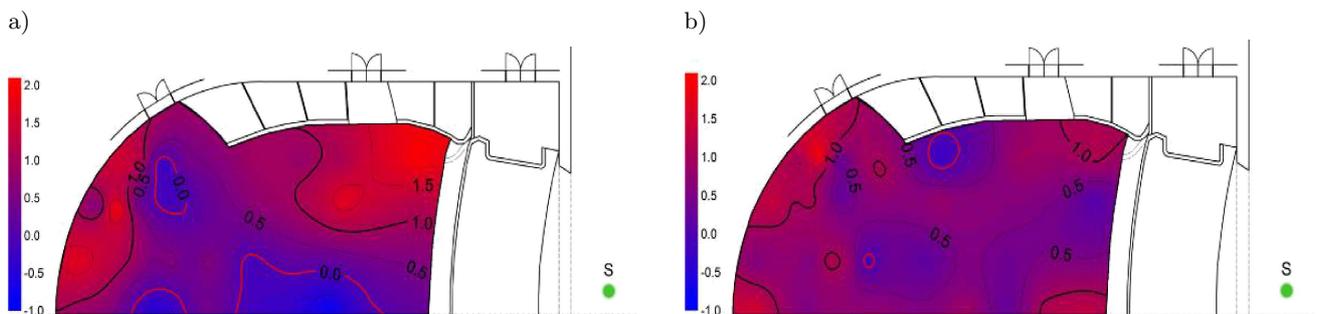
Fig. 15. The effect of mounting the diffusers on the sound strength G : a) $G_{80 \text{ ms}, 4k}$ and b) $G_{\text{Late}, 4k}$.

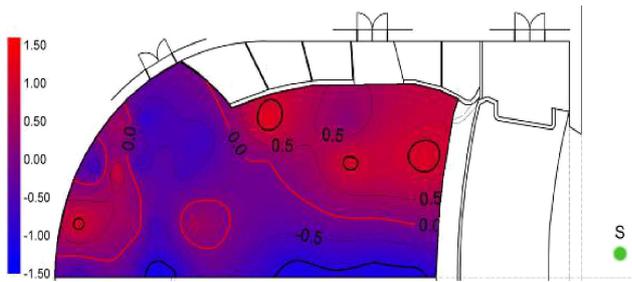
Fig. 16. The effect of mounting the diffusers on the sound clarity $C_{80, 4k}$.

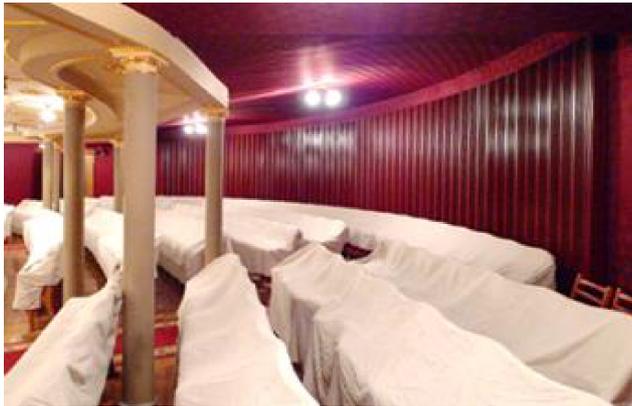
Fig. 17. The underbalcony space in the Lviv Opera House after mounting the sound diffusers.

surements covered the whole stalls. The measurements were taken in the unoccupied hall. From among all parameters that were examined, the sound strength G was the one which demonstrated the most noticeable effect related to mounting the diffuser on the rear wall. The increase was particularly high in the medium ($G_{0.5-1 \text{ kHz}}$) and high ($G_{4 \text{ kHz}}$) frequency regime in the whole area of stalls (Fig. 14). The other parameters noticeably improved in the underbalcony cavity and in the areas close to proscenium, at the expense of a slight reduction of their values in the auditorium center (Figs. 15 and 16). A view of the underbalcony cavity with the diffusers installed on the rear wall is presented in Fig. 17.

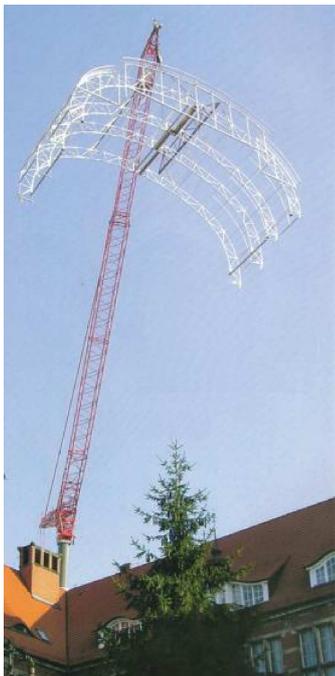
Fig. 19. Transferring glazed roof framework from the assembly site onto the Hevelius Courtyard (CYWIŃSKI, 2012).

The courtyards remained open-air spaces until 2004 when glazed roofs were installed over both of them. The load-bearing structure is based on arched steel trusses with the span reaching about 22.5 m. The roof shell is made of double-pane insulation glass units with voids filled with argon. The outer panes made of tempered glass are 10-mm and 8-mm thick, while the inner pane is a 2 × 4 mm glass laminate with plastic film glued between the layers (Figs. 18–20).

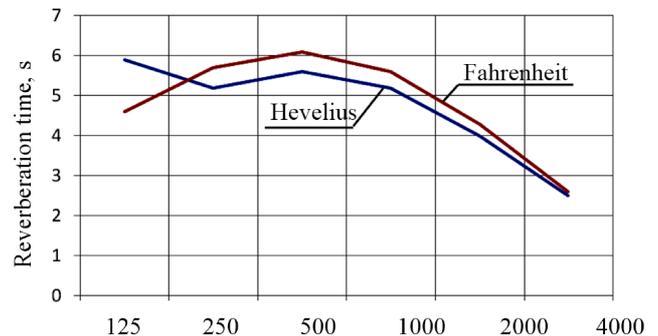
Fig. 21. Reverberation time of the courtyards after textural plaster renovation and face brick cleaning (July 2007).

availability of the courtyards was created at the expense of serious degradation of their acoustics. The reverberation time characterizing both courtyards increased more than 2.5 times (cf. Fig. 23), which resulted in significant deterioration of speech intelligibility parameters.

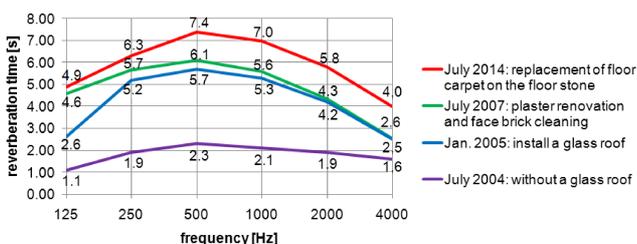
Fig. 23. The Fahrenheit Courtyard reverberation time after successive renovation stages.

The original acoustics of the courtyards was characterized with a short reverberation time (cf. Fig. 23, the lowest curve). The original acoustics of the courtyards was distinguished with a short reverberation time and high degree of sound diffusion. This followed from diversified structure of the brick elevation with significantly resolved stone decorations and resulted in good speech intelligibility. Such characteristics was favorable from the point of view of the functional program of the courtyards despite exposition of the space to the elements.

als are intended mainly for outdoor applications, such repairs result in further deterioration of acoustic conditions prevailing in the courtyards. For instant, the recent stage of renovation included laying a stone floor (Fig. 22) which was the cause of further increase of the reverberation time, as the stone, alike the glass used for the roofing, is a material reflecting virtually the whole of incident acoustic energy. After subsequent work stages, the reverberation time increased gradually and from the initial 2.5 s, it increased up to the current 7.5 s, whereas the value recommended for the official functional program of the interiors should not exceed 2.0–2.5 s (Fig. 23).

where $T_0 \approx 7.0$ s is the currently observed reverberation time (cf. Fig. 23), and ΔA is the acoustic absorptivity increase relating to application of the foil, value of which can be calculated as

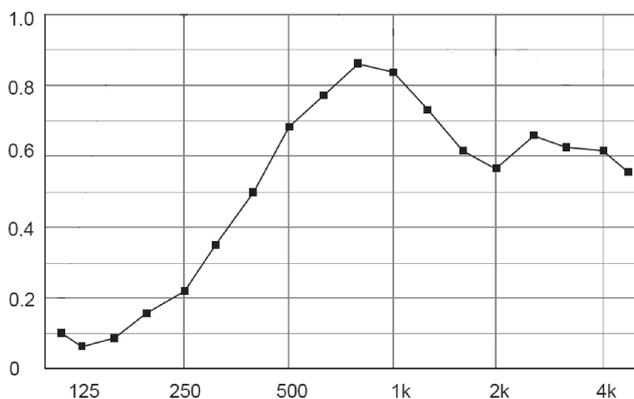
Fig. 24. The sound absorption frequency characteristic for the microperforated foil stretched at a distance of 10 cm from glass pane. Film parameters: thickness 0.18 mm; 500,000 $\varnothing 0.1$ mm holes per m²; perforation rate 1%; sound absorptivity class D, $\alpha_w = 0.55$ (NOCKE, 2014).

where $\alpha = 0.85$ is the absorption coefficient of the foil (cf. Fig. 24) and $S = 1.079$ m² is the total area of glazed surfaces (cf. Subsec. 4.1).
