ANNA WASSILKOWSKA, KAROLINA KUC, MICHAŁ ZIELINA*

A STUDY OF THE COMPOSITION OF CEMENT MORTAR LINING IN WATER AND SEWAGE PIPELINES

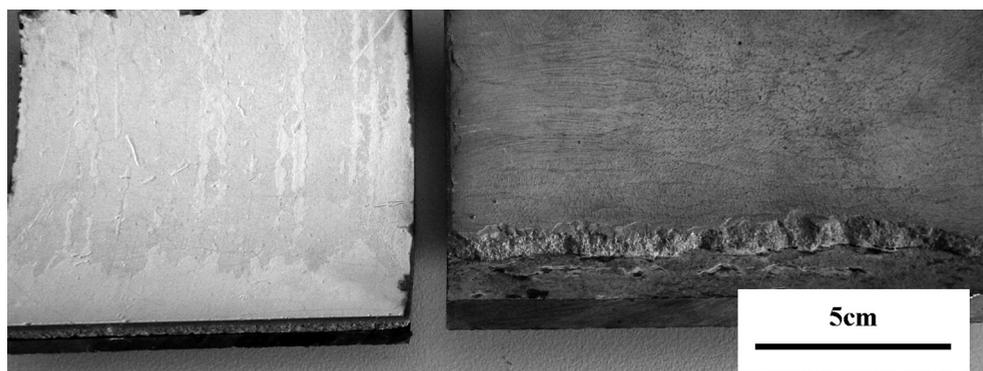
Fig. 1. Image of the factory cement lining: specimens S (on the left) and B (on the right)

The materials for the study consisted of three cast iron pipes from different suppliers, lined with standard cement mortar coating. The collected samples were determined as follows: *E* and *S* – coating of water pipes with a diameter 150 mm, *B* – a coating of sewer pipe with a diameter 100 mm. Macroscopic inspection included visual inspection of the appearance and colour of the lining surface (Fig. 1) and measurement of coating thickness using a micrometer screw (Table 1). It was assumed, that the comparative test will be made with Portland cement. The sample M was taken from the pipes, which are part of the laboratory equipment, as described in Ref. [6]. Concrete mix was prepared from cement CEM I 42.5R and fine sand in relation 1:1 with the addition of water, which guaranteed water-cement ratio $w/c = 0.3$. The coating was applied manually in the laboratory, hence the lack of segregation of components in its cross section.

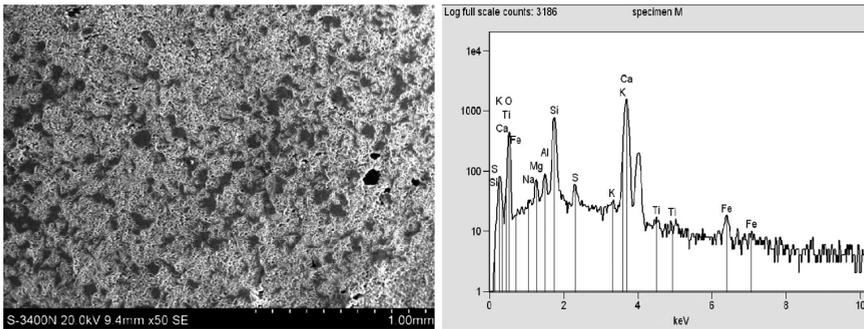
Fig. 2. Surface analysis of a reference Portland cement lining (specimen M)

For various cements based on Portland cement clinker, the difference in the composition of the upper layer of the cement coating surface has been expected, due to differences in the composition and the respective proportions of clinker minerals, undergoing binding and hardening. Table 1 shows that the estimated thickness of the cement laitance (G_2) does not depend on the overall thickness of the coating (G_1). Microscopic photographs of the Surface coating (Figs. 2–5) disclosed qualitatively different characteristics: open porosity (*M* and *S*), small cracks (*E* and *S*) and roughness (*M* and *B*). On the Surface of the sample *E* showing a part of the slag, which confirms the use of cement of CEM III class. For comparison only of the Surface of the sample – the typical spectrum is given in the next picture to the structure from Fig. 2 to Fig. 5. More particularly, for spin-coating applied, it is the cement laitance.

Comparative coating *M* matured in different natural conditions than factory-allied, but according to the literature [11, 12], should show typical composition of clinker: 62–68% CaO, 18–25% SiO₂, 4–8% Al₂O₃, 2–4% Fe₂O₃, 0.5–0.6% MgO, 0.8–3.0% SO₃, 0.4–3.0% N₂O+K₂O. For Portland cement, hydrated silicates, aluminates and ferrites calcium proceeds to form ettringite-like compounds, portlandite (called “slaked lime”), and tobermorite silicate phase (gel substance with high fineness) [9]. It is known that, in contrast to Portland cements (*M*), blast furnace cement contain less lime, more silica and generally more alumina [9]. The calculation of the composition of the oxide phase in Portland cement clinker is pointless here, since the analysis of coatings was carried out by semi-quantitative method – the results are compared in Table 2.

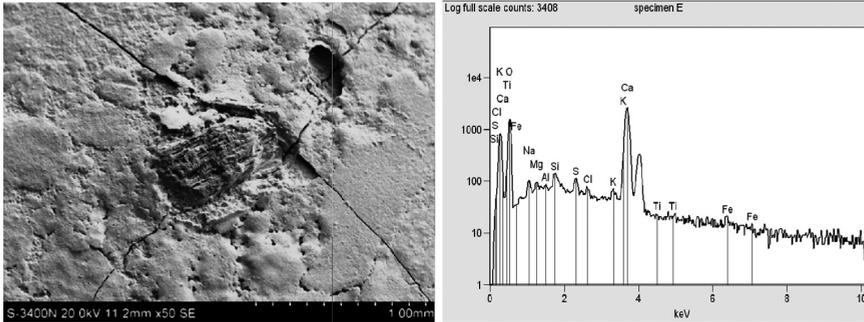
Fig. 3. Surface analysis of a cement-mortar lining from water supply pipe (specimen E)

The results for water pipe linings showed that specimen (*S*) contains more silica and iron-aluminate than the specimen (*E*); the linings have also different content of magnesium, sodium and sulfur. The composition of cement lining (*B*) shows a large amount of aluminate phases, higher concentration of Mg and, above all, the presence of Ti in quantities equal to Si. According to [13] titanium dioxide is „self-cleaning” on concrete surfaces, neutralizes organic compounds and prevents the emergence of fungi and lichen on the air.

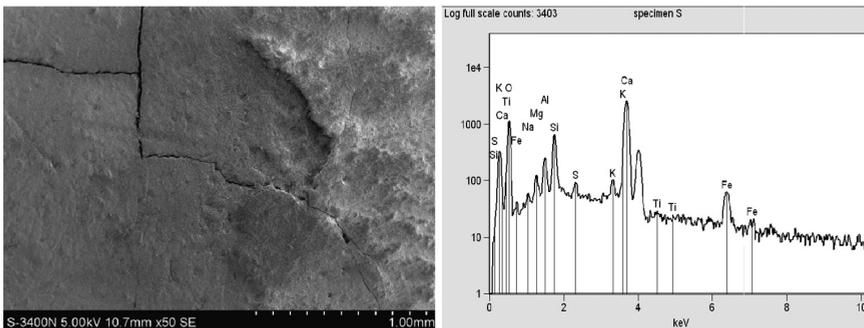
Fig. 4. Surface analysis of a cement-mortar lining from water supply pipe (specimen S)

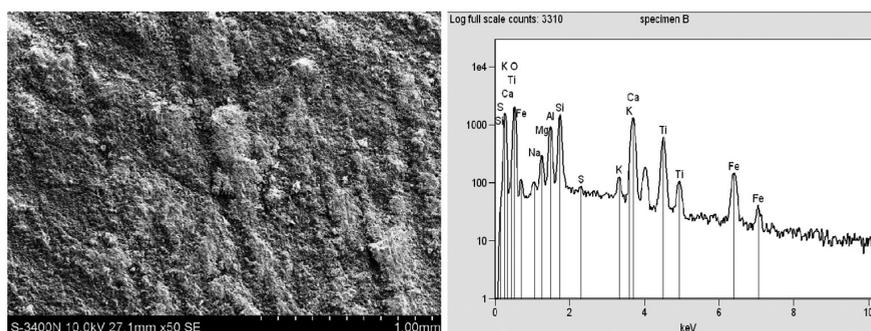
Fig. 5. Surface analysis of a cement-mortar lining from sewage pipe (specimen B)
